REPORT OF INVESTIGATION

**Surface Nonmetal Mine
(Granite)**

**Fatal Falling Material Accident
June 12, 2007**

**Felton Quarry
Granite Construction Co.
Felton, Santa Cruz County, California
Mine ID No. 04-00107**

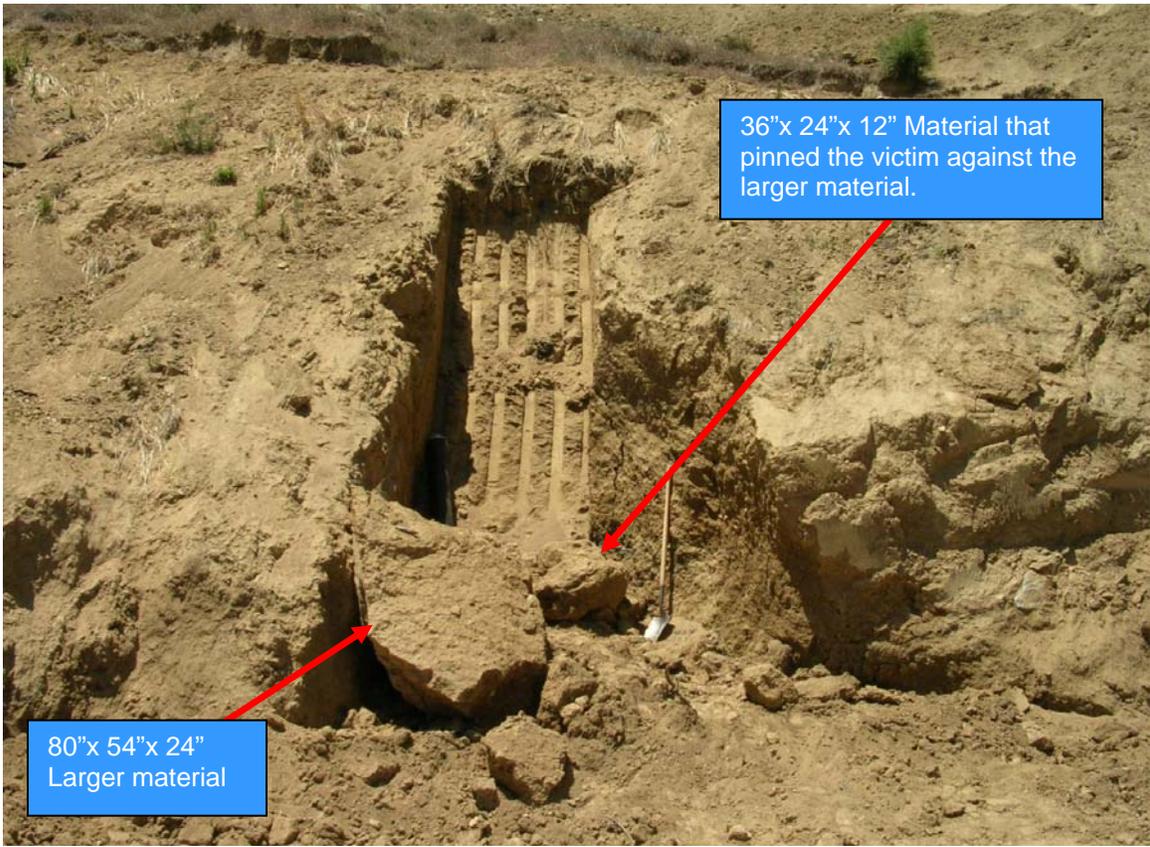
80"x 54"x 24"
Larger material

36"x 24"x 12" Material that
pinned the victim against the
larger material.

The accident occurred when a mass of material separated from the right trench wall and collapsed into the trench. The material fell into the trench predominantly by toppling and to a lesser degree by sliding.

The volume of collapsed material was estimated to weigh about 3 to 4 tons. A large portion of material collapsed in the form of cohesive boulder-sized soil pieces. The largest piece was 7 feet by 4 feet by 2 feet. It came to rest with the surface that separated from the trench wall facing upwards, suggesting predominantly toppling motion. The next largest piece reportedly came to rest against the lower back of the victim, pinning him against the large piece. This smaller piece was approximately 3 feet, by 2 feet by 1½ feet, weighing approximately 500 pounds.

The trench wall collapse was precipitated by the development of tension cracks in the unstable, 9 to 10 feet high, vertical trench wall. The soil was moist, but not saturated at the time of the collapse. The ground surface at the top of the trench was covered with loose, dry soil that may have concealed evidence of instability in the form of tension cracking at the ground surface. Unsupported vertical trench faces in soil are not normally regarded as stable.

Corrective Action: Management should establish procedures to ensure that persons can safely work in the area of excavations. Management should monitor persons working in these areas to ensure that the policies and procedures are effective to protect all persons.
