REPORT OF INVESTIGATION

UNDERGROUND METAL MINE

Fatal Fall of Person Accident  
July 29, 2007

Cowin & Company, Inc  
Contractor I.D. B84  
at  
Immel Mine  
East Tennessee Zinc Company, LLC  
Mascot, Knox County, TN  
Mine I.D. 40-00170

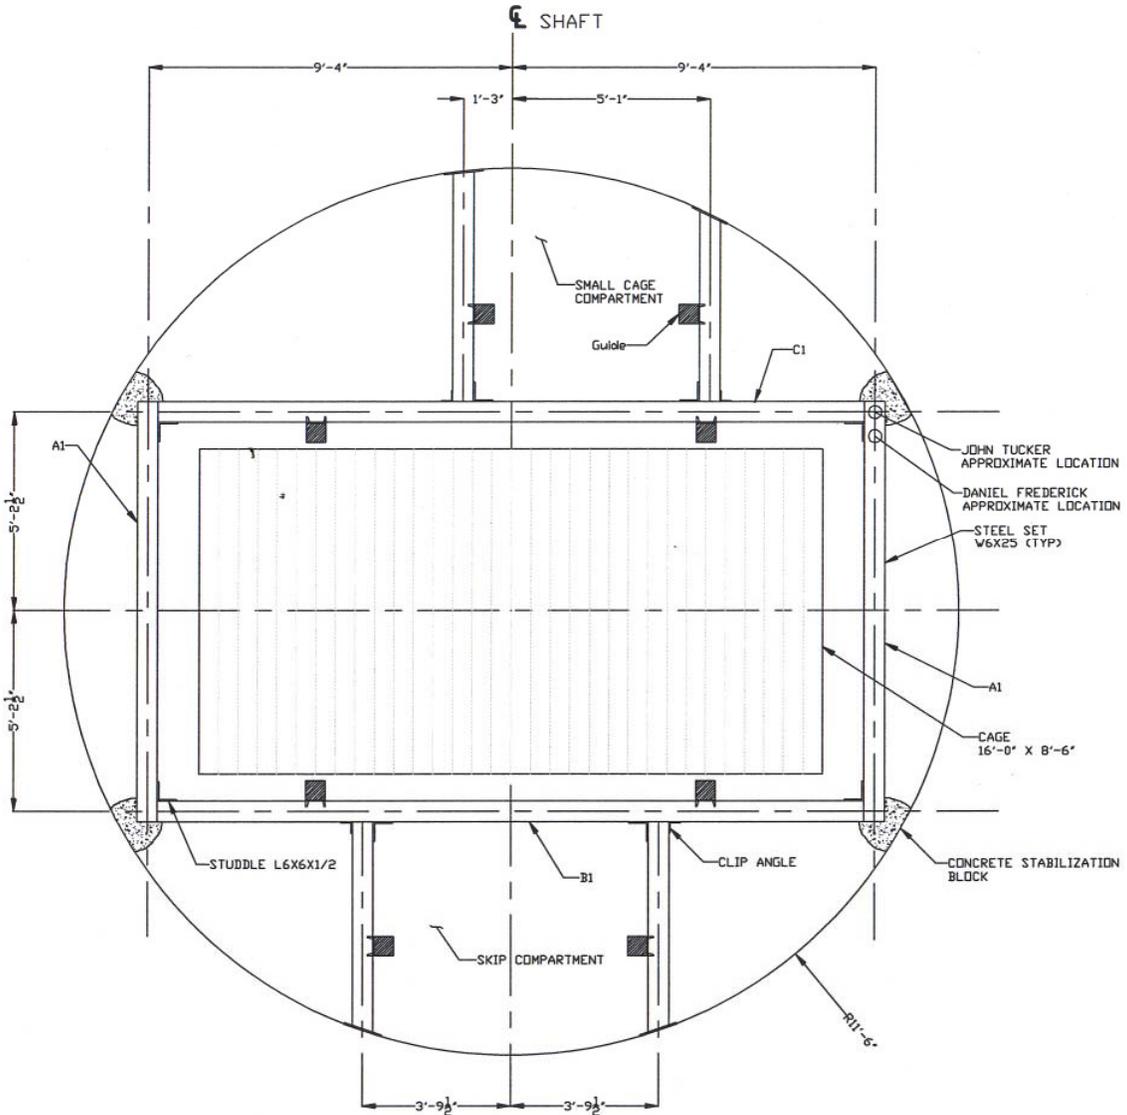
APPENDIX B  
Figure 1

Nine  $\frac{3}{4}$ -inch A325 bolts were used to connect the steel sets at each of the four corner studdles. Four of these bolts were used to connect each leg of the studdle to the flange of each adjoining steel set beam (A1-B1 and A1-C1). The one remaining bolt was used during initial erection of the steel sets to connect the flange of an abutting beam (A1) to a clip angle that was riveted to each end of the B1 and C1 beams.

As part of the rehabilitation work, the corner studdles were removed before the concrete stabilization blocks were removed. As a result of removing the eight bolts attaching the studdle to the steel set, a single  $\frac{3}{4}$ -inch bolt remained between A1 and C1. This bolt was encapsulated in the concrete stabilization blocks. Due to this encapsulation, the work crew could not see the bolt to verify its structural integrity or existence.

Figure 1. - Steel-Set Layout and Locations of Accident Victims at Immel Mine Production Shaft, 642 Feet Below the Collar.

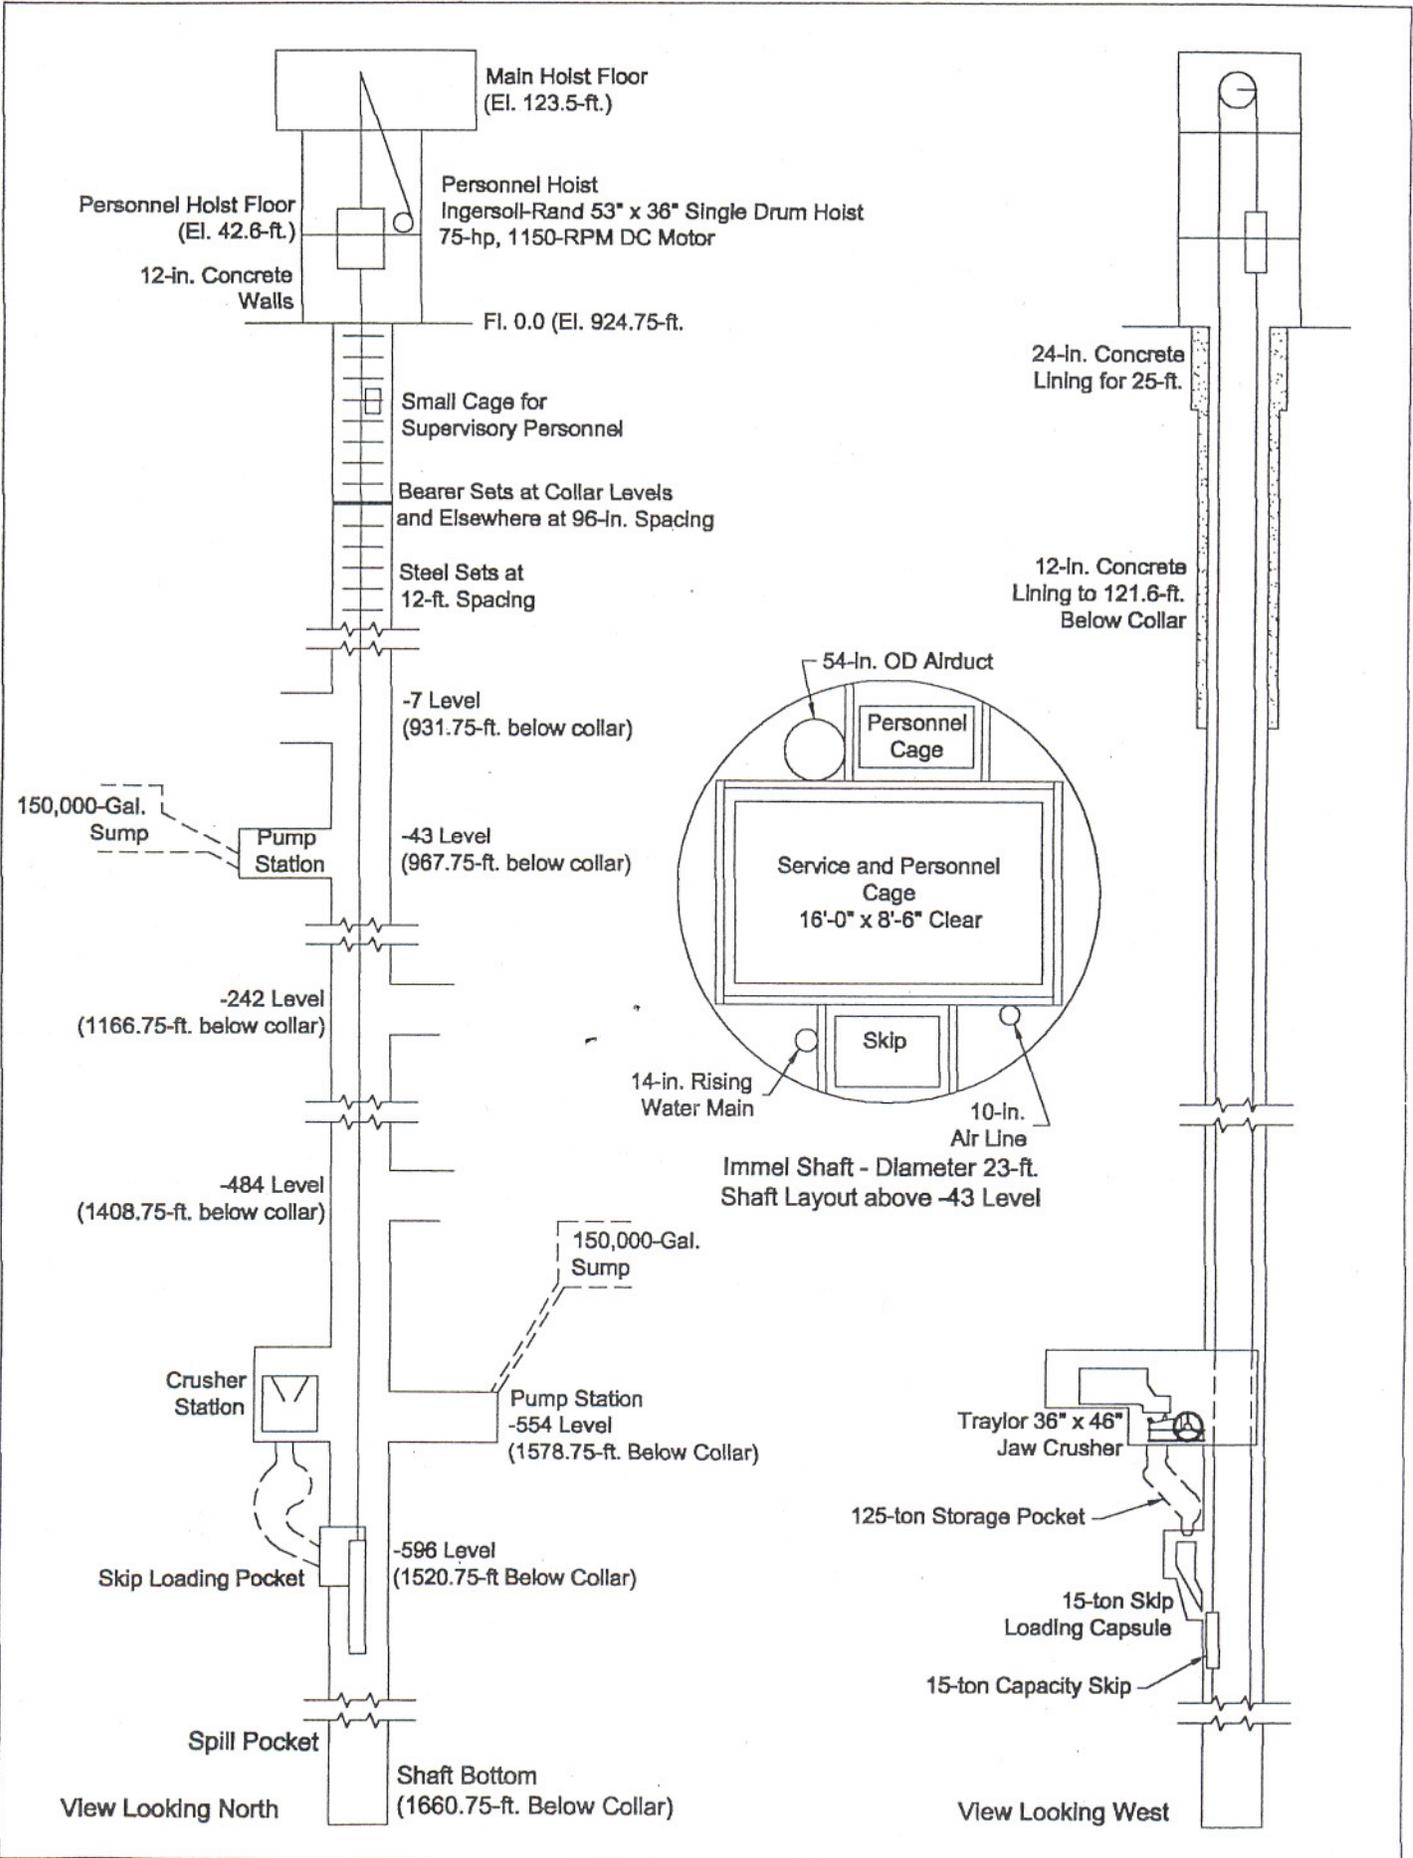
Figure 2

The production shaft was circular, unlined, 23 feet in diameter, and 1,642 feet deep. The shaft consisted of three main compartments with one conveyance in each compartment. An ore skip, a small personnel cage, and a larger service and personnel cage were in the compartments. (Appendix B, Figure 1 & 2). Three auxiliary compartments, adjacent to the three main compartments, were used for mine services – compressed air, water, and electricity.

The steel sets in the shaft were on 8-foot vertical centers and the bearing beams were on 96-foot vertical centers. The bearing beams supported the dead weight of the steel sets and were anchored into the rock of the shaft wall. Concrete blocks were cast between the shaft wall and corners of the steel sets to stabilize each steel set and to prevent lateral movement during travel of the skip and cages.

# Section Through Immel Shaft
