REPORT OF INVESTIGATION

Fatal Fall of Roof Accident
June 3, 2008

Gibson Mine
Gibson County Coal, LLC
Princeton, Gibson County, Indiana
I.D. No. 12-02215

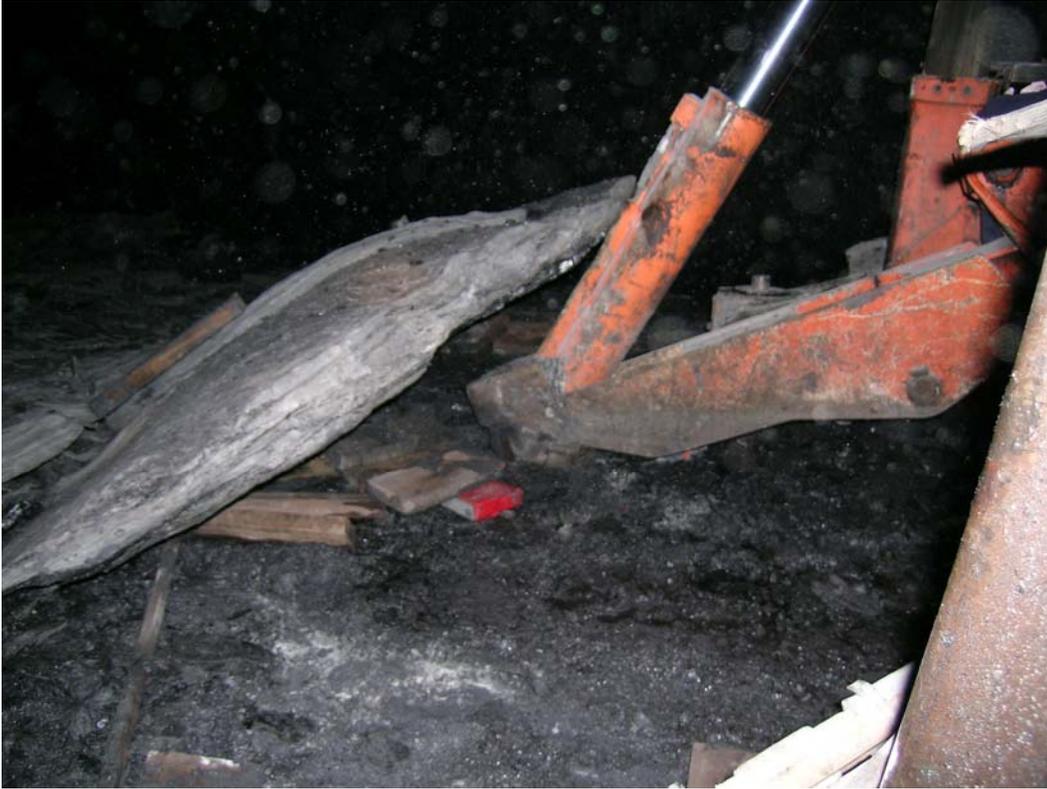
Photograph of accident scene showing Fletcher roof bolter with rock leaning against the ATRS raise cylinder

In front of the ATRS, a linear series of three shallow cavities oriented along a trend of N 50° W were defined where large pieces of sandstone had dropped out of the unbolted cut. The linear trend touched the inby edge of the right side of the ATRS bar, and trended inby toward the left rib. The ATRS bar had broken off the outby piece of sandstone. The cavities were slightly undulatory, defining hump-backs that were bounded by thin, black shale partings and concentrated fossil debris in sandstone. The fatal rock was one of three that defined what may have originally been a single, long, flattened cigar-shaped cantilever of 4- to 6-inch thick sandstone. The individual pieces of layered sandstone broke from the original single piece along black shale partings and diffuse zones with high concentrations of carbonized plant debris. The dimensions of the original single piece were estimated with a laser range finder as 18.6 feet long x 3-4 feet wide x 4-6 inches thick. The entire original length of sandstone is estimated to have

weighed approximately 2 tons, while the single piece of rock involved in the fatality, which pinned the victim to the vertical hydraulic support cylinder of the ATRS, is estimated to be approximately 8 feet long x 4 feet wide x 6-8 inches thick and weigh approximately $\frac{3}{4}$ ton.

Corrective Action: The mine operator submitted a revision to the roof control plan to the District Manager. The revision requires: 1) During bolting operations, when the Automatic Temporary Roof Support is pressurized against unsupported roof, operators will not travel between the left and right booms except by walking behind the machine; 2) Two operators will be present on dual boom roof bolters while installing primary support; 3) Miners, except examiners and roof bolters, will not travel or work inby the 2nd row of bolts outby unsupported roof; 4) All underground MMU workers were trained regarding the hazards related to the revised company policy and the related mine roof hazards.

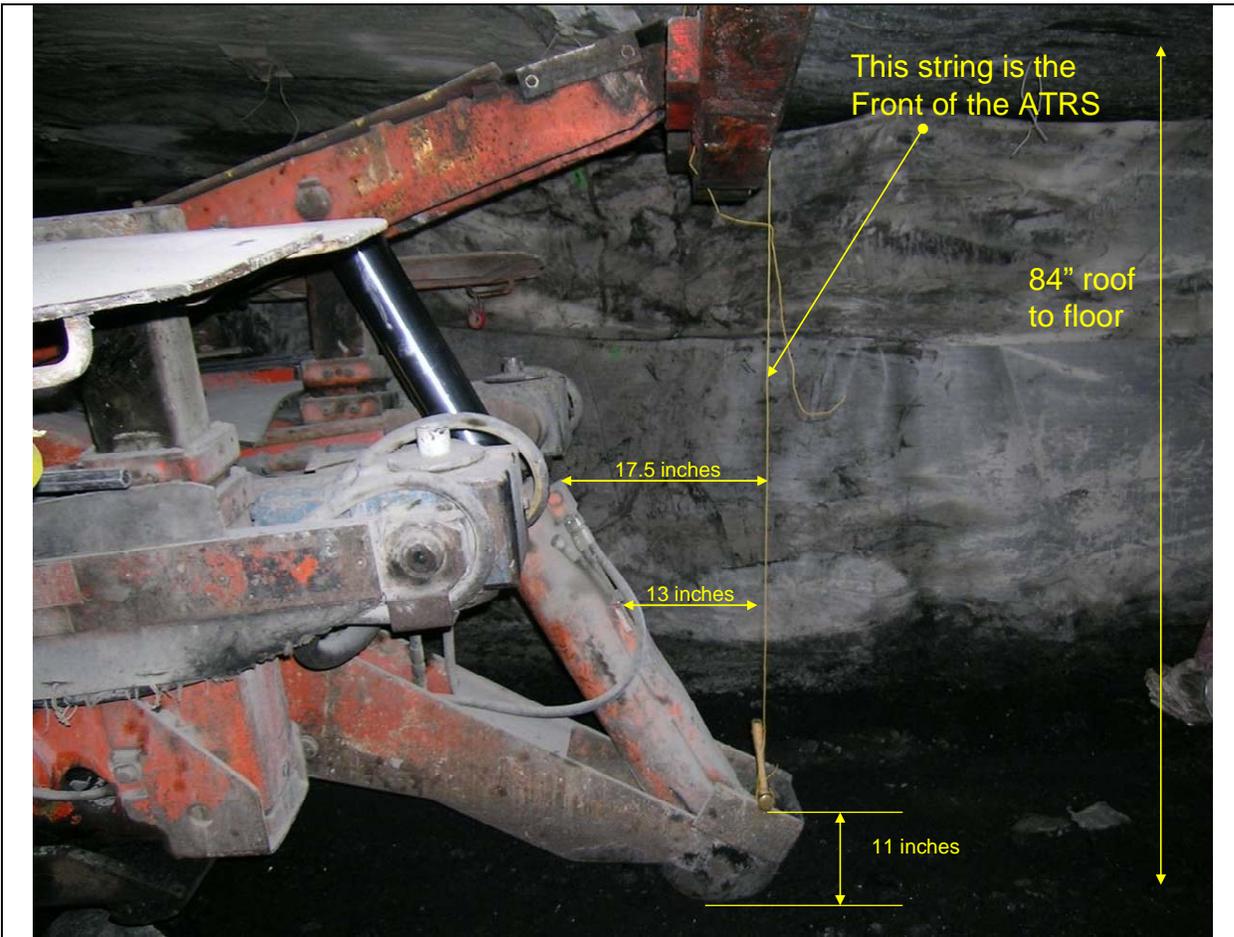
Appendix C

The accident occurred in the #1 entry approximately 60 feet inby Spad 24107. The rock that struck the victim fell from near the center of the entry at the inby edge of the ATRS support beam and rotated in the outby direction. It pinned the victim against the ATRS raise cylinder. The rock did not fall far enough outby to reach either of the drill stations. The mine floor around the right side drill station where Wilkin had been working was free of any rock or debris and the coal rib was intact. There was not a section of drill steel inserted in the drill pot and no indications on the mine roof that the hole for the right side center bolt had been started. Evidence indicates that the victim attempted to travel from the right side of the machine to the left side by walking in front of the roof bolter. Measurements taken on the roof bolting machine (Appendix C) reveal that the area between the front of the ATRS support beam and the ATRS raise

cylinder is very narrow. In addition, the ATRS foot actually extends beyond the ATRS support beam. It is unlikely that a person could travel in front of the machine without being in front of the ATRS support and under unsupported roof.
