REPORT OF INVESTIGATION

Surface Nonmetal Mine  
(Cement)

Fatal Exploding Vessel Under Pressure Accident  
May 14, 2010

Knoxville Cement Plant Cemex Inc.  
Cemex Construction Materials Atlantic, LLC  
Knoxville, Knox County, Tennessee  
Mine I.D. No. 40-00840

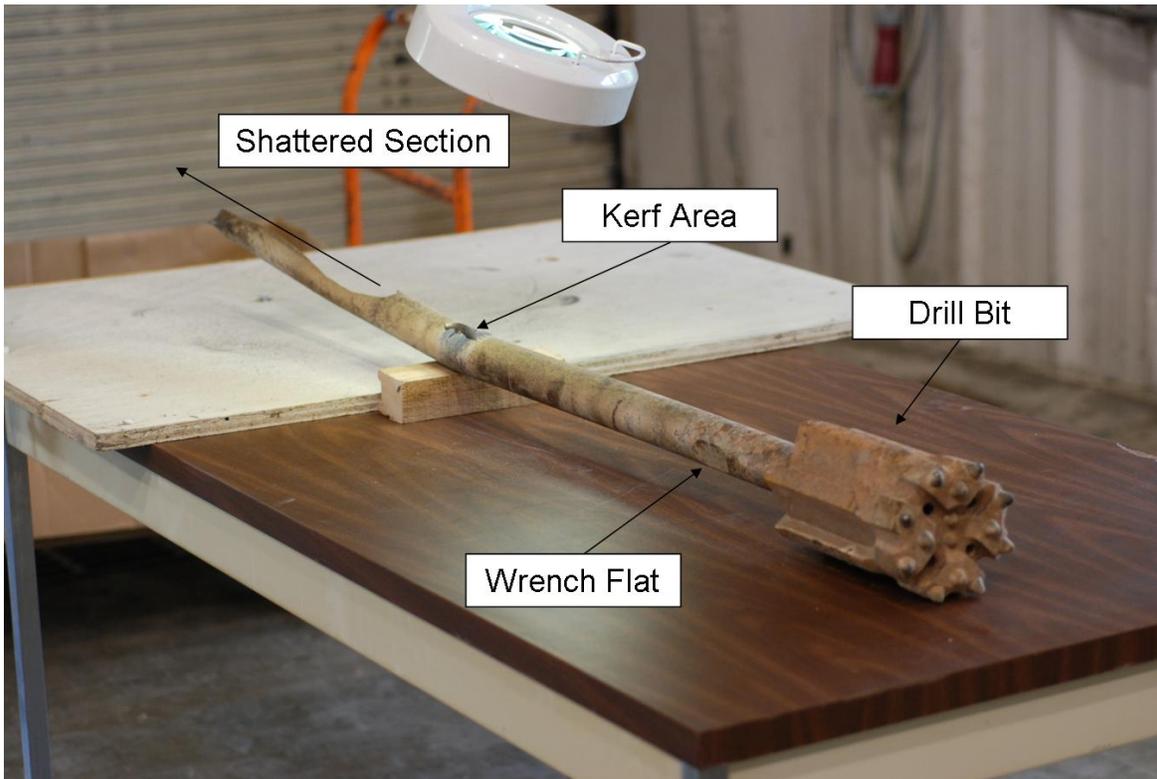
The drill steel shattered primarily toward the end opposite the drill bit. The area being cut by the victim (kerf area) was approximately 2 feet from the drill bit and was between the drill bit and the shattered section of the drill steel (see Photo No. 1). Investigators estimated that approximately 8 feet of the drill steel was shattered during the event. Smaller sections of the drill steel body had also shattered from either side of the kerf area (cut area) as shown in Photo No. 2. The sections missing in this kerf area contained marks that would visibly confirm whether or not the cut actually breached the inner diameter of the drill steel.

Photo No. 1: General Features of Drill Steel Involved in Accident

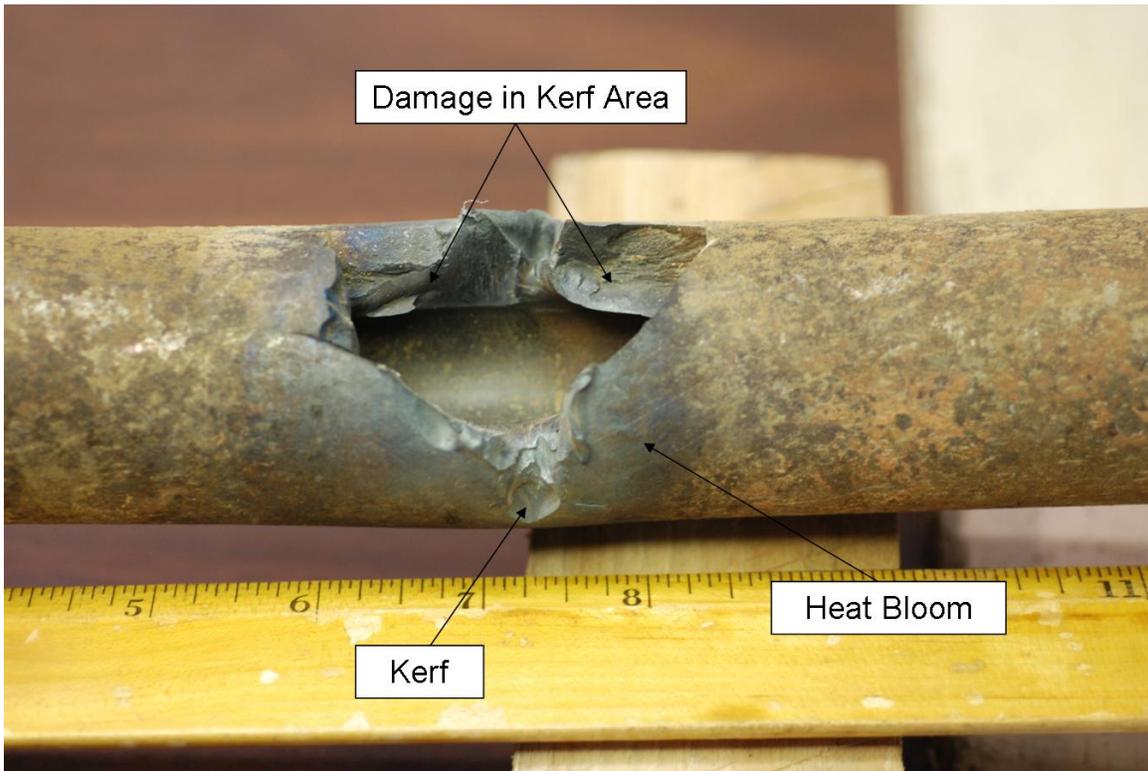
Photo No. 2: Damage to Kerf Area

Based on the relative sizes of the visible heat blooms and the position of the visible kerf, it appears that the victim was cutting the drill steel body in the counterclockwise direction (bottom towards top of Photo No. 2).

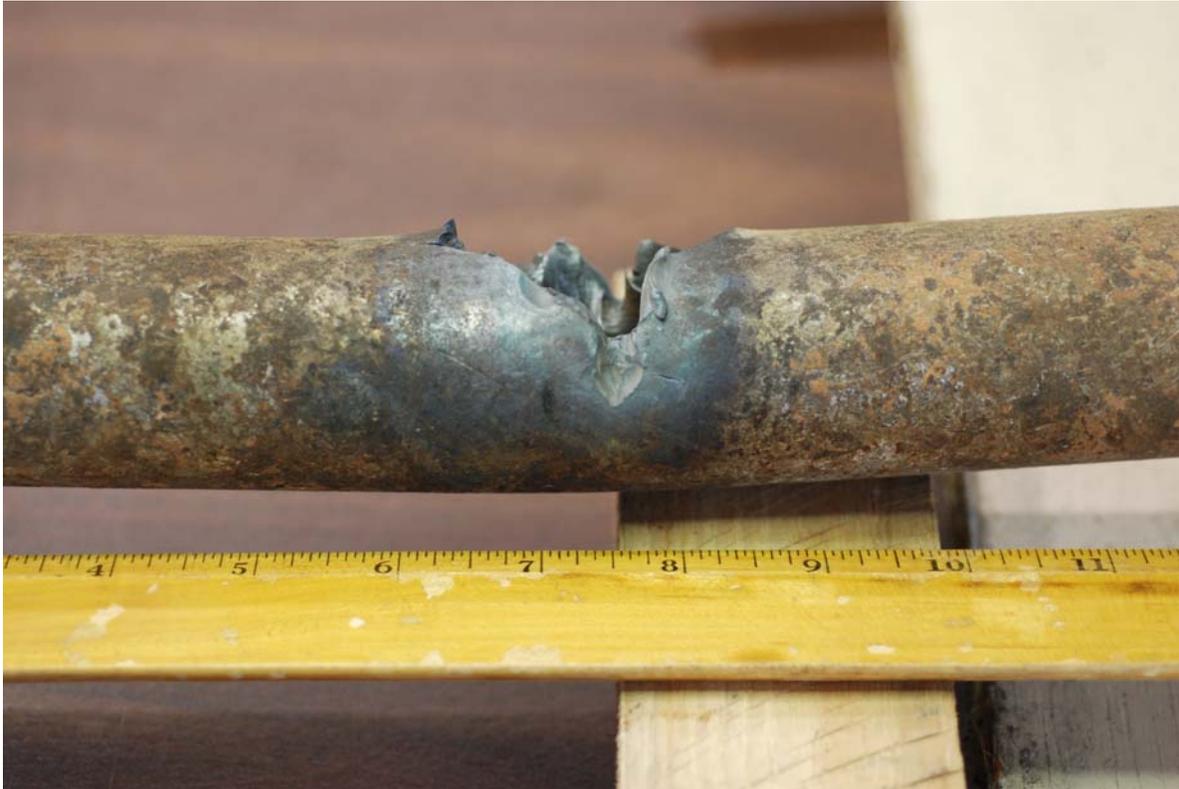
The area of the drill steel being cut by the victim at the time of the accident had a heat bloom (visible surface discoloration due to heat) on either side of the drill steel body. For discussion purposes, references hereafter will refer to the locations when viewing the end of the drill steel from the drill bit end. The heat bloom observed clockwise of the cutting area was visibly larger than the heat bloom in the counterclockwise direction of the cutting area; see Photo No. 3 and Photo No. 4, respectively.

Photo No. 3: View of Heat Bloom Clockwise of Cutting Area

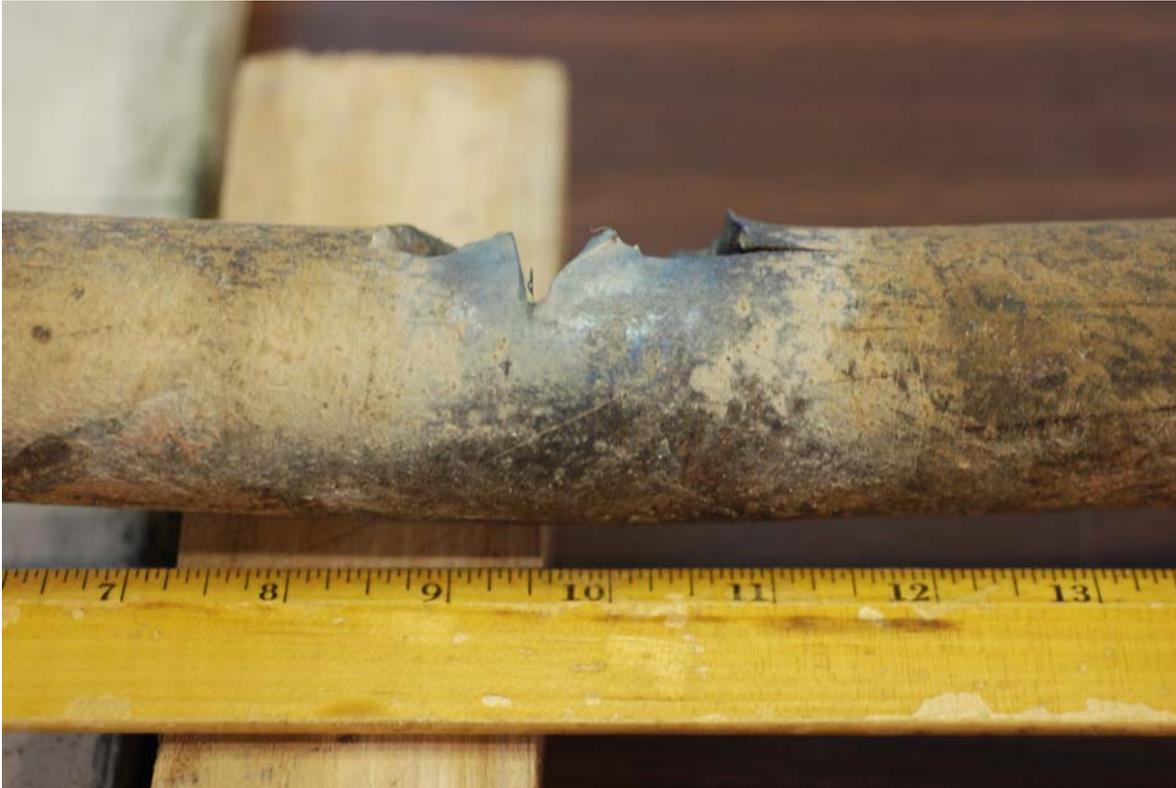
Photo No. 4: View of Heat Bloom Counterclockwise of Cutting Area

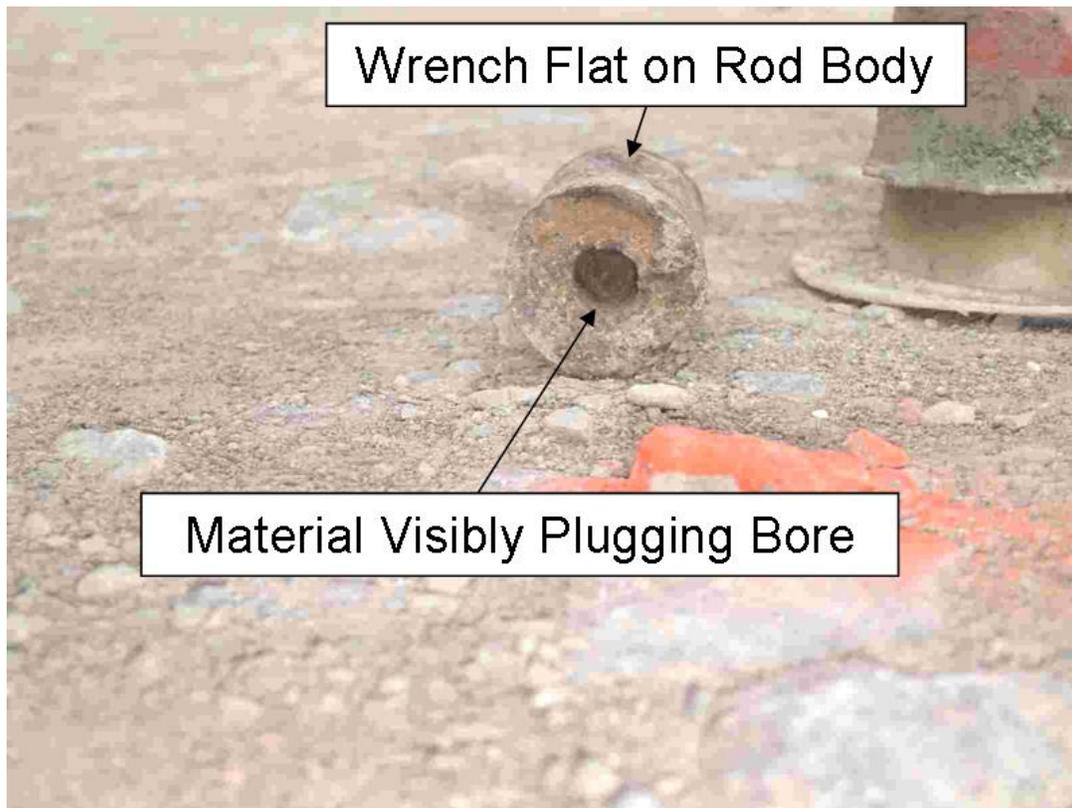
A piece of the ruptured drill steel recovered at the accident scene had material visually plugging the inner diameter of the drill steel (labeled Item No. 18 during the investigation), see Photo No. 5. This plugged section of the drill steel had wrench flats on the rod body which are only present near the threaded ends of the drill steel (See Photo No. 1 for relative locations). This indicated that this plugged section was near the threaded end of the drill steel and on the end opposite to that of the drill bit, i.e. in the end of the section of drill steel that shattered. Additionally, a photo of a section of the ruptured drill steel (labeled Item No. 13 during the investigation) taken by the Knoxville police department shortly after the accident (see Photo No. 6) shows material within the bore area and on the fracture surfaces visibly similar in color to that within the plugged bore of Item No. 18. These observations confirm that conditions existed to provide some level of pressure confinement and to cause reflective pressures axially (along the length of the rod bore) in the end of the drill steel that shattered.

Photo No. 5: Visible Material Plugging Inner Bore of Item No. 18

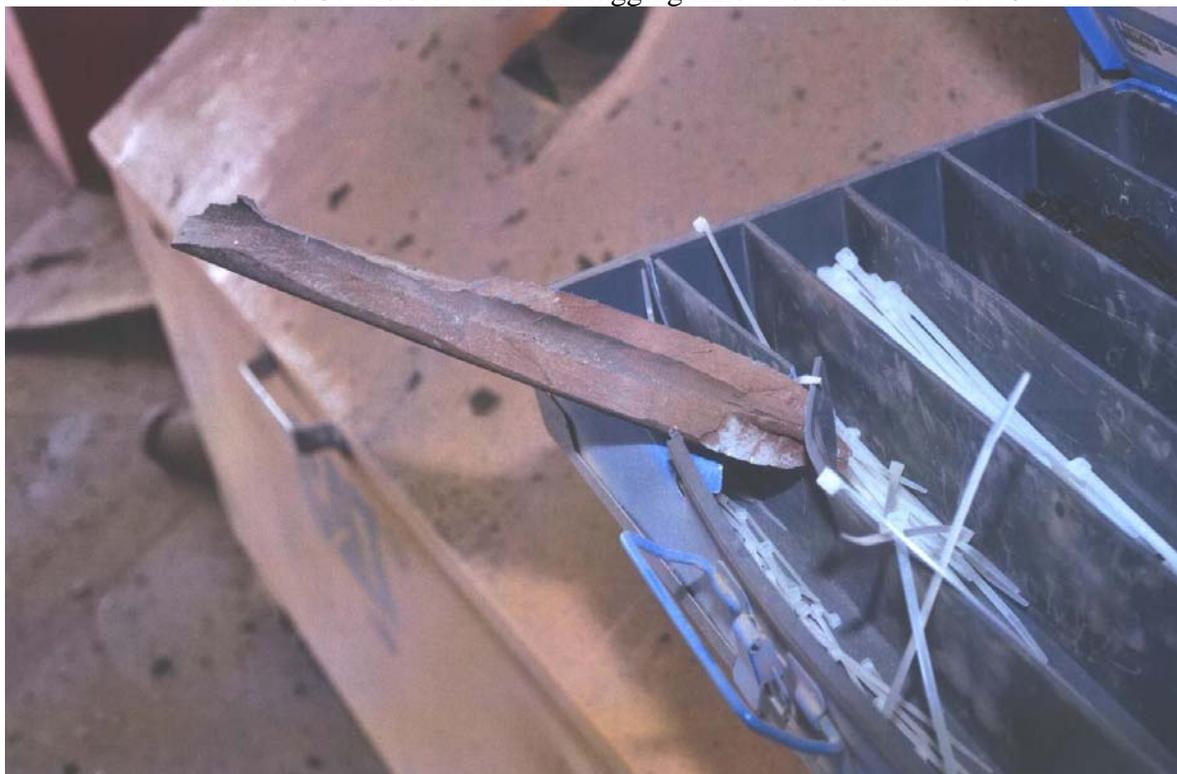
Photo No. 6: Visible Material on Inner Bore and Fractured Surfaces of Item No. 13

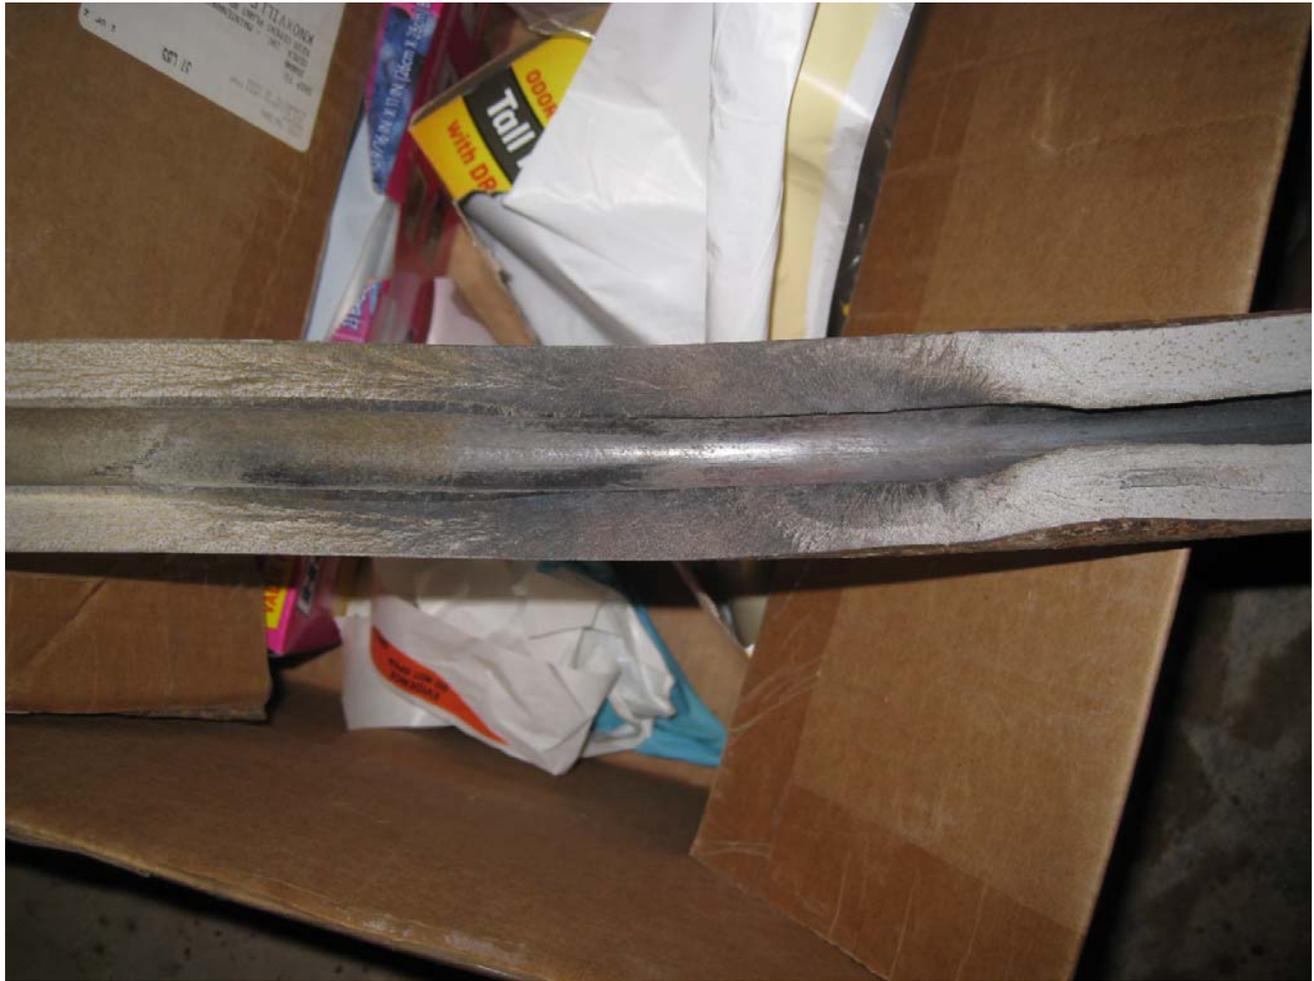
Catastrophic failure of the drill steel did not occur in the immediate area of the cut but small sections around the cut area did fail and break away. The drill steel shattered along a length of approximately 8 feet. The exact location(s) of initiation of the structural failures along the length of the drill steel could not be determined without further metallurgical examination. However, fracture patterns observed on recovered shards of the drill steel appeared to indicate that failure of the drill steel initiated in more than one area. The soot like material observed on the shard in Photo No. 7 (labeled Item No. 20 during the investigation) highlights the fracture patterns in this area, with these fractures pointing back to the general origin of the soot like material within the bore of the drill steel. Similarly, the earth colored material observed on the shard in Photo No. 6 highlights the fracture patterns on another shard, with the fractures also pointing back to the general origin of the earth colored material within the bore of the drill steel. Having multiple areas where failures initiated is consistent with appearances of thick walled cylinders subjected to an explosive internal pressure.

Photo No. 7: Soot Like Material on Item No. 20 and Highlighting of Fracture Pattern
