MNMM Fatal 2010-01

- Falling Material Accident
- January 9, 2010 (Arizona)
- Copper Operation
- Contract Laborer
- 20 years old
- 21 weeks of experience

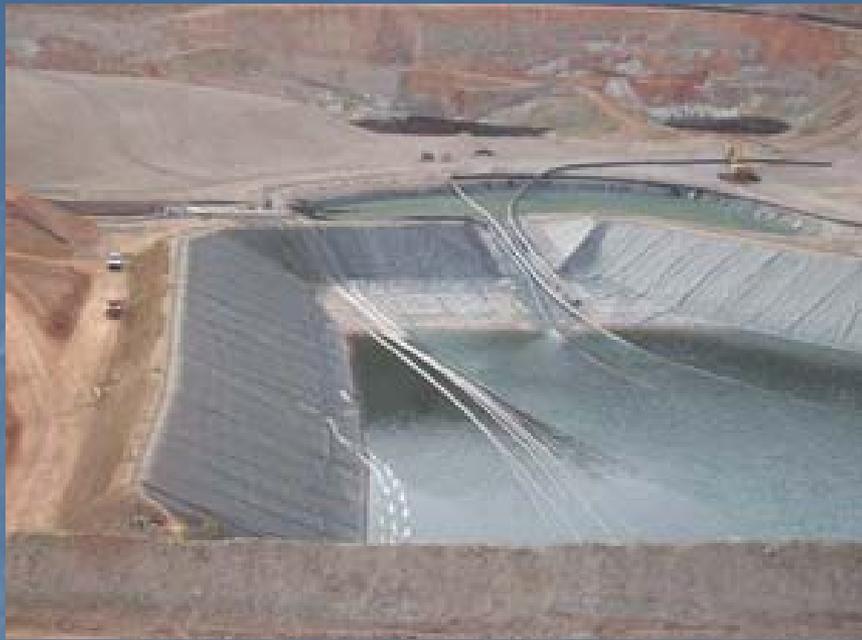
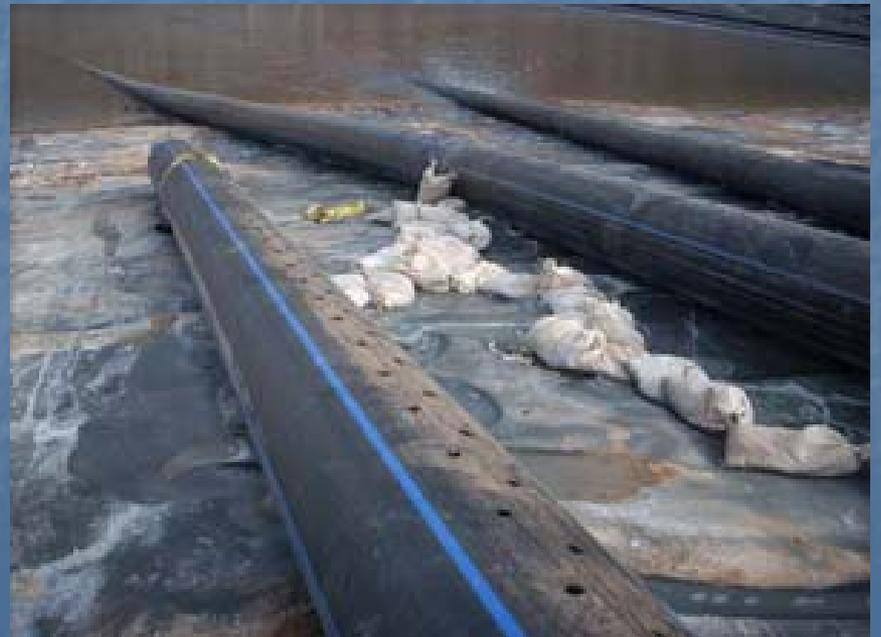
The victim was fatally injured when , when a suspended 400-foot long section of 24-inch diameter high density polyethylene pipe fell and struck him. The pipe was being installed into a new pregnant leach solution reservoir.

The accident occurred because contractor management policies and controls were inadequate. A risk assessment to discuss the task and identify possible hazards was not conducted prior to placing the pipe. The procedures failed to ensure that persons stay clear of suspended loads.

Root Cause: Contractor management policies and work procedures were inadequate and failed to ensure that persons stay clear of suspended loads.

Corrective Action: The contractor operator amended the written work procedure for moving, installing, and guiding HDPE pipe. When using taglines, persons will remain at least twenty feet away from suspended loads or be protected by equipment or other substantial barriers.
