# MNMM Fatal 2010-05

- Machinery Accident
- May 5, 2010 (Alabama)
- Crushed Stone Operation
- Contract Driller
- 21 years old
- 8 months of experience

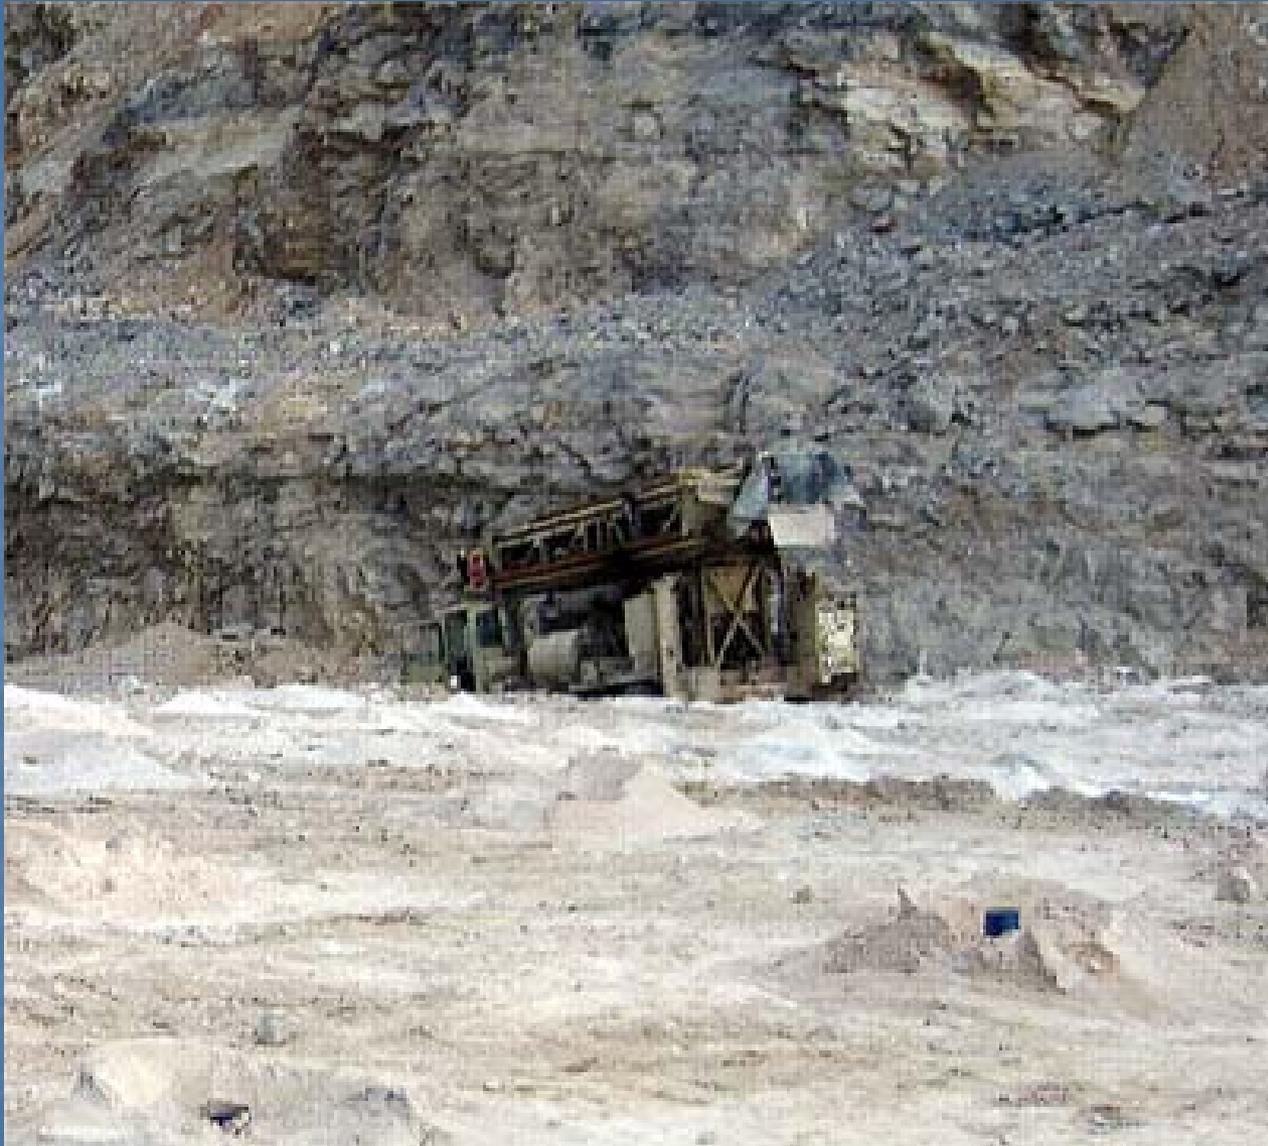
The victim died when the drill he was attempting to reposition ran over him. He was operating a rubber tired drill in a sloping work area of a quarry.

The accident occurred because contractor management policies, procedures, and controls were inadequate. Contractor management trained the drill operators to move the rubber-tired, truck mounted drill from drill hole to drill hole by leaving the transmission in neutral and allowing the rubber-tired, truck mounted drill to roll to the next hole to be drilled.

**Root Cause:** Contractor management policies, procedures, and controls were inadequate and failed to ensure that operators could safely move the drill from one hole to the next hole to be drilled.

**Root Cause:** Contractor management failed to properly task train drill operators in the safe operation of the rubber tired drill.

**Corrective Action:** Contractor management policies, procedures, and controls were established to ensure that persons used the proper procedures to maintain control of the drill at all times when re-positioning it to another hole.

**Corrective Action:** All drill operators were tasked trained in the safe operation of the drill.
