**REPORT OF INVESTIGATION**

**Surface Nonmetal Mine  
(Crushed and Broken Limestone)**

**Fatal Powered Haulage Accident  
December 17, 2010**

**S W Barrick & Sons  
S W Barrick & Sons  
Woodsboro, Frederick County, Maryland  
MSHA I.D. No. 18-00008**

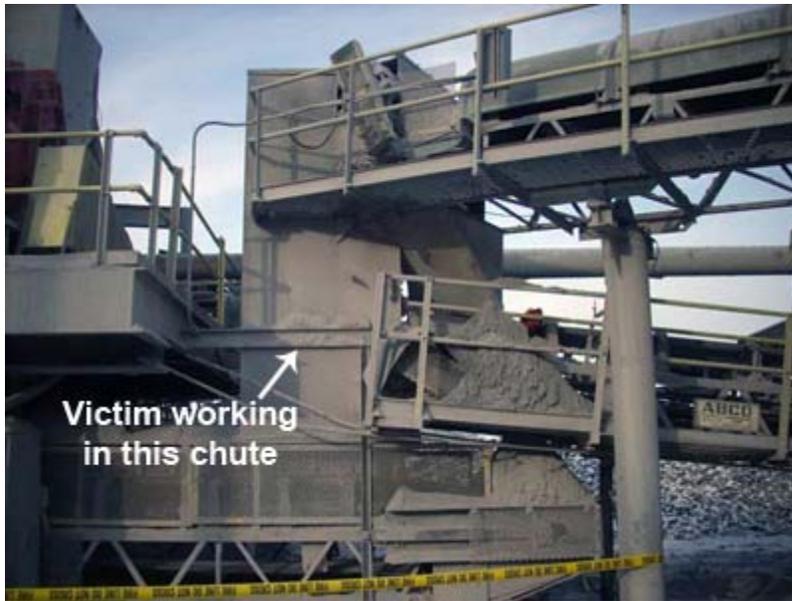
Victim working  
in this chute

The area of the accident included four chutes that directed the flow of material as it was fed onto the 10(A) belt conveyor. Gaither was working inside the No.6 chute. The clearance between this chute and the top of the 10(A) belt conveyor was 18 inches. The next chute above the 10(A) belt conveyor is positioned under the Hazemag crusher, model no. APSE-1315/Q. This chute has approximately 14 inches of clearance between the bottom of the chute and the top of the 10(A) belt conveyor. The Impact Services Corp. impact crusher, model no. 82-VSI, was positioned over the 10(A) belt conveyor. The clearance between the chute below the crusher and the top of the 10(A) crusher is approximately 14 inches. The fourth and final chute involved in the accident was located directly under the Impact Services Corp. impact crusher, model no. 103-VSI. The clearance between this chute and the top of the 10(A) belt conveyor is approximately 18 inches.

Upon startup of the 10 (A) belt conveyor, Gaither was carried along the 10 (A) belt conveyor and under the four chutes described above. The maximum clearance between the 10 (A) belt conveyor and the bottom of the aforementioned chutes was 18 inches, with a minimum clearance of 14 inches.

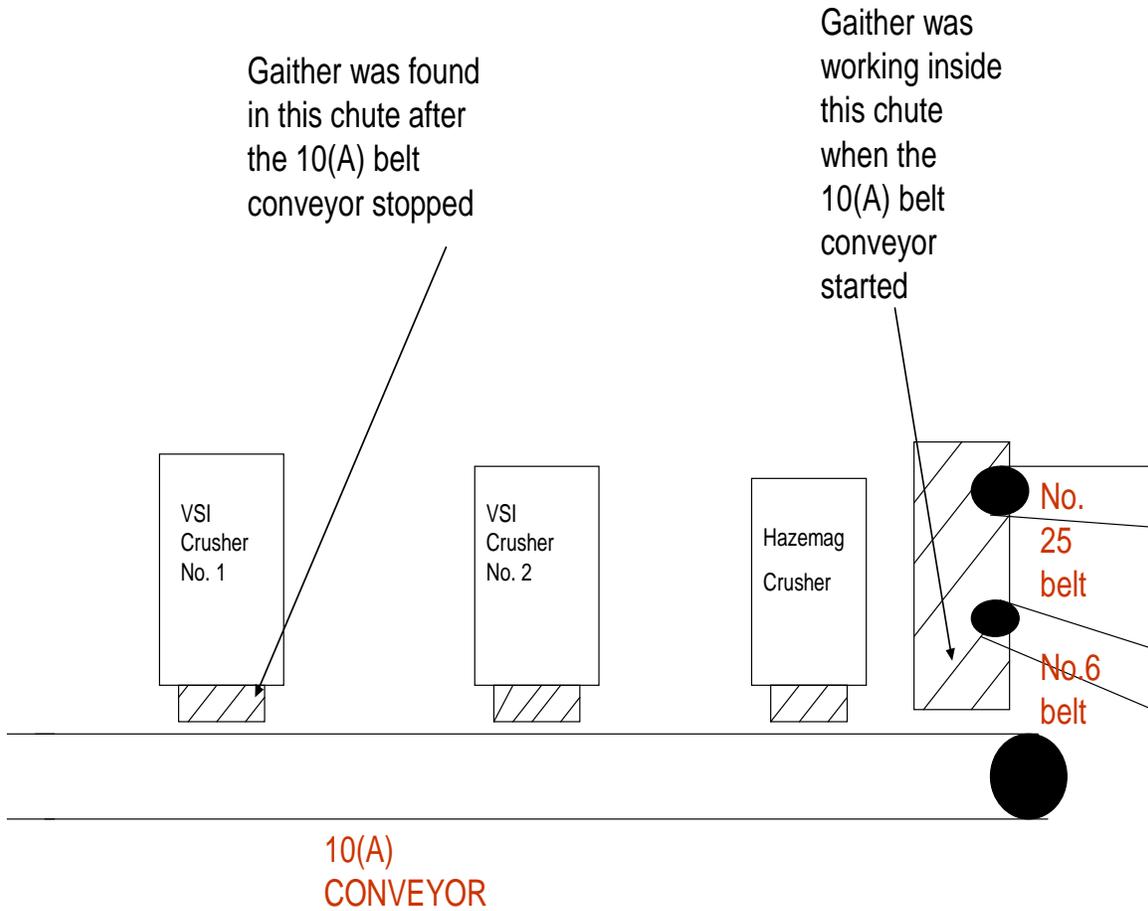
**SKETCH OF ACCIDENT SCENE (NOT TO SCALE)**

The accident occurred in the secondary crushing plant on the 10 (A) belt conveyor.
