MNMM Fatal 2011-05

- Fall of Roof Accident
- April 25, 2011 (Ohio)
- Underground Stone Operation
- Driller
- 31 years old
- 6 weeks of experience

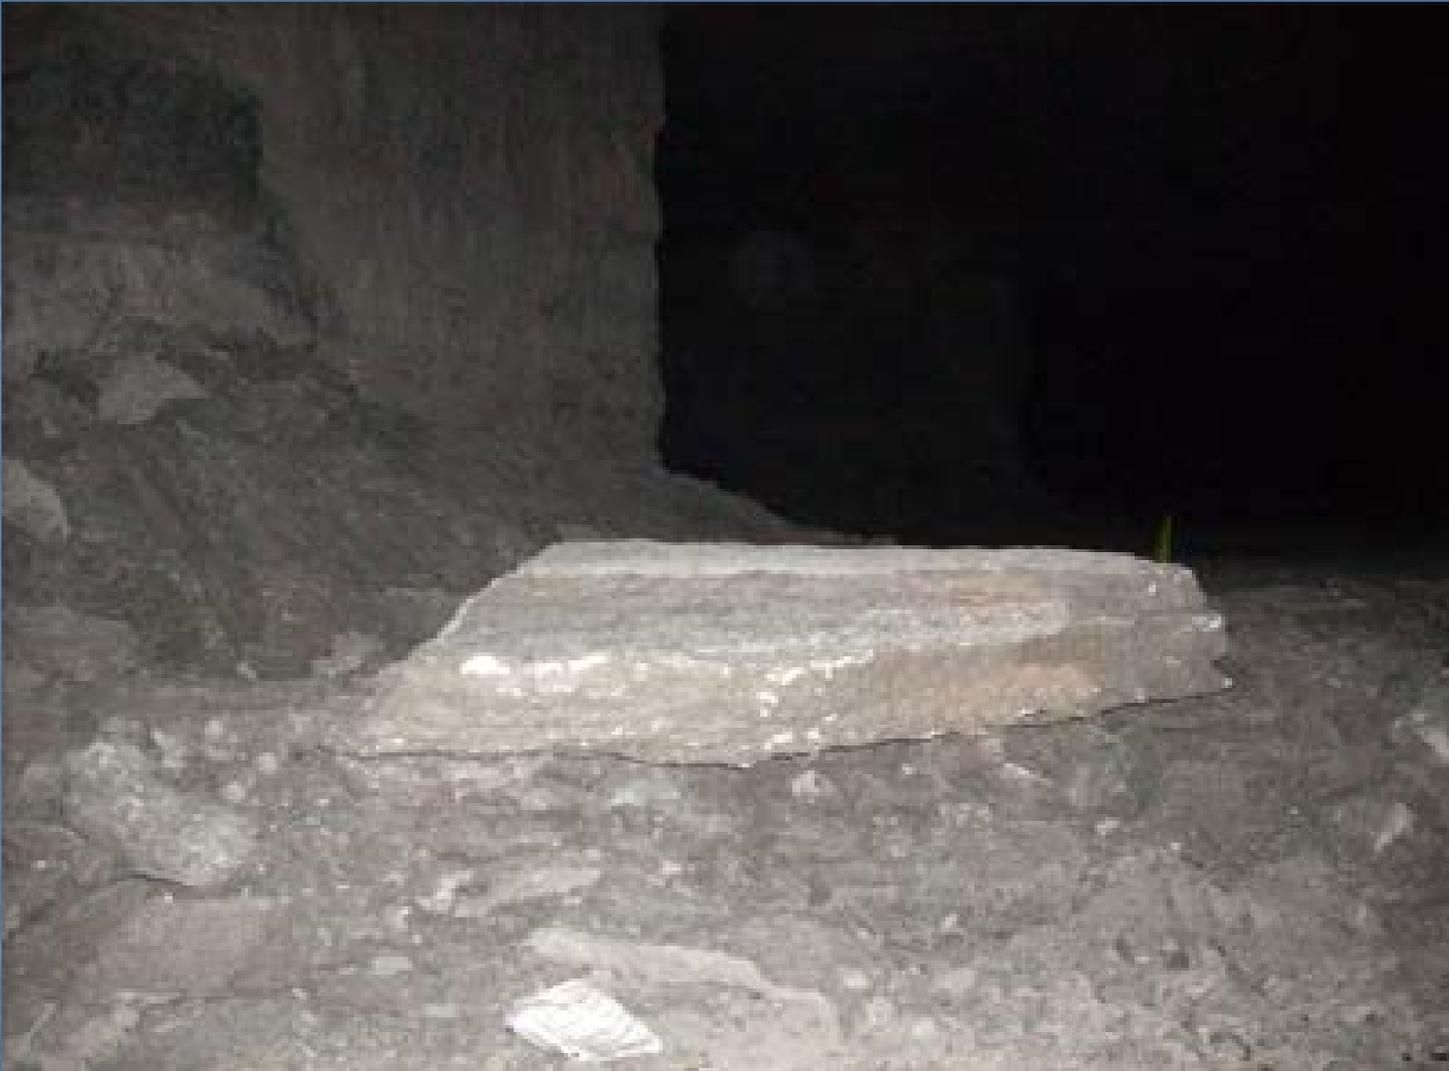
The victim was killed when a slab of roof struck him. He was walking through 34 cross cut when a slab of rock approximately 6 feet long by 5 feet wide by 12 inches thick fell.

The accident occurred because management policies, procedures, and controls were inadequate. The area where the rock fell was not examined and tested by an experienced person designated by the mine operator prior to work commencing.

Additionally, procedures to ensure that persons scale loose ground and drill and bolt laminated roof areas were not followed.

Root Cause: Management policies, procedures, and controls failed to ensure that experienced persons examined and tested for loose ground in areas prior to work commencing.

Root Cause: Management policies, procedures, and controls failed to assure that loose ground was scaled down or supported in areas where work and travel was being performed.

Corrective Action: Management amended the written work procedures to ensure that experienced persons examine and test for loose ground in areas prior to work commencing.

Corrective Action: The mine operator has re-trained all miners to assure that ground conditions are taken down or supported before travel or work is performed.
