REPORT OF INVESTIGATION

**Surface Nonmetal Mine
(Cement)**

**Fatal Powered Haulage Accident
May 28, 2012**

**Lehigh Northeast Cement Company
Glens Falls Plant
Glens Falls, Warren County, New York
I.D. No. 30-00585**

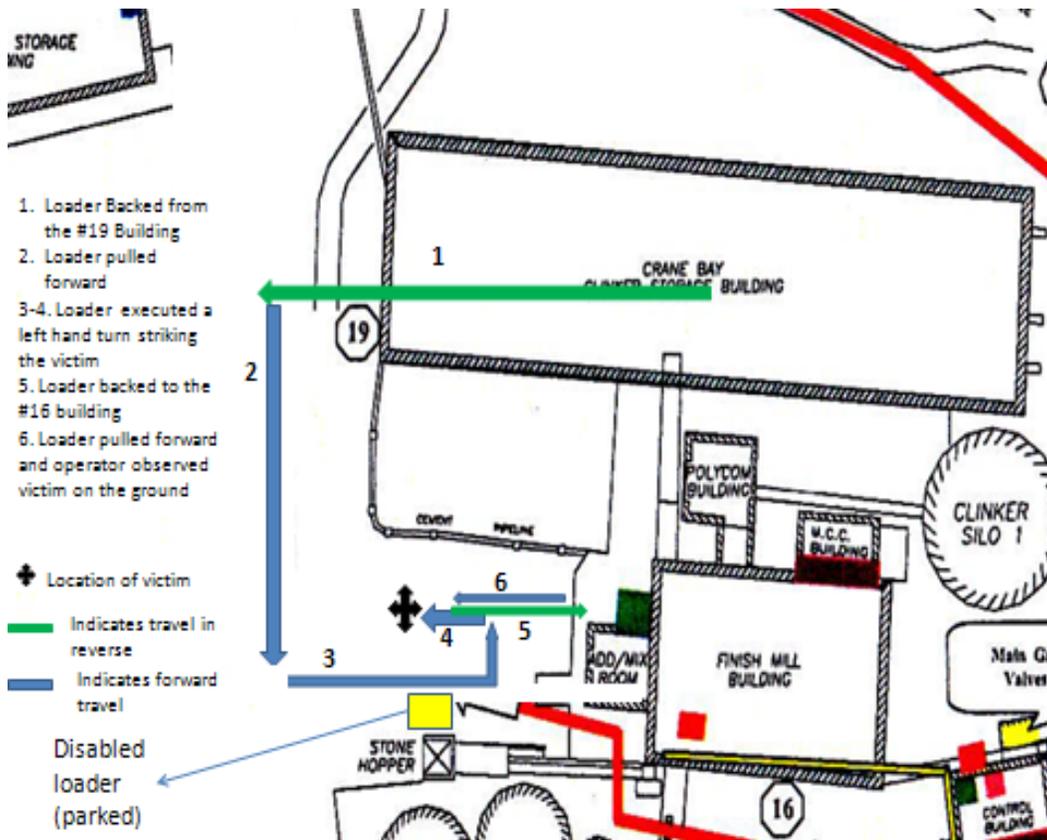
Appendix B - Sketch of Accident Scene

The accident occurred on the south side of crane bay building No.19. A front-end loader travels in the immediate area where the accident occurred multiple times per shift to feed material in two separate hoppers. Persons travel on foot between the No.1 mill building and the plant office building No.21 on a daily basis. At the time of the accident, the area was dry and level with no hazardous travel conditions.

When the front-end loader struck the victim, investigators determined the bucket of the loader was in a raised position (approximately 4 feet off the ground). This configuration reduced the visibility of the operator of the front-end loader. The front-end loader, traveling with the bucket in this raised position, created a blind spot of approximately 20 feet in front of the machine.

CORRECTIVE ACTION: Management established safe operating procedures for mobile equipment operators when operating mobile equipment in close proximity to both pedestrians and other vehicles. All mobile equipment operators were instructed in these safe operating procedures.
