REPORT OF INVESTIGATION

Surface Facility

Exploding Vessels Under Pressure Accident

Five Mile Prep Plant & Refuse Impoundment
Midland Trail Energy, LLC
Tad, Kanawha County, West Virginia
I.D. No. 46-09226

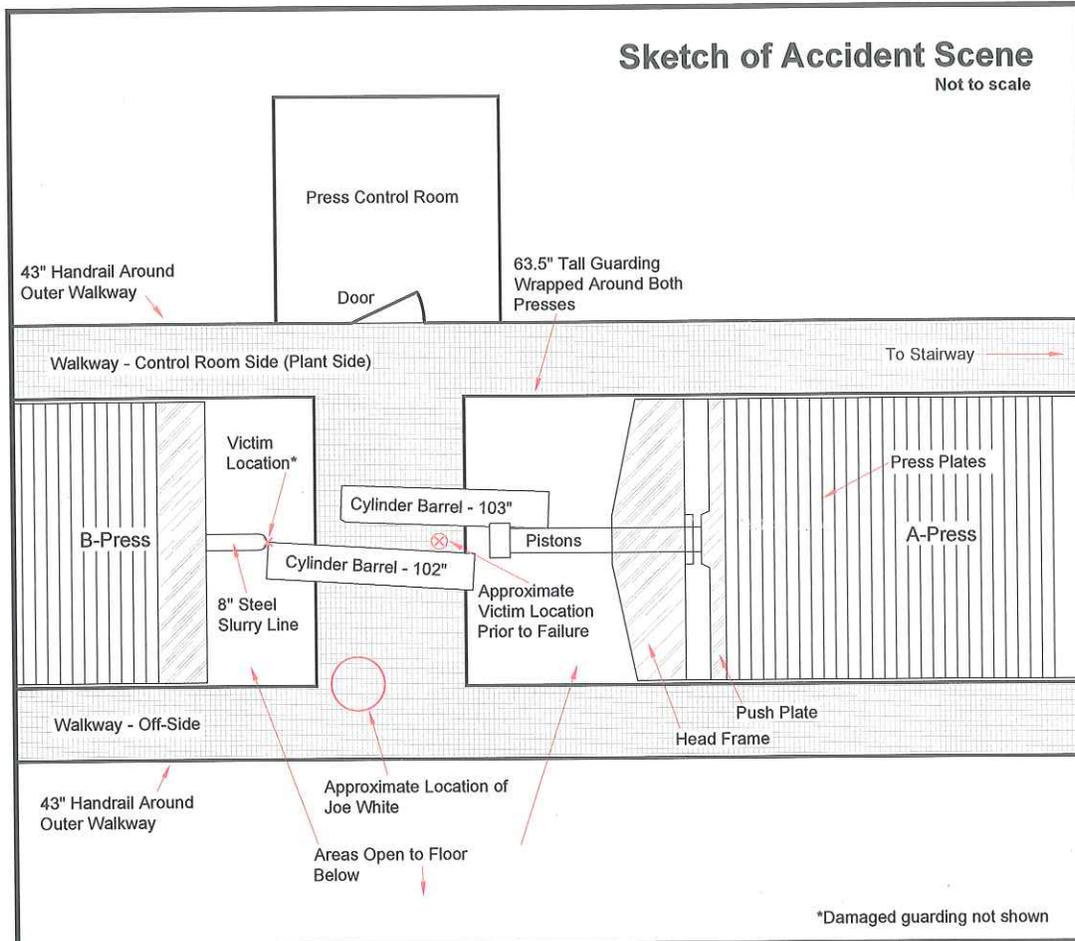
APPENDIX C

Townsend turned left into the walkway between the A-Press and the B-Press, stopping behind the hydraulic cylinders of the A-Press (see Appendix C), in order to examine the hydraulic pressure gauge mounted on top of the upper cylinder (about at eye level) of the A-Press. At approximately 4:00 p.m., while Townsend was standing in the walkway between the two presses, examining the pressure gauge, there was a sudden and catastrophic failure of both hydraulic cylinders.

In an instant, the broken cylinder barrels (weighing over 2,000 pounds each), shot into the walkway, crashing into the end guarding and thrusting it against Townsend, driving him back, approximately 7-8 feet, into adjacent guarding and piping on the B-Press. He was caught between the two sections of displaced guarding and pinned against the adjacent press by the hydraulic cylinder barrels where he sustained multiple traumatic injuries which led to his death. Simultaneously, White was struck in the face. The blow left White lying on the walkway with serious injuries including a broken jaw and missing teeth.

Corrective Action: The mine operator implemented a time and space barrier in order to reduce exposure to pressurized components. Area guards were placed across the walkway where the accident occurred. These guards are secured by lock and the key is retained by plant management. Hydraulic gauges were moved to a safe location where they could be observed without exposure to press componentry. Warning lights were also installed to warn press operators when the feed cycle, or pressurizing of the press, was beginning. This indicates that press operators are to move to another location while slurry is injected into the presses to reduce exposure to slurry blow outs. Plexiglass was also provided on the sides of both presses in an effort to prevent exposure to slurry spray while traveling alongside the presses.

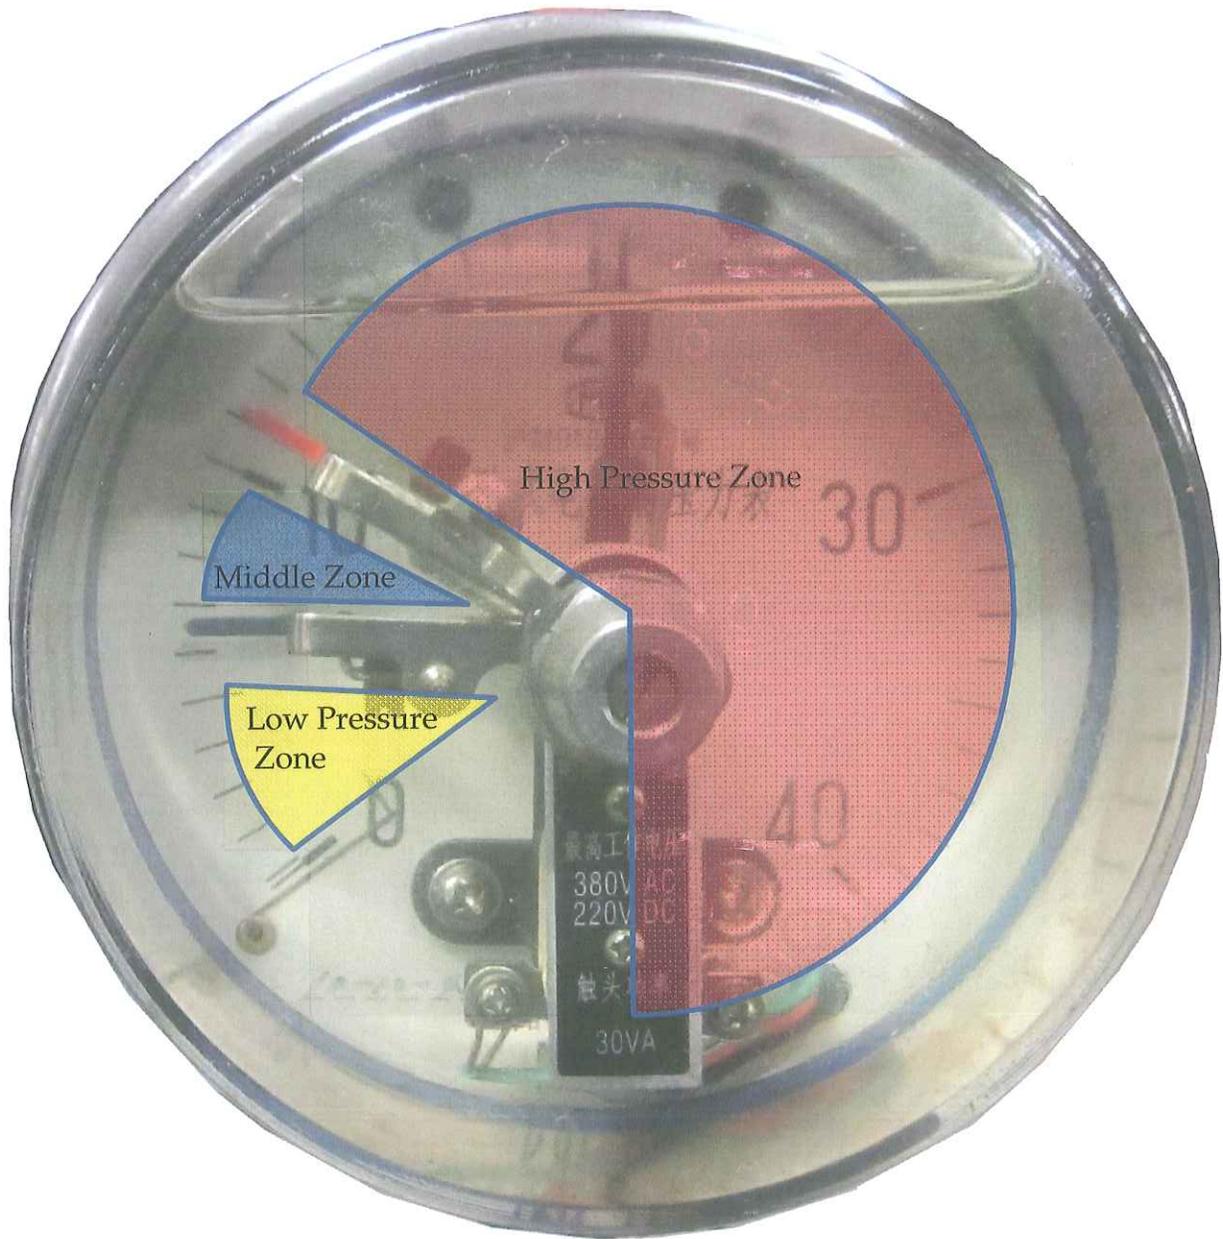
Witness testimony indicates that the hydraulic pressure gauge/switch (see Appendix D) located on top of the upper hydraulic cylinder of the A-Press failed to function properly immediately prior to the failure of the cylinders. Several persons interviewed confirmed that they did not hear the hydraulic pump shut off or stop running immediately prior to the accident. When examined and tested following the accident, the upper limit switch contained in this gauge/switch failed to make contact several times. The upper limit switch functioned properly only after it was manually forced to

make contact by investigators during testing. Information obtained in the interview process also shows that the upper hydraulic limit setting of the gauge was reduced on several occasions in an effort to make the hydraulic pump motor stop. While the pressure gauge/switch did sustain some apparent damage as a result of the accident, the low limit switch functioned properly when tested. The failure of the upper limit switch contributed to the accident.

The electrical output of the switches falls into three zones based on the pressure measured by the gauge portion of the gauge/switch combination unit. The first zone (low pressure zone) is defined by a pressure reading below the setting of the lower pressure setting arm. In this zone, the low pressure switch is open and the high pressure switch is closed. In the middle zone, defined by a pressure reading between the settings of the lower pressure setting arm and the upper pressure setting arm, the low pressure switch is closed and the high pressure switch is also closed. In the upper zone (high pressure zone), defined by a pressure setting above the upper pressure setting arm, the low pressure switch is closed and the high pressure switch is open. When the press is closed during a normal cycle, this unit helps maintain system hydraulic pressure within the middle zone. The three zones are shown in Illustration 1.

Illustration 1: Hydraulic Gauge/Switch Combination Unit showing switch output zones.

Corrective Action: Dual hydraulic pressure transducers were installed in lieu of the original combination gauge and switch. These dual transducers are connected to the PLC system and enable it to stop the hydraulic system once desired pressure is reached. Also, the readings from the transducers are visible on the PLC screen so that the operator can see them. These measurements are saved and trends are recorded in the PLC system. These dual transducers provide a failsafe or backup to ensure that the hydraulic pump will stop at the desired pressure. The transducers will be recalibrated or replaced on an annual basis. Gauges have been installed as a visual check for transducer accuracy and will be viewed by the press operators while operating the presses.

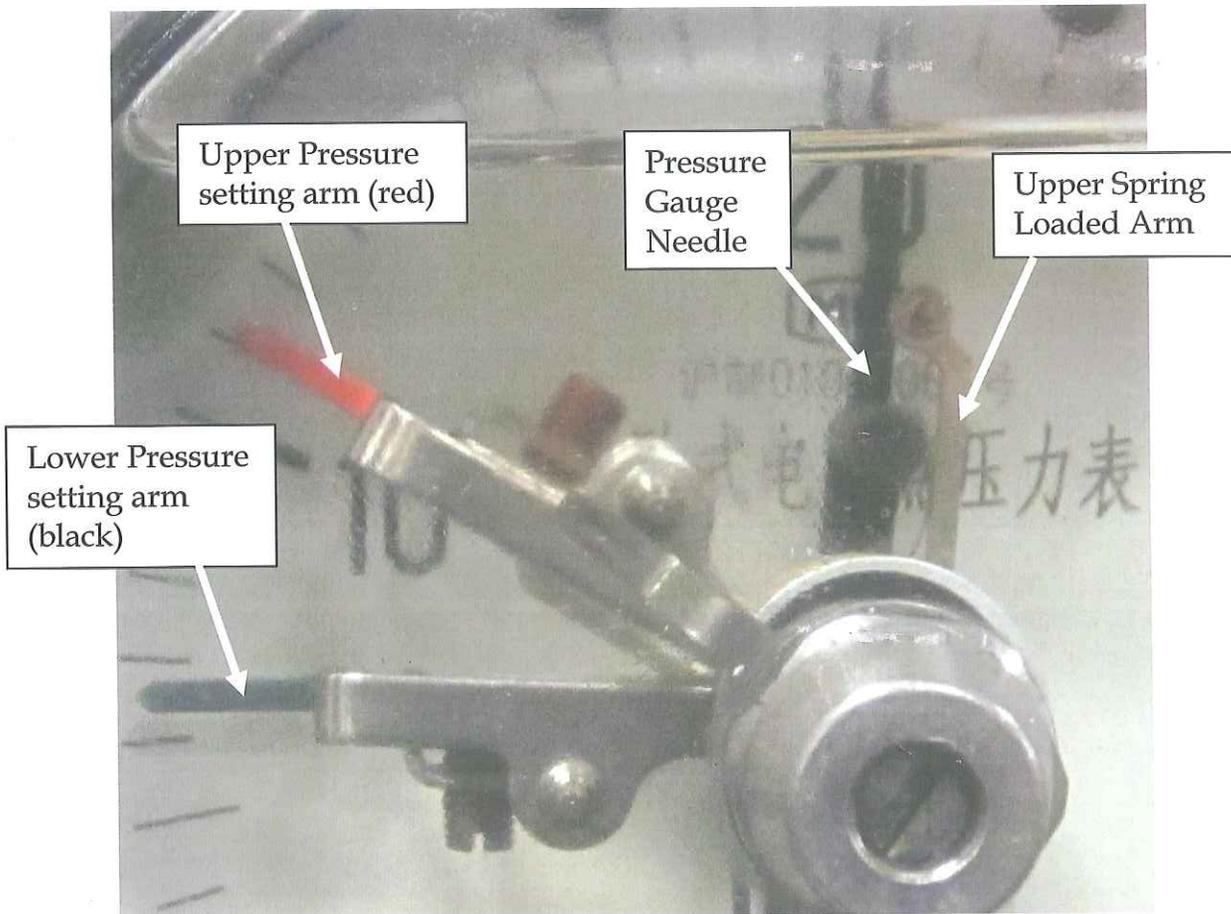
Each switch closes when a spring loaded arm presses against its respective pressure setting arm. Each switch opens when the spring loaded arm is held away from its respective pressure setting arm by the pressure gauge needle. Illustration 2 shows the high pressure setting spring loaded arm held away from the high pressure setting arm by the pressure gauge needle.

Illustration 2: Hydraulic Gauge/Switch Combination Unit showing a pressure reading in the high pressure zone. Note that a protrusion on the pressure gauge needle holds the upper spring loaded arm away from the upper pressure setting arm, opening the upper pressure switch. The lower pressure switch is closed and the lower spring loaded arm is not visible behind the lower pressure setting arm.
