REPORT OF INVESTIGATION

Fall of Face Accident  
November 4, 2013

MC #1 Mine  
M-Class Mining, LLC  
Macedonia, Franklin County, Illinois  
I.D. No. 11-03189

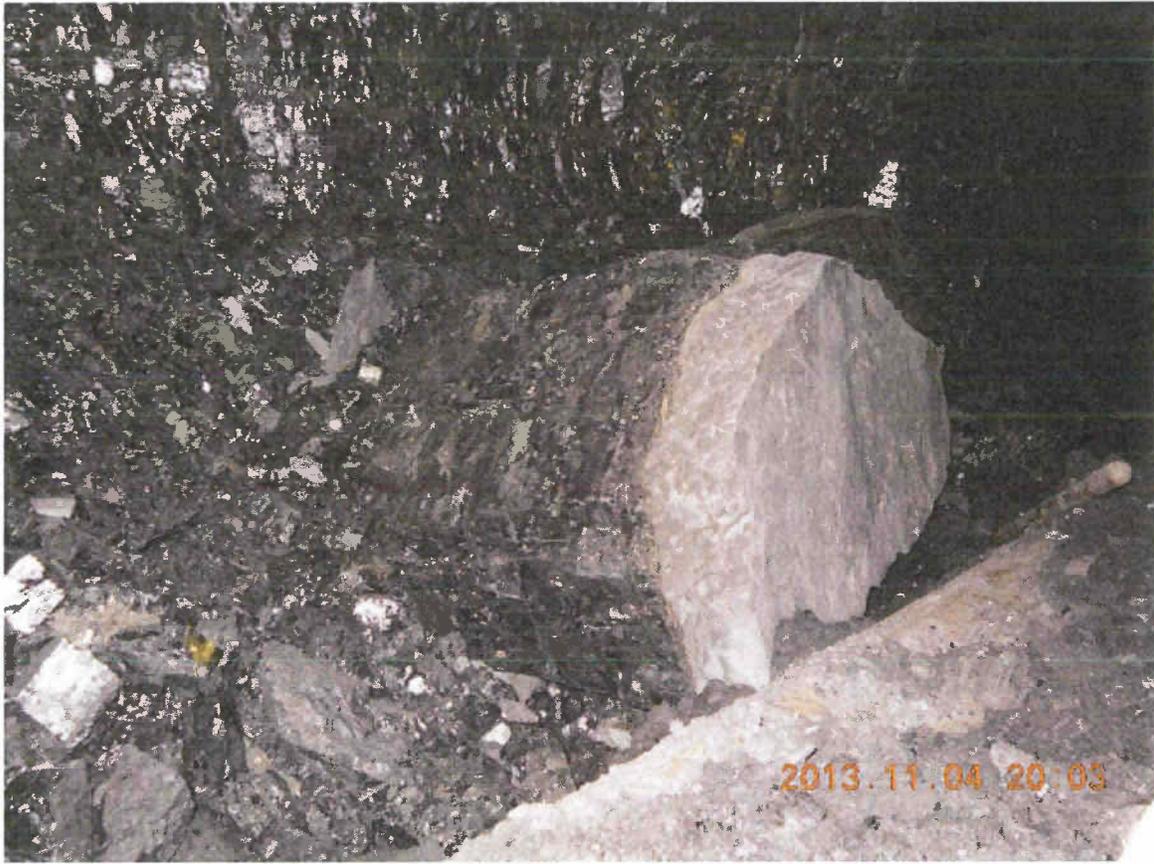
Accident Scene Photograph Showing Coal and Cap Rock Between the Face and Front of the Longwall Panline

The fallen coal and rock from the accident measured approximately 4 feet 10 inches in length by 2 feet 3 inches wide and up to 24 inches thick. The weight of the fallen coal and rock was approximately 1 ton.

When investigators arrived at the accident scene, Travelstead had been removed from the mine and transported to the Franklin County Hospital. The solid piece of coal and cap rock that had pinned Travelstead was lying on the face side of the panline.

The mine operator submitted a roof control plan revision that details the required equipment, procedures, and precautions in order to level the longwall panline. The revision stipulates procedures for leveling the pan line, which include blocking the pan line from the shield side, removing material from under the pan line from the shield side, and undercutting the mine floor to allow the pan line to level properly. In addition, if any work is required between the pan line and the face, horizontal jacks will be installed to the face, the face will be scaled, the number of miners exposed will be limited, proper testing and examinations will be done, and a certified foreman will be present at all times. The affected miners were trained in the revised roof control plan requirements.

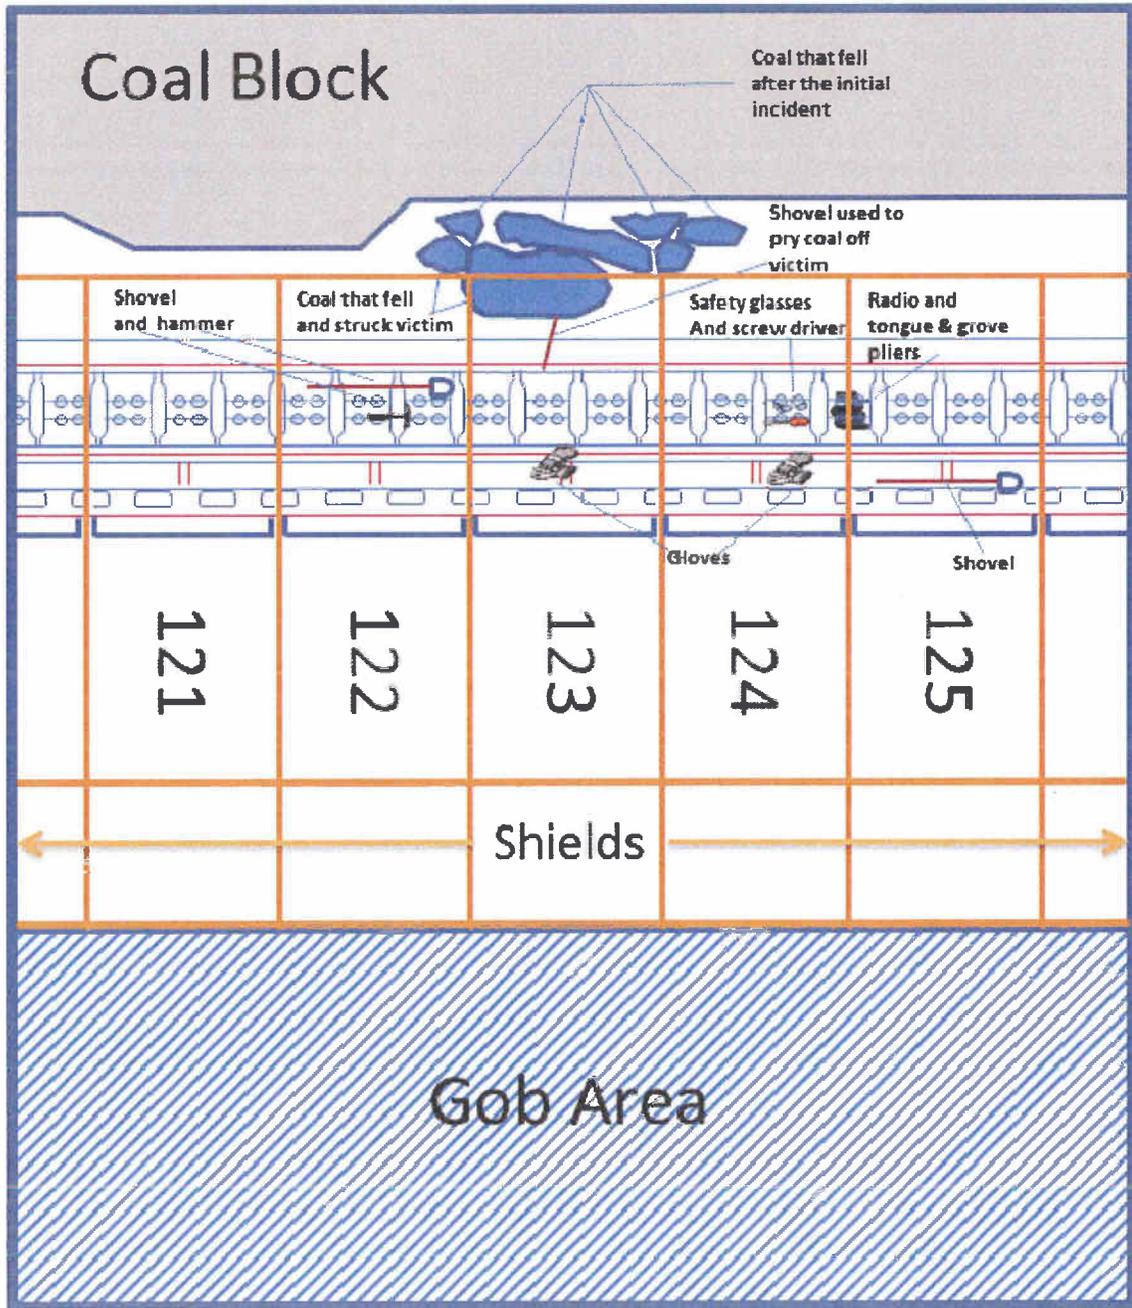
## Drawing of Accident Scene

At approximately 1:50 p.m., Travelstead was shoveling under the tip of shield No. 123 on the face side of the panline. Webb, England, Wheeler, and Murphy were shoveling in close proximity to Travelstead. Webb and England had stepped in the panline to take a break, when a solid piece of combined coal and cap rock fell from the coal face, striking Travelstead on his mid to lower back, pinning him against the face side of the panline. (See Appendix A, Drawing of Accident Scene.)

The accident occurred between the longwall face and the panline at shield No. 123 on the South District 1, Headgate No. 2 Longwall section (MMU 004-0). The longwall face was aligned with spad (survey station) No. 4875, which was located in the belt entry.
