**UNITED STATES
DEPARTMENT OF LABOR
MINE SAFETY AND HEALTH ADMINISTRATION
Metal and Nonmetal Mine Safety and Health**

REPORT OF INVESTIGATION

**Fatal Fall of Person Accident
February 21, 2014**

**Personal Touch Inc.
Contractor ID No. F223
at
Cemex Inc.
Kosmos Cement Co.
Louisville, Jefferson County, Kentucky
Mine ID No. 15-04469**

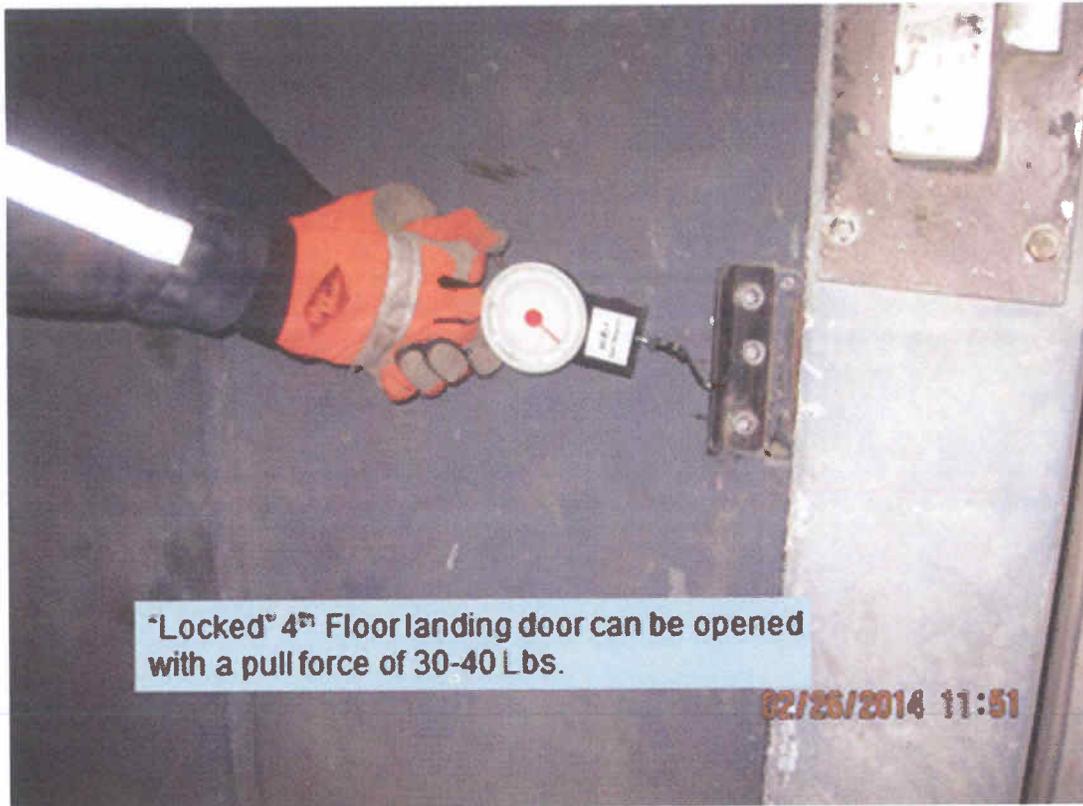
- The 4th floor landing door entrance hardware assembly was severely worn.
- The 4th floor landing door interlock did not function properly.
- The 4th floor landing door could be opened with minimal effort when the elevator car was away from the landing.
- The 4th floor in service light did not function

Locked 4th Floor landing door can be opened with a pull force of 30-40 Lbs.

Corrective Action: The fourth floor elevator has not been repaired and is still under a 103 (k) Order. The mine operator ceased use of this elevator and will determine if the elevator will be repaired. Miners are currently using stairs.

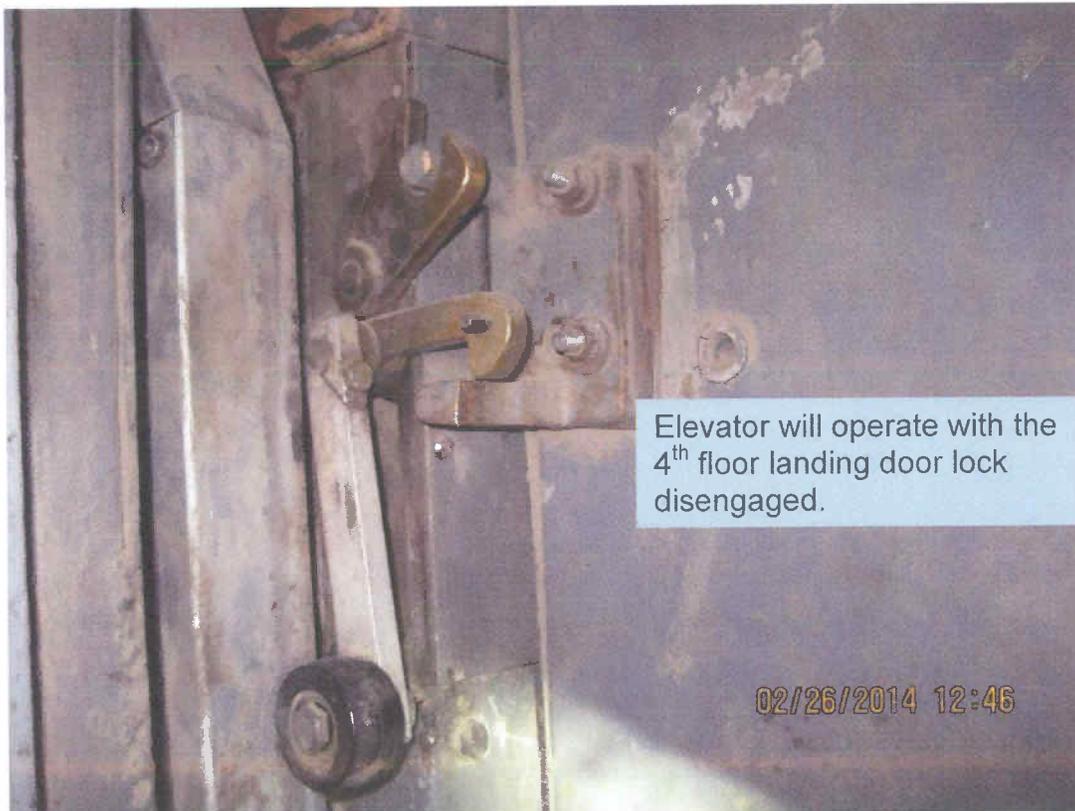
Elevator will operate with the 4th floor landing door lock disengaged.

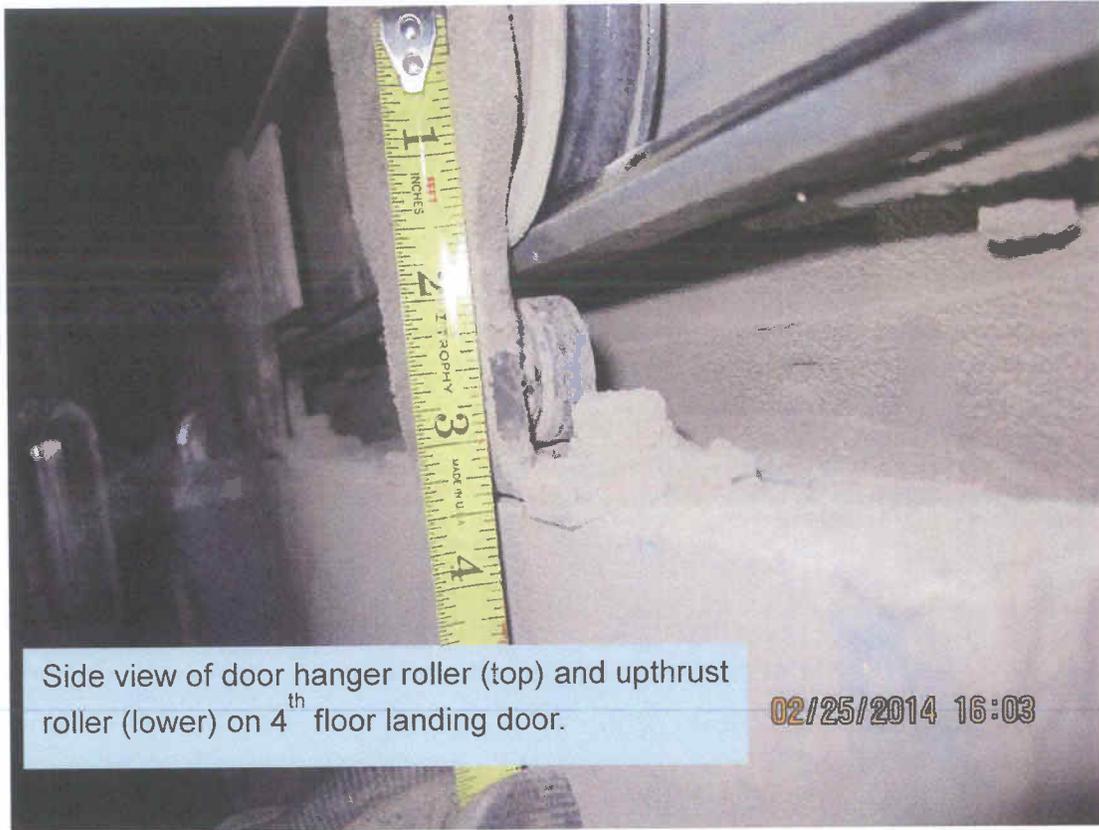
Root Cause: Management did not ensure the fourth floor hoistway landing door's worn condition was corrected, which caused the mechanical interlock to malfunction allowing the door to open when the elevator car was not present.

Side view of door hanger roller (top) and upthrust roller (lower) on 4th floor landing door.
