REPORT OF INVESTIGATION

Surface Nonmetal Mine
(Trap Rock)

Fatal Handtools Accident

February 2, 2007

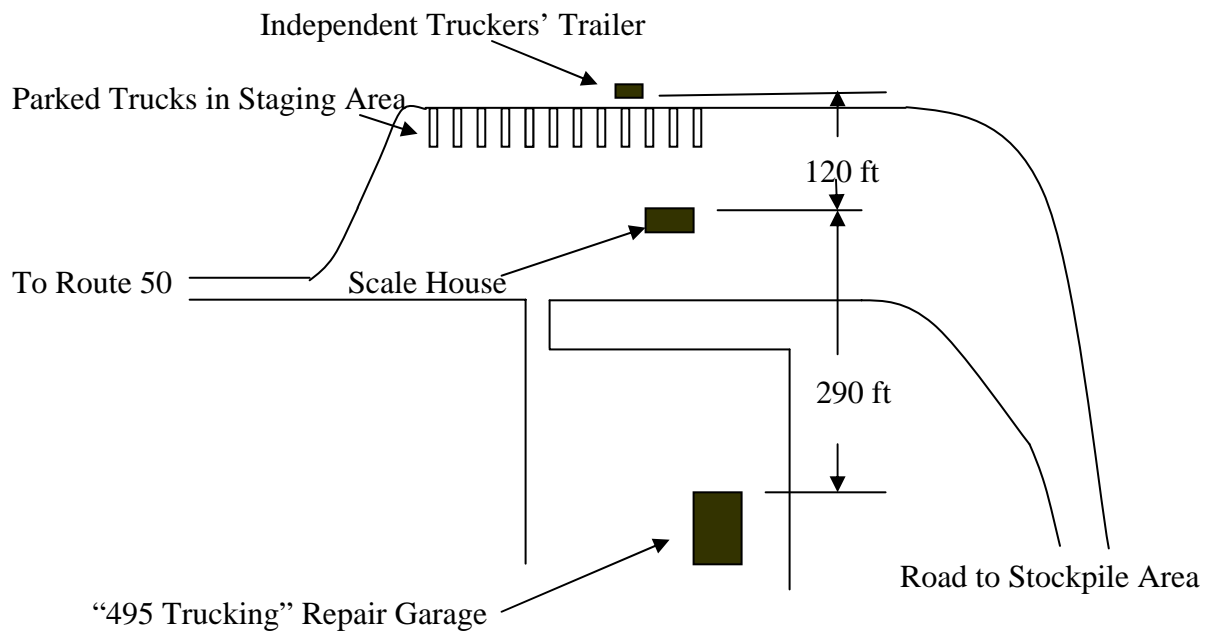
The accident occurred on mine property at an area located about 60 feet west of the scale house. Chantilly permitted independent truck drivers to park their trucks overnight in this location.

Figure 2 – Schematic of Independent Truck Staging Area

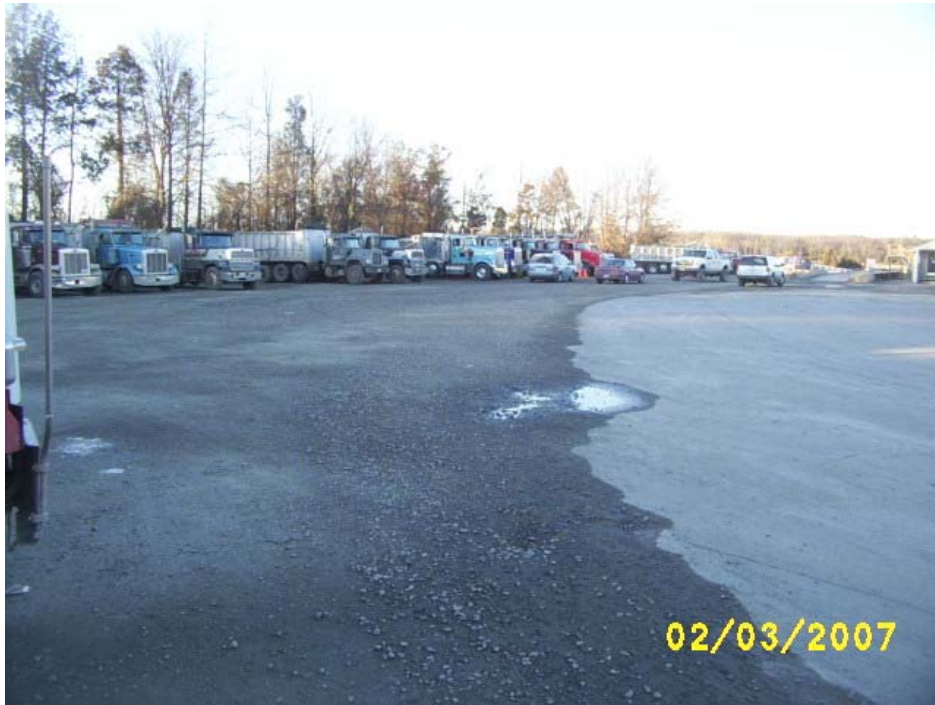
Figure 3 – View of Independent Truck Staging Area looking east toward Mine Scale House

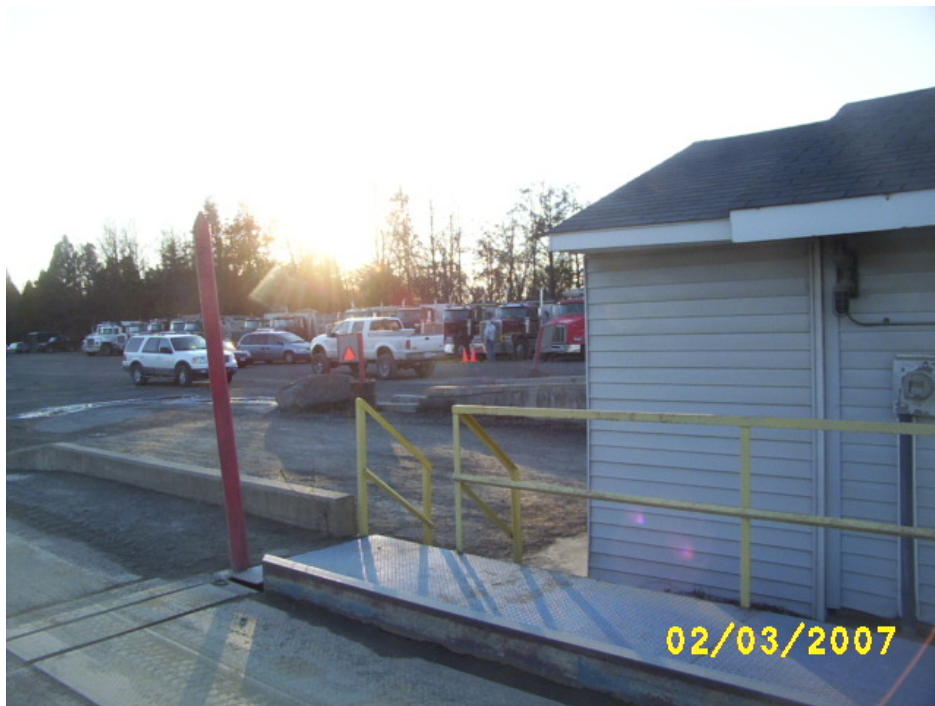
Figure 4 – View of Independent Truck Staging Area looking west from Mine Scale House
