REPORT OF INVESTIGATION

Underground Coal Mine

Fatal Machinery Accident
March 25, 2014

Gibson Mine
Gibson County Coal LLC
Princeton, Gibson County, Indiana
ID No. 12-02215

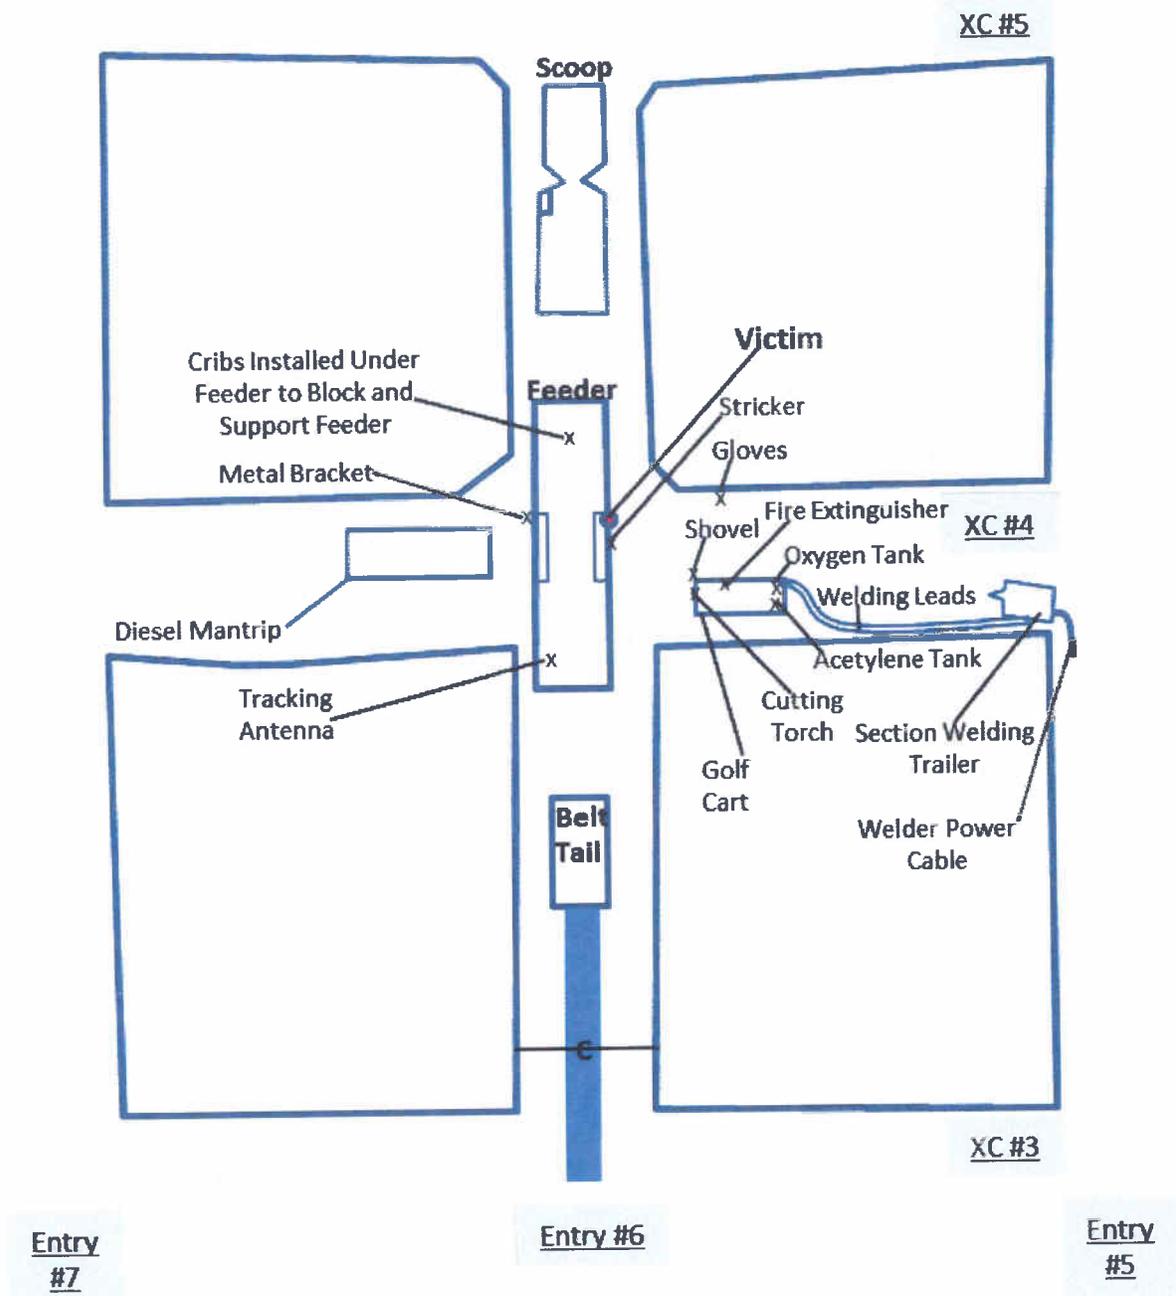
APPENDIX A - Sketch of Accident Scene

After arriving on the unit, Memmer prepared the welder and torch for the repair of the feeder. Memmer and Horton assessed the location of the feeder and decided to move the feeder to the inby intersection to better access the area of the feeder that needed repair. Horton positioned the feeder and actuated the hopper jacks to elevate the hopper end of the feeder. Memmer, Horton, and Steve Walden, Mechanic, constructed a crib underneath the center of the hopper end of the feeder to block the hopper (See Appendix A).

The feeder was an Auxier Welding Inc. feeder, Model No. AF41-50DD-GIB-950V, and Serial No. 13524. When the side plates were being cut with a torch, the hopper end of the feeder was raised and blocked with a crib block. The dump end of the feeder was not blocked against motion, and no blocking was provided between the cat track and the hopper of the feeder. When the inner side plate was cut through with the torch, the track assembly pivoted upward at the hopper jack end, pinning the victim. This was because the front end of the cat track assembly acted as a fulcrum, and the mine floor under the cat track assembly was uneven. The resulting distribution of forces caused the hopper jack end of the cat track assembly to pivot upward.

Corrective action: The mine operator developed and submitted a written action plan for completion of the repair work on the feeder, as well as provisions for blocking other feeders for repair. The action plan includes provisions for blocking under the frame on the dump end (outby) of the feeder, between the cat track and the frame of the feeder, and the inby end of the feeder. Other provisions related to rock dusting, lock-out, tag-out, gas checks, etc., are included in the action plan. All maintenance workers were trained on the action plan for repairing feeders.
