Appendix M – MSHA Technical Support Memoranda on UBB Floor Bursts

SUBJECT: Evaluation of Controls on Floor Bursts at Performance Coal
Company, Upper Big Branch Mine - South, MSHA I. D.
No. 46-08436

SUBJECT: Methane Floor Outbursts at Performance Coal Company's
Upper Big Branch Mine - South, MSHA I.D. 46-08436

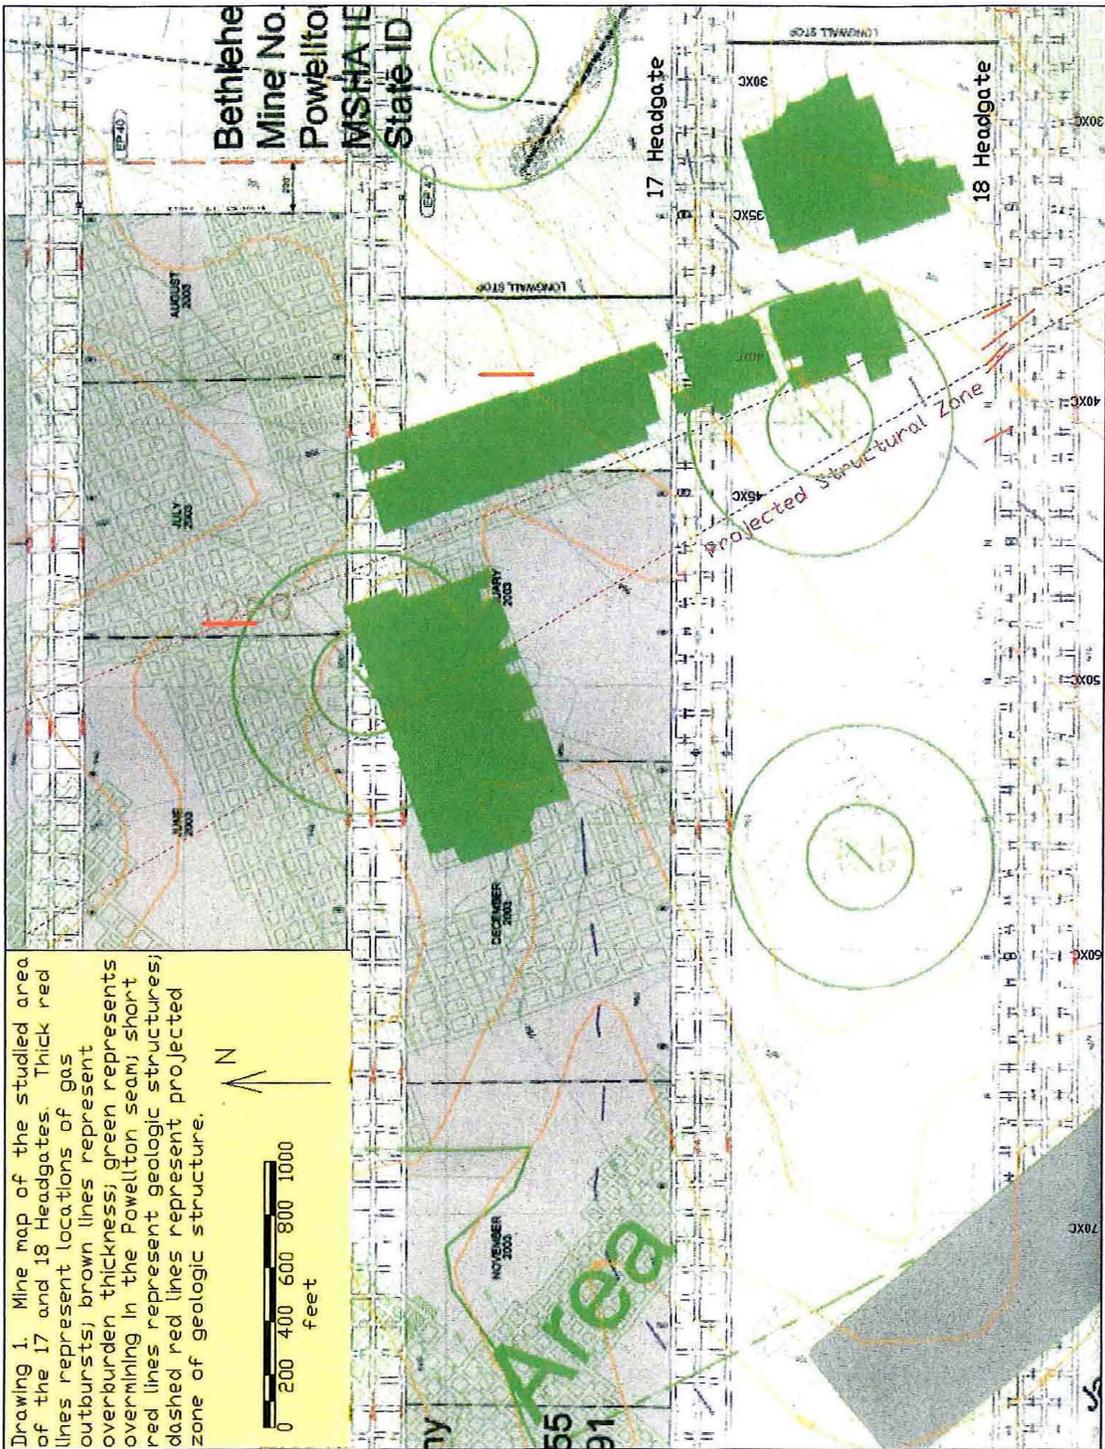
Several factors may have influenced the two floor bursts that occurred in July 2003 and February 2004. These factors include: (1) critical overburden value of 1100+ feet; (2) critical Eagle/Lower Eagle interburden thickness of 12 feet; (3) location of barrier pillars in the overlying Powellton seam; and (4) projected zone of geologic weakness.

Another factor that may have influenced the formation of the floor fractures is represented by the zone of sub-parallel slickensides observed in the 36-39 Crosscut area in Headgate 18. Although by themselves the individual slickensides appear to be minor features, their occurrence within a restricted zone that projects through the location of the July 2003 floor burst site may be more than mere coincidence. The zone of slickensides could represent a subtle fault zone that is simply not expressed in the Eagle coal seam. Similarly, the slickensides might represent a change in lithology from sandstone to shale. In either case, the zone of geologic discontinuity could represent a dismembered block of rock that could have formed a cantilever effect onto the shields. In combination with high overburden and thin interburden, the cantilevered body of rock might then act as a platen on the shields, transmitting sufficient stress to fracture the floor. A similar situation is believed to have caused three pillars to burst in a coal bump at a Western longwall mine; the pillars were adjacent to a subtle fault zone that did not offset the coal, but did apparently dismember the roof beam, possibly allowing the hard sandstone roof to cantilever onto the pillars. Mine maps indicated that a lineament projects directly through the site of the February 2004 floor burst location, although no evidence of this lineament was found during the underground

Drawing 1. Mine map of the studied area of the 17 and 18 Headgates. Thick red lines represent locations of gas outbursts; brown lines represent overburden thickness; green represents overlying in the Powellton seam; short red lines represent geologic structures; dashed red lines represent projected zone of geologic structure.

Mine personnel indicated that degasification wells are planned for the next longwall panel in an effort to bleed off any gas prior to encroachment of the longwall face. This appears to be a reasonable plan to reduce the future occurrences of floor bursts, but will not mitigate the floor fracturing that may be due to the other controls discussed. In order to more efficiently direct the placement of degasification wells, it could be beneficial to construct a hazard map, based on superimposing areas with 1,100 feet or more of overburden, less than 13 feet of interburden between the Eagle and Lower Eagle seams, the projected structural zone identified in Headgate 18, and overmined areas. Correlating these areas with the floor bursts that have occurred in the mine may reveal possible problem areas or the areas best suited for methane drainage holes.
