Coal Mine Fatal Accident 2006-13

Operator:	Maverick Mining Company, LLC
Mine:	Mine #1
Accident Date:	January 10, 2006
Classification:	Fall of Roof
Location:	Dist. 6, Pike County, Kentucky
Mine Type:	Underground Coal Mine
Employment:	9
Production:	140 Tons/Day

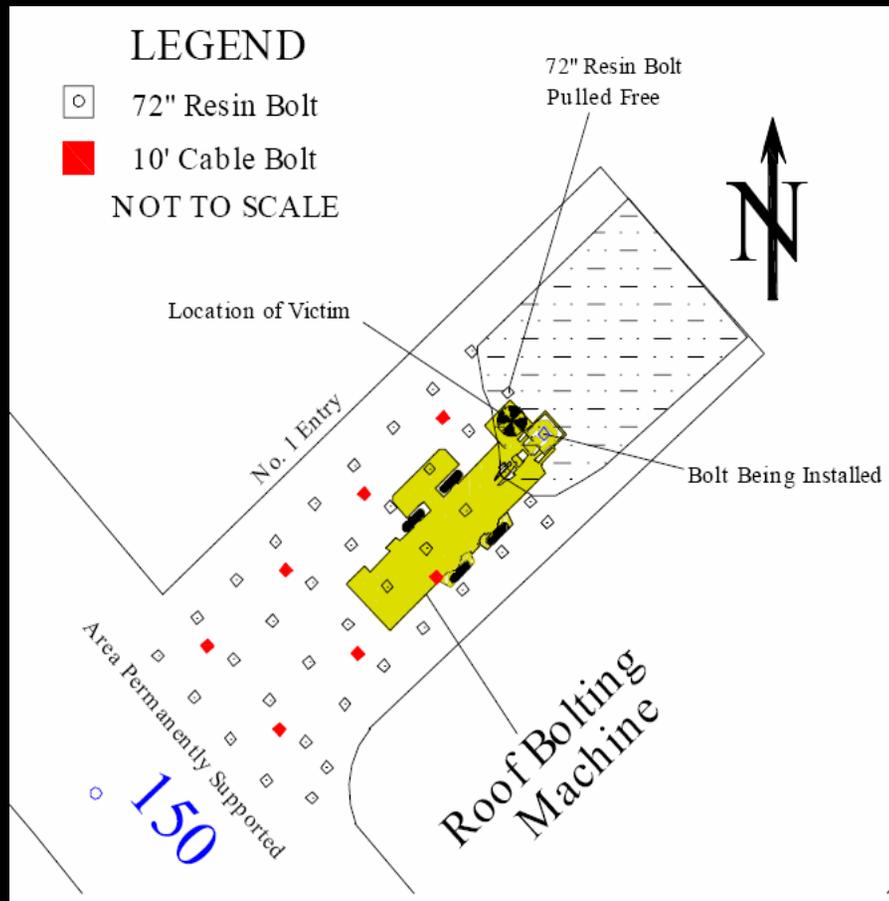
On January 10, 2006, a 44-year old roof bolting machine operator, was fatally injured in a roof fall accident on the 002-0 MMU Section.

The accident occurred as the roof bolter operator was drilling a hole in the roof to install the third roof bolt of a row in the normal roof bolting cycle in the No. 1 heading. A section of unsupported roof rock measuring approximately 14 feet by 20 feet by 3 feet thick fell against the Automated Temporary Roof Support (ATRS) and operator's canopy on the Model 320 Galis Roof Bolting Machine. The ATRS and canopy collapsed under the weight of the rock pinning the victim underneath resulting in fatal crushing injuries.

Causal Factor: Mine management did not take additional measures to protect persons when an unusual roof hazard was encountered. A persistent bedding plane weakness was present at the 3-foot roof horizon throughout the mine. In addition, a drag fold was present that roughly paralleled the entry. Both of these factors weakened the immediate roof and made it susceptible to failure and were evident in the cut just outby the accident site. The standards, policies, and administrative controls in use at the mine did not ensure that additional measures were taken to identify and correct conditions associated with the occurrence of the draw rock.

Causal Factor: The on-shift examination conducted in the working places of the 002 MMU working section failed to detect and subsequently correct the hazardous roof condition created by the presence of a drag fold and unconsolidated draw rock which separated from the overlying strata.

Corrective Action: The roof control plan was revised to show 3 feet of draw rock taken during coal extraction, limit the depth of cuts to 12 feet, use 8" by 8" bearing plates, and use a dual boom roof bolting machine equipped with a t-bar type ATRS.

Corrective Action: The operator had all working places and work areas examined and all underground personnel were trained in workplace examination and recognizing roof cracks and separations.
