REPORT OF INVESTIGATION

**Fatal Powered Haulage Accident
June 21, 2012**

**T H Kinsella Incorporated
Kinsella Quarry & Mill
Fayetteville, Onondaga County, New York
ID No. 30-01279**

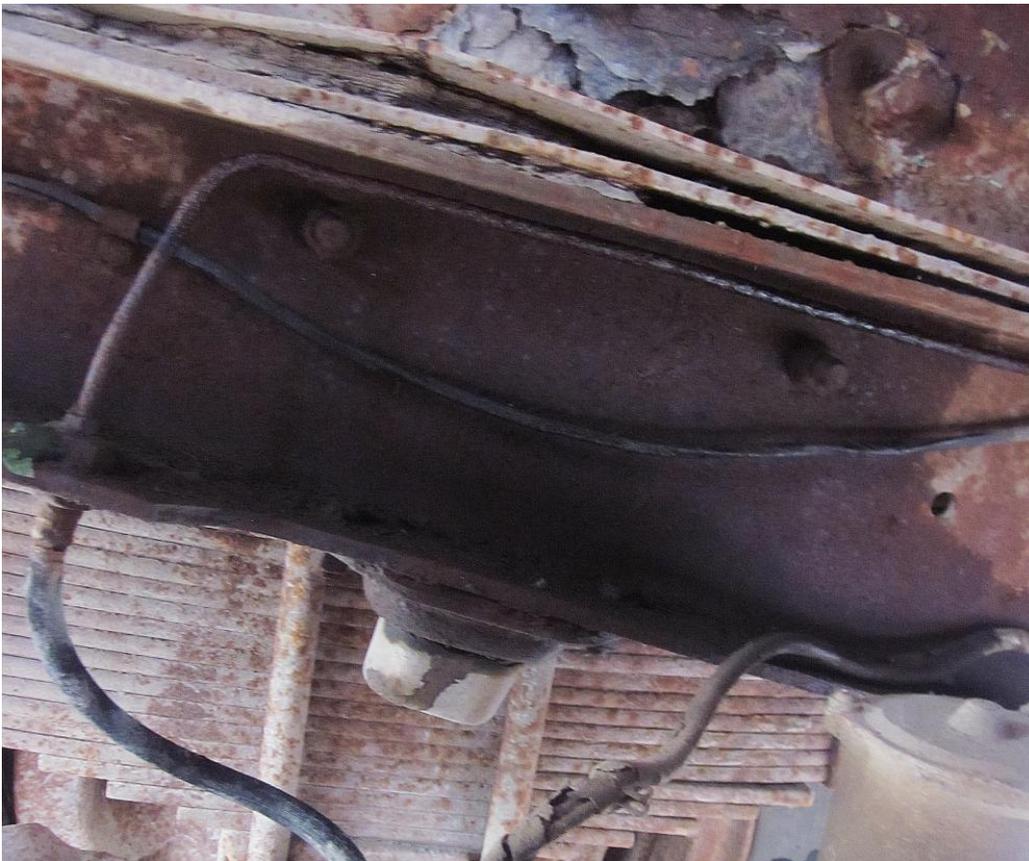
Investigators conducted a visual inspection of the truck's brake system before testing or disassembling any component. No defects were observed regarding the condition of the parking brake band and visible portions of the parking brake shoes. Some of the brake lines appeared to have been recently replaced and showed only mild weathering. Other brake lines showed signs of corrosion. A section of wet brake line above the rear axle and the surrounding portion of the truck frame was also wet. This brake line and frame section is shown in Illustration 1. Note the rough corroded appearance of the brake line.

Illustration 1: Wet brake line and frame.

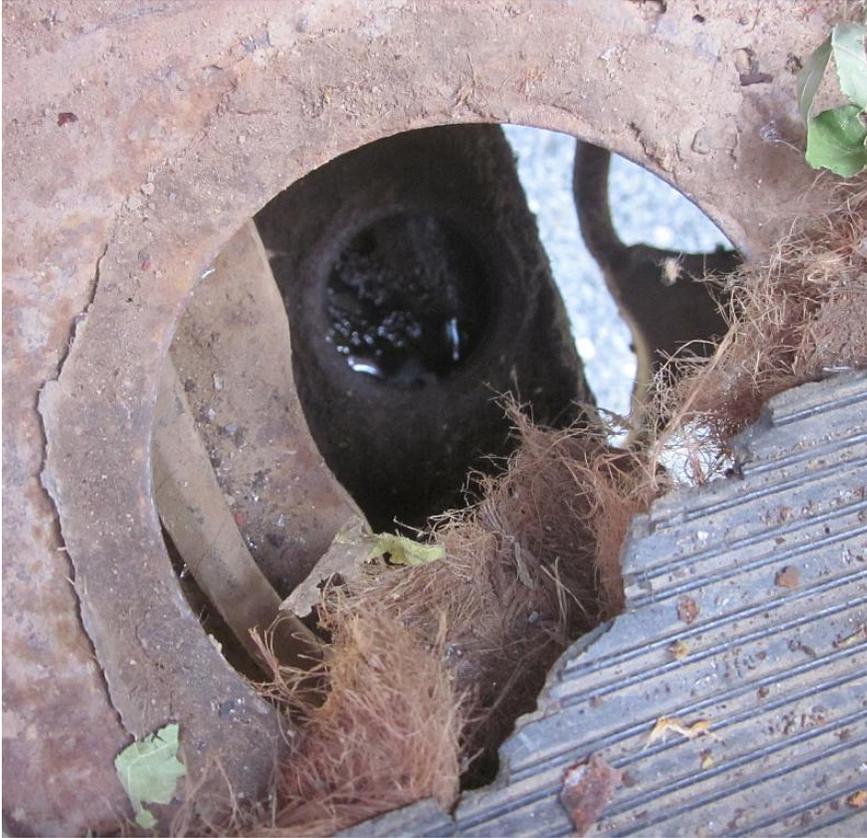
accessed through a hole in the floor, did not have a cover at the time of the accident. Dirt and residue around the rim of the opening where the cover was supposed to be attached indicated the cover had been missing for some period of time. The master cylinder had no visible level of clean brake fluid in it but contained a wet muddy looking fluid. Illustration 2 shows the master cylinder.

Illustration 2: Master Cylinder top and inside seen through truck floor.

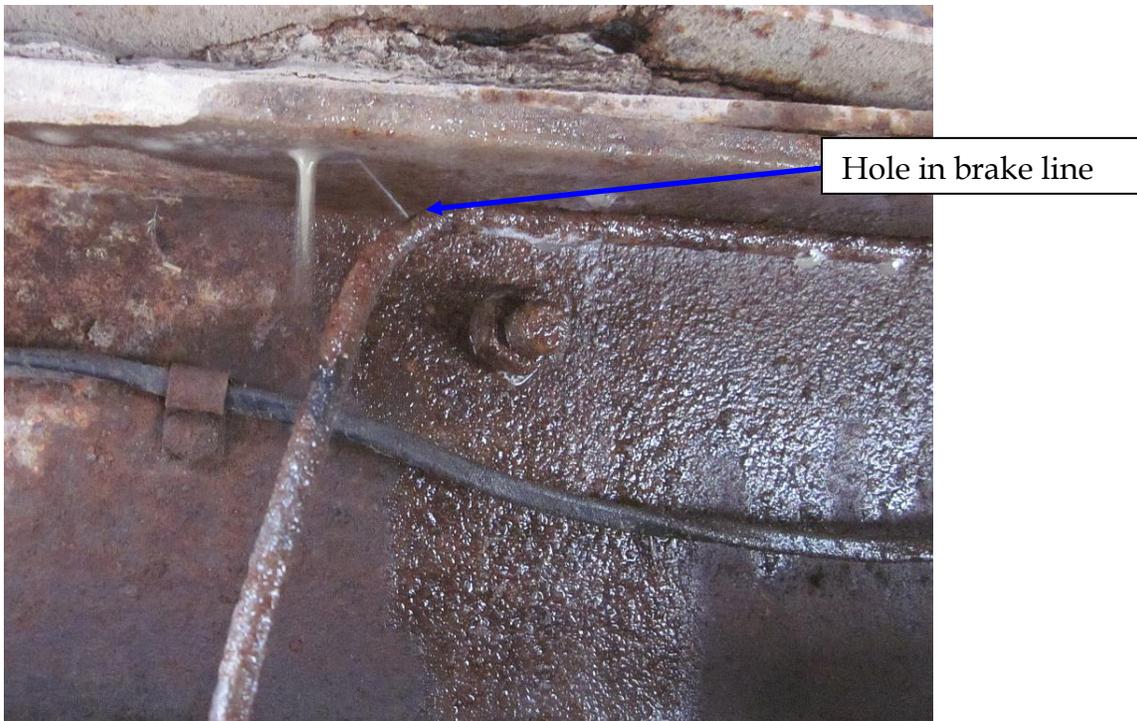
Due to accident damage, no attempts were made to start the truck. When pressed, the brake pedal moved freely with little resistance and went to the floor. When brake fluid was added to the master cylinder, the amount of brake pedal resistance increased, but the rear brakes did not apply. The brake line running from the power assist unit (located under the bed of the truck) was disconnected and compressed air fed into it. This compressed air revealed a hole in the brake line. Soapy water was sprayed onto the outside of the brake line, making the compressed air escaping through the hole visible, as shown in Illustration 3.

Illustration 3: Leaking brake line

1. A brake line in the truck hydraulic brake system leaked. Since this truck is a single circuit brake system, all service brake capacity was lost.
2. Rear brake linings on both rear wheels were adequate at the time of the accident. No brake fluid leaks were observed and the wheel cylinders of both wheels were in good condition and appeared to have been replaced recently.
3. Oil was observed on the linings of the brake shoes on the right rear wheel. Investigators could not determine if this contamination occurred during recovery of the truck or if it was a preexisting condition.
4. The steering was tight and intact.

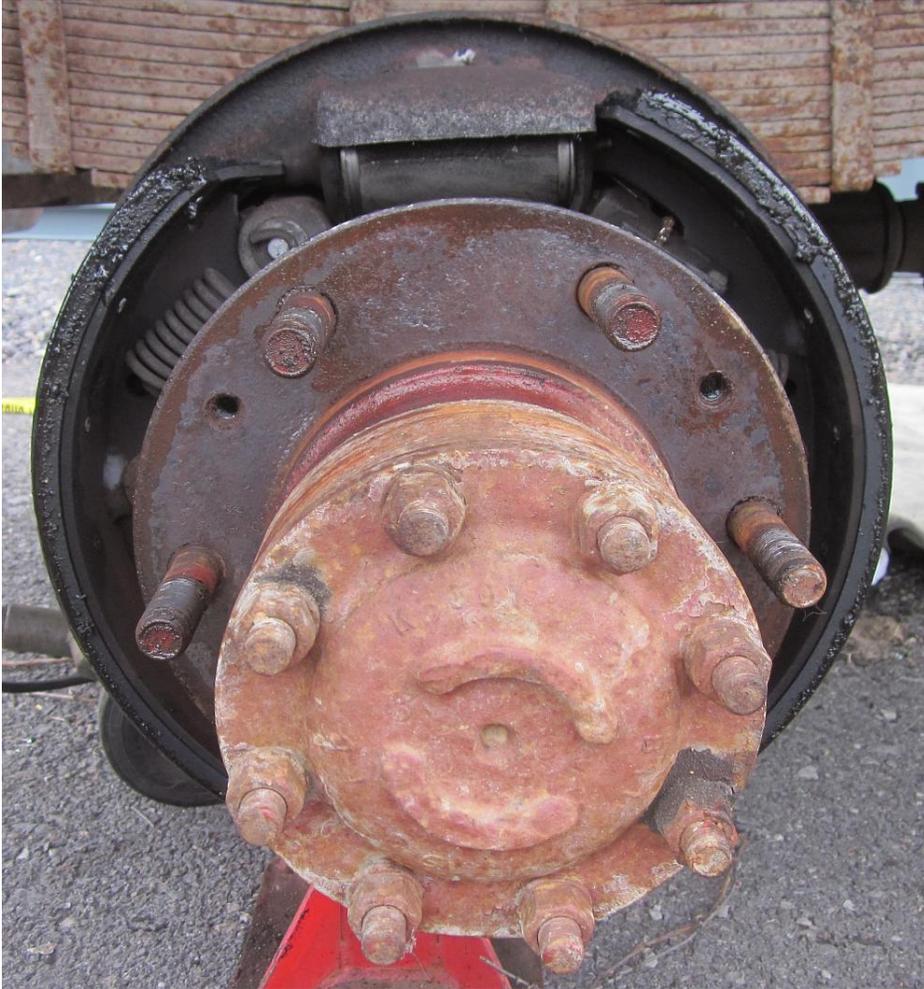
The truck was raised on jack stands and the wheels and drum on both sides of the rear axles removed. Each wheel on this truck had 2 brake shoes operated by separate wheel cylinders and with separate adjusters. The brake shoes and internal components were coated with oil inside the right rear drum (passenger side). This is the same wheel previously noted showing signs of leakage when viewed from underneath the truck. Investigators could not determine if this oil leakage existed prior to the accident, caused by the accident, or resulted from towing the truck to the police impoundment lot. Illustration 4 shows the oil on the right rear wheel brake components. The grease like substance is a mixture of oil with brake dust or dirt. The inside of the left rear wheel (driver's side) was clean with no evidence of oil contamination.

Illustration 4: Oil inside right rear wheel end

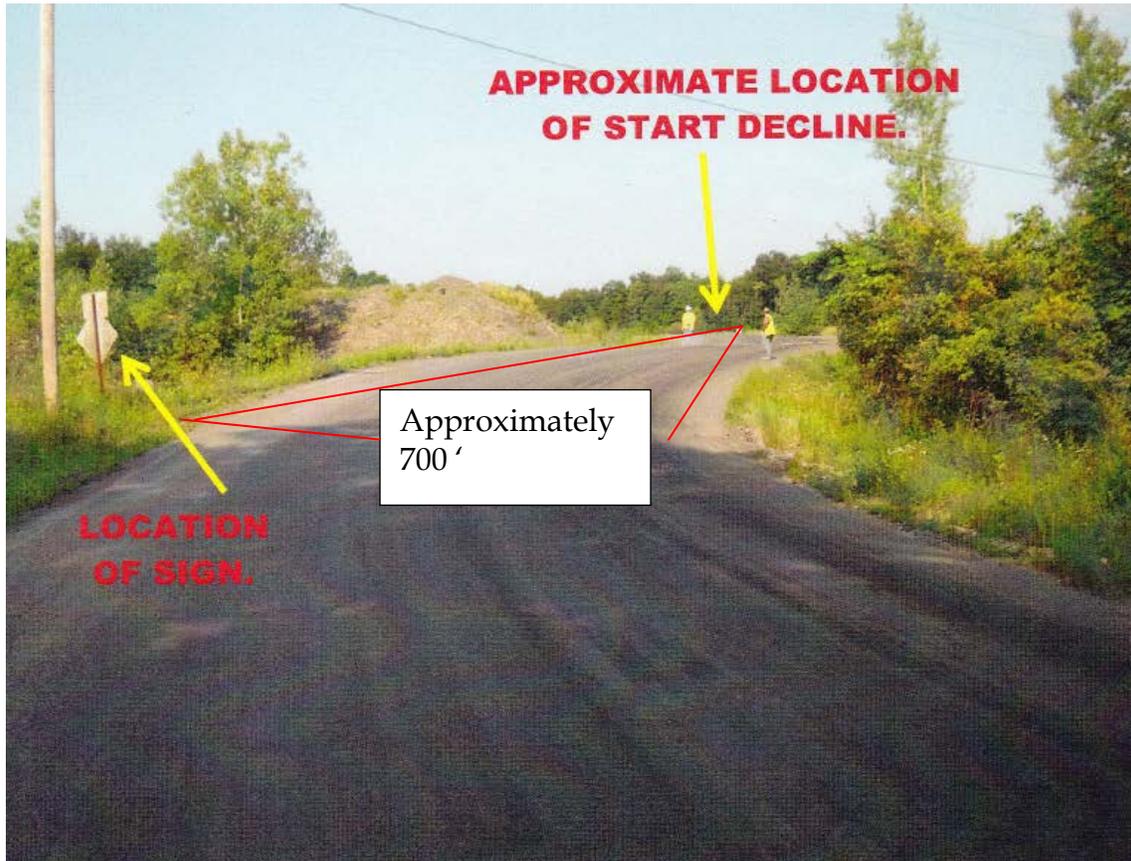
The decline of the access road is about 1,400 feet long and varies between 5 and 9 degrees (8% and 14 %) in the direction of travel. A sign indicating a steep grade requiring the use of low gear was found placed approximately 700 feet past the point where the decline began. Illustration 5 shows the approximate locations of the existing sign and the start of the decline.

Illustration 5: Approximate locations of the existing sign and the start of the decline

5. Traffic control devices did not warn mobile equipment operators of the approaching decline in the roadway.

Root Cause: The access road from the quarry to the scale house is a decline starting at approximately 5 degrees increasing to approximately 9 degrees. When the truck's brakes failed while descending the decline, the operator was unable to shift to a lower gear. The sign at the top of the decline is placed approximately 700 feet from the crest of the hill. The sign was not placed in a position along the roadway to effectively warn mobile equipment operators to reduce speed or shift to a lower gear before descending the decline. In addition, the operator's methods for ensuring that all visitors receive site-specific hazard awareness training was not adequate.

Corrective Action: Management placed a sign at the crest of the hill prior to the start of the decline to effectively warn mobile equipment operators to reduce speed or shift to a lower gear before descending the decline. Management also posted a sign in plain view that contained all required site-specific hazard awareness information.
