UNITED STATES
DEPARTMENT OF LABOR
MINE SAFETY AND HEALTH ADMINISTRATION

COAL MINE SAFETY AND HEALTH
REPORT OF INVESTIGATION

Fatal Machinery Accident
September 15, 2014

Black Warrior Minerals, Inc.
Manchester Mine
Jasper, Walker County, Alabama
ID No. 01-01362

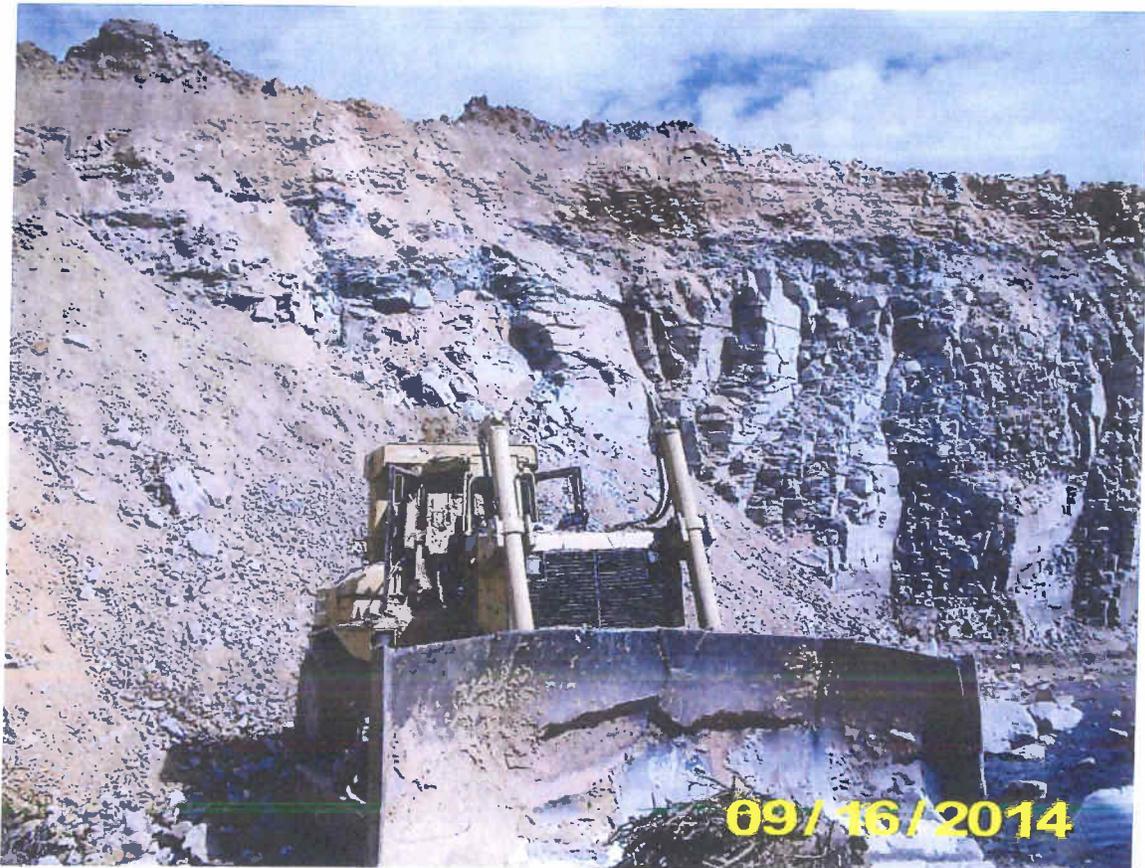
On Monday, September 15, 2014, at approximately 12:40 pm., a 53-year old bulldozer operator sustained fatal injuries when the bulldozer he was operating traveled over the highwall and fell 50 feet into the pit. The victim had been assigned to level a bench for drilling.

The bulldozer operator failed to maintain full control of his equipment while it was in motion in close proximity to the edge of the highwall. The victim was not wearing his seat belt.

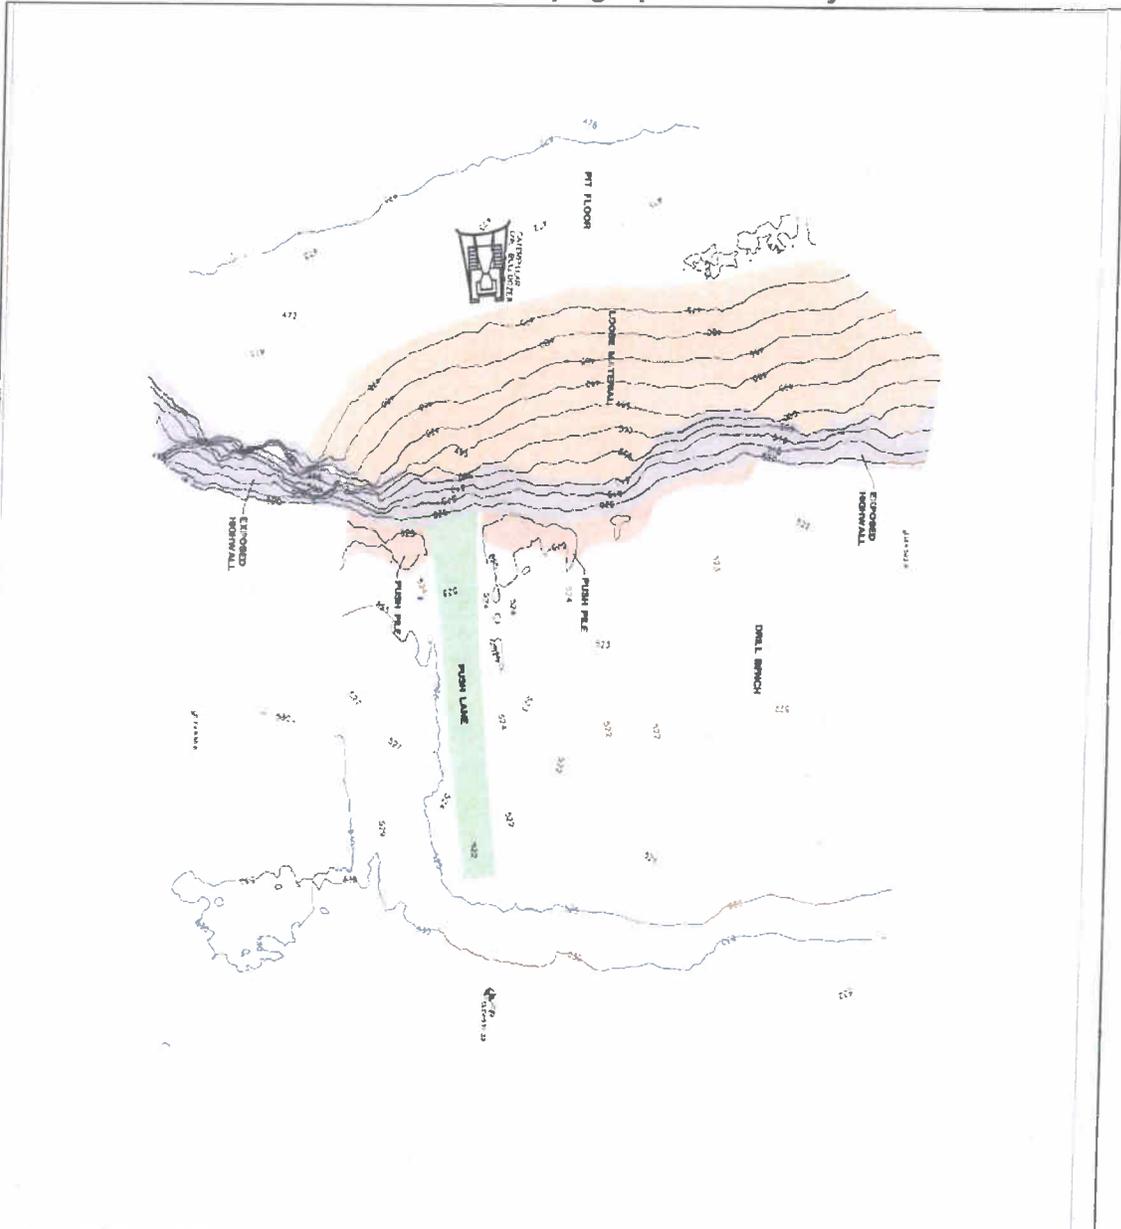
APPENDIX C - Topographical Survey

The accident scene consisted of a highwall in which the upper bench was being prepared for the drilling phase of the mining cycle. The lower pit level had already been mined. The highwall measured 50 feet in the area where the bulldozer traveled off the highwall. There were no cracks in the bench floor or areas where the highwall had broken. The inspection of the highwall revealed no evidence of ground failure. The weather conditions did not contribute to the accident. The day was a mostly cloudy with a temperature of 84 degrees Fahrenheit (°F). The bench area was dry.

The upper level of the highwall was in the construction phase. The investigation showed that normal mining practices were used in clearing and leveling the bench for drilling. A portion of the berm was not left on the edge of the bench, which was the area where the bulldozer traveled over the highwall.

On the push by the bulldozer when the accident occurred, there was a gouge in the bench floor close to the edge of the highwall. The bulldozer blade was dropped down when it should have been level or been raised prior to the bulldozer backing up for another push. The last push was the only location on the bench that showed evidence of this occurrence and was a change in the method of bulldozer's operation during the last push, as compared to the rest of the bench.
