REPORT OF INVESTIGATION

**Underground Metal Mine
(Gold)**

**Fatal Machinery Accident
April 28, 2014**

**Klondex Midas Operations, Inc.
Midas Mine
Midas, Elko County, Nevada
Mine ID No. 26-02314**

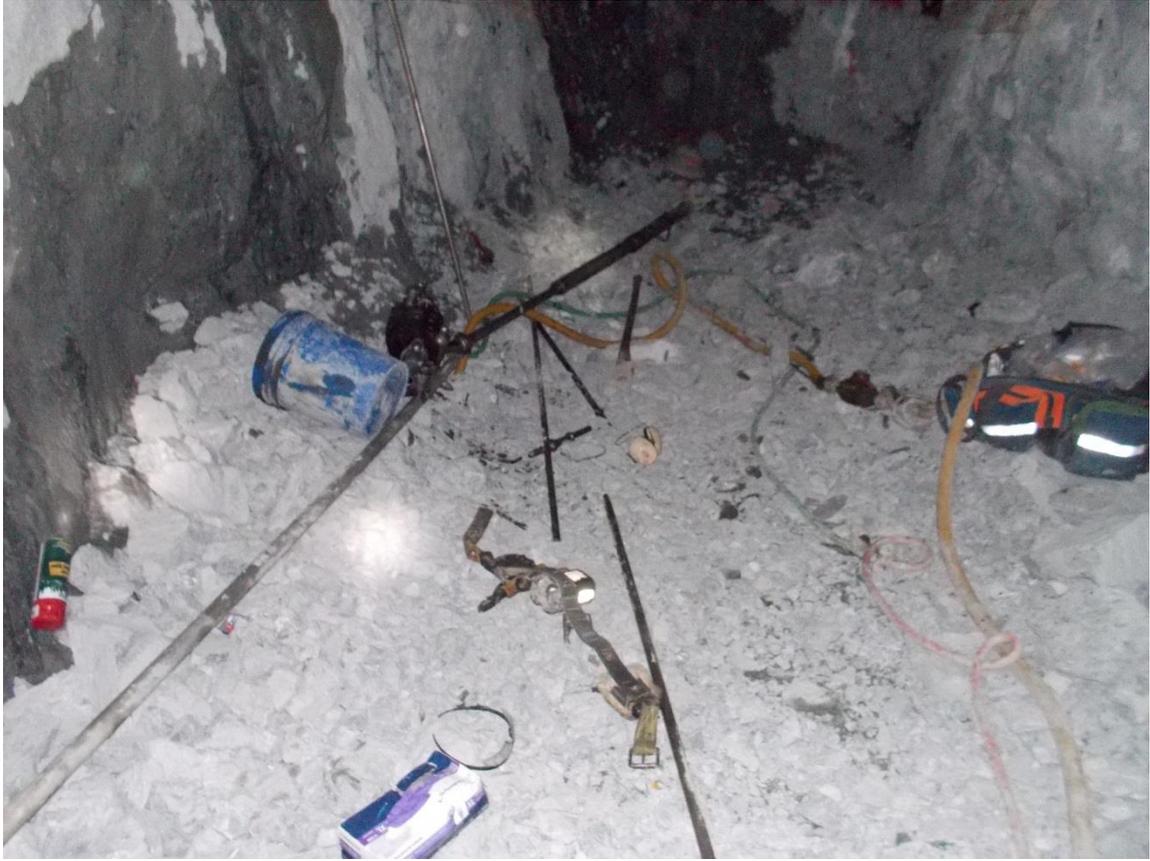
The accident occurred at the No. 8-4540 south stope near the face. Otto had drilled nine holes in the face and had drilled 4 feet of the tenth hole when the accident occurred. The No. 8-4540 south stope is 8 feet wide by 12 feet high in this area. The jackleg drill was located 13 feet 9 inches from the face, with the leg extended out full length towards the face. Otto was found 15 feet 6 inches away from the face with a 6-foot drill steel connected to the jackleg drill. The drill's throttle was in the "full-on" position and the leg extension air throttle control in the "quarter-on" position. According to witnesses interviewed, the drill steel was turning when the victim was found.

There were two 6-foot steels, two bolt drivers, an axe, one 6-foot steel with a broken shank, a five gallon bucket of oil, and large rocks scattered around the workplace.
