REPORT OF INVESTIGATION

Fatal Hoisting Accident

January 11, 2015

**Leeville
Newmont USA Limited
Carlin, Eureka County, Nevada
Mine ID No. 26-02512**

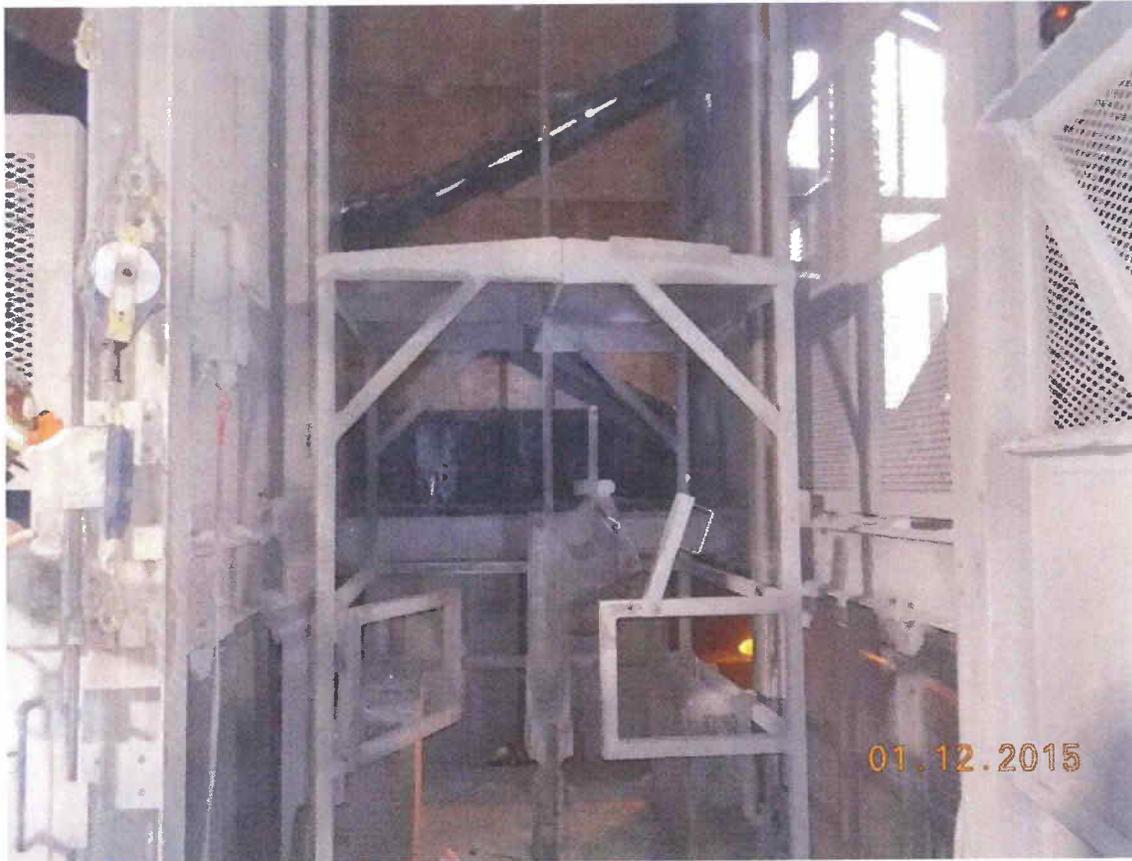
Work platform on top of the ventilation shaft skip

When interviewed, Hughes stated that immediately after the skip started to travel up, he saw Holmes sneeze and move his head forward, hitting a shaft structural steel cross beam at the 195 feet level. Holmes was caught between the hand rail and the beam. The clearance between the skip work deck hand rail and the steel beam measured 5½ inches. The skip was traveling at 200 feet per minute.

A steel work platform, 11 feet 6 inches long, by 5 feet 8 inches wide, is mounted above each of the skips. Each is provided with a bonnet, handrails, and a gate. The top handrails are 42 inches from the floor.

Corrective Action: The mine operator installed new enclosed cages on top of the skips.
