REPORT OF INVESTIGATION

Surface Nonmetal Mine
(Construction Sand & Gravel)

Striking or Bumping
June 12, 2015

Fillmore Industries Inc.
Fillmore Pit & Plant
Loudon, Merrimack County, New Hampshire
Mine I.D. No. 27-00222

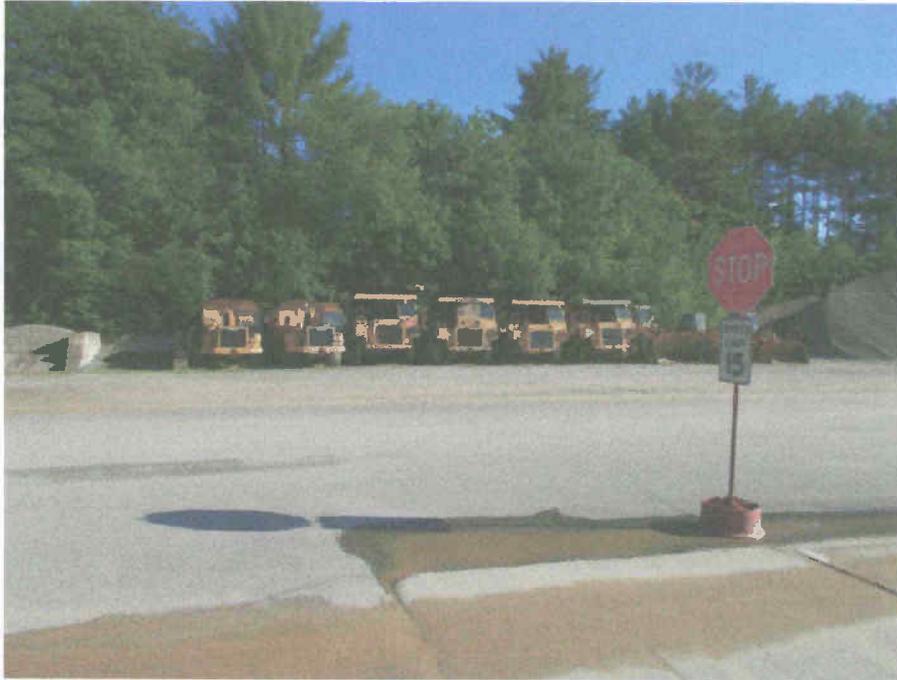
Figure 1 - Six haul trucks in line waiting for repairs.

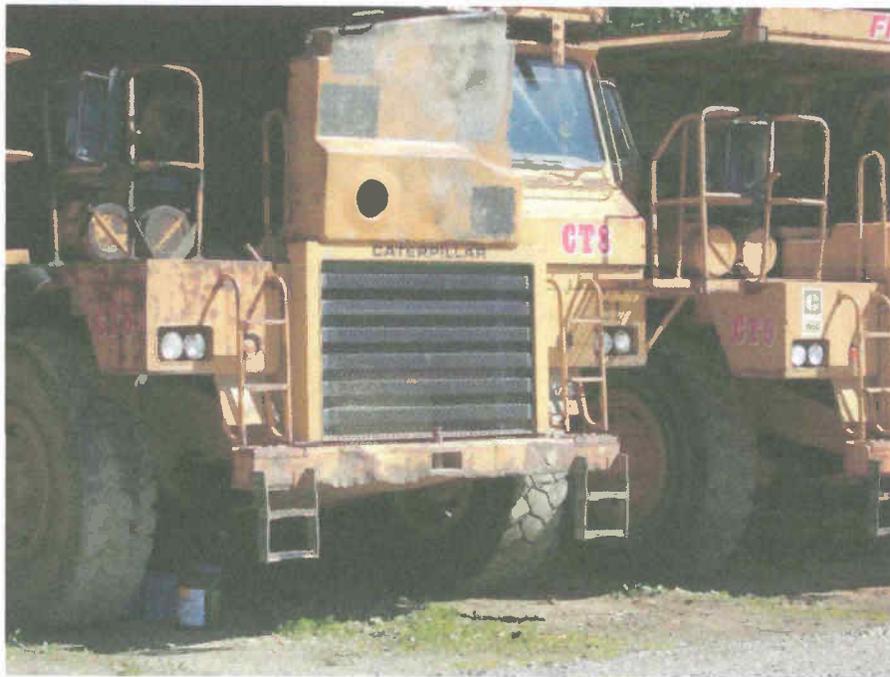
On June 12, 2015, Laurence D. Yeaton (victim) reported for work at 6:35 a.m., his usual starting time. Yeaton was instructed to perform repair work on several haul trucks to prepare them for sale. Yeaton began his shift by inflating the left front tire on one truck (CT 4). Afterward, Yeaton began replacing the auxiliary steering system jack shaft on a second truck (CT 8).

Figure 2 - Haul truck (CT 8) victim was working on prior to going to "boneyard."

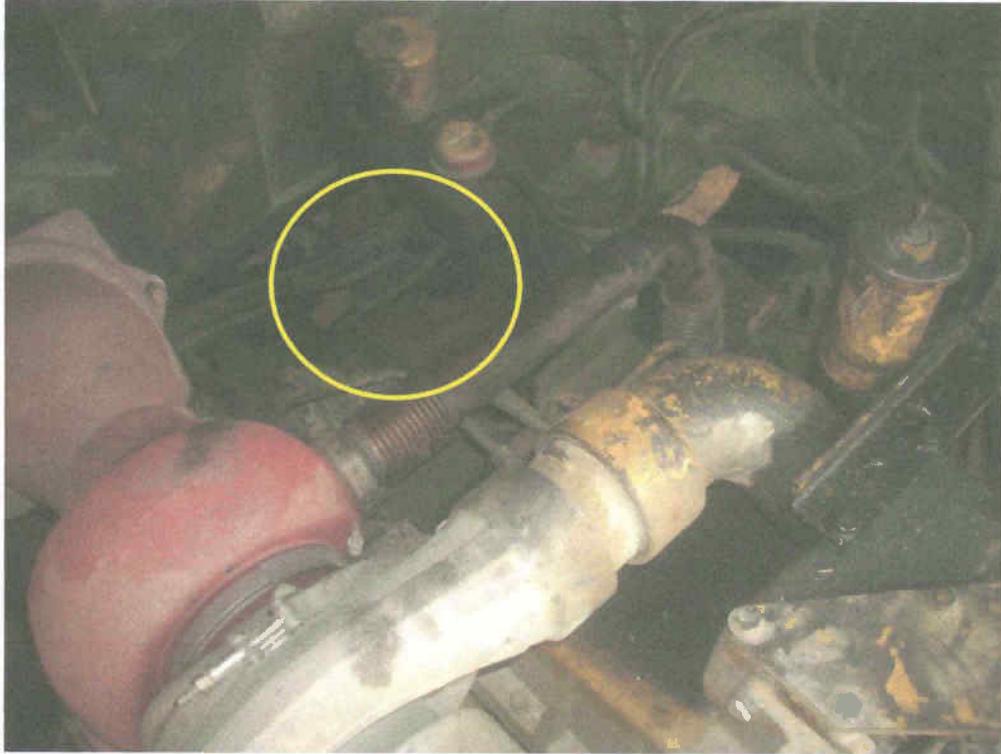
Figure 3 - Location of the jack shaft being replaced.

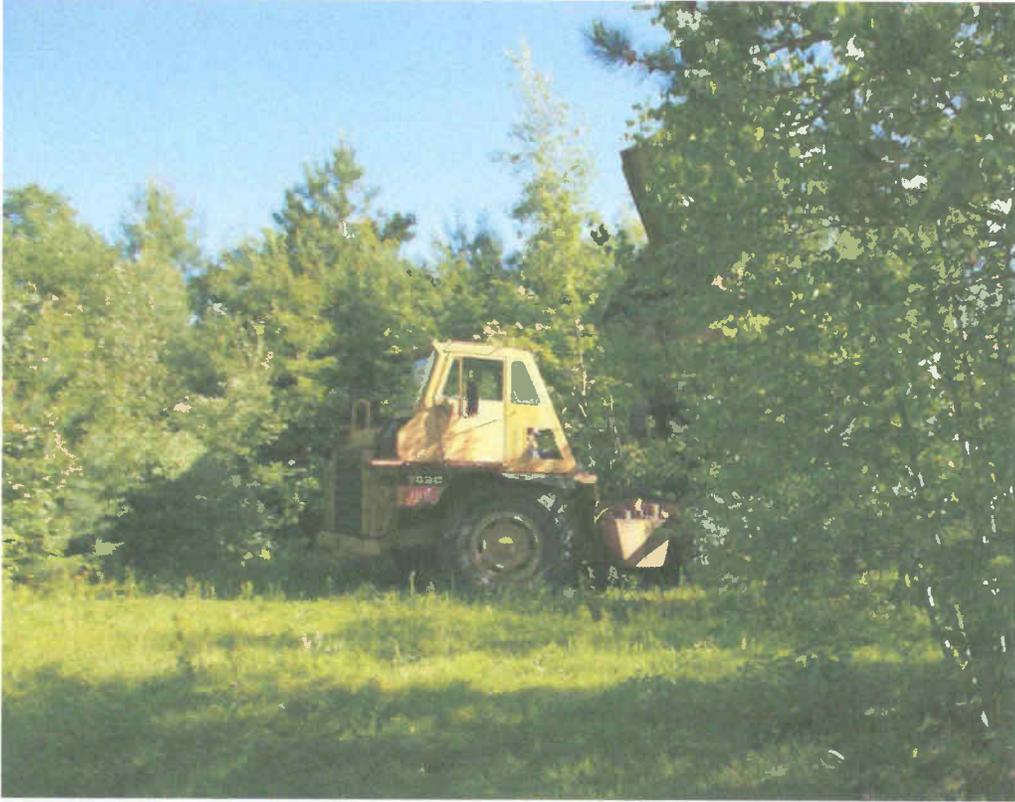
Figure 5 - Haul truck (CT 6) at boneyard
