DAILY COVER SHEET

EVENT NO. 4118295

Traveled to Performance Coal Co, UBB 46-08436
EOP inspection

Upon arrival to closed AN EOP inspection
I was informed by Bill Harless, mine foreman
that a roof fall had occurred on NW1 Section
in the face of NW1 entry, an EOP inspection was
started. A 103(R) order was issued
at verbally at 0950..

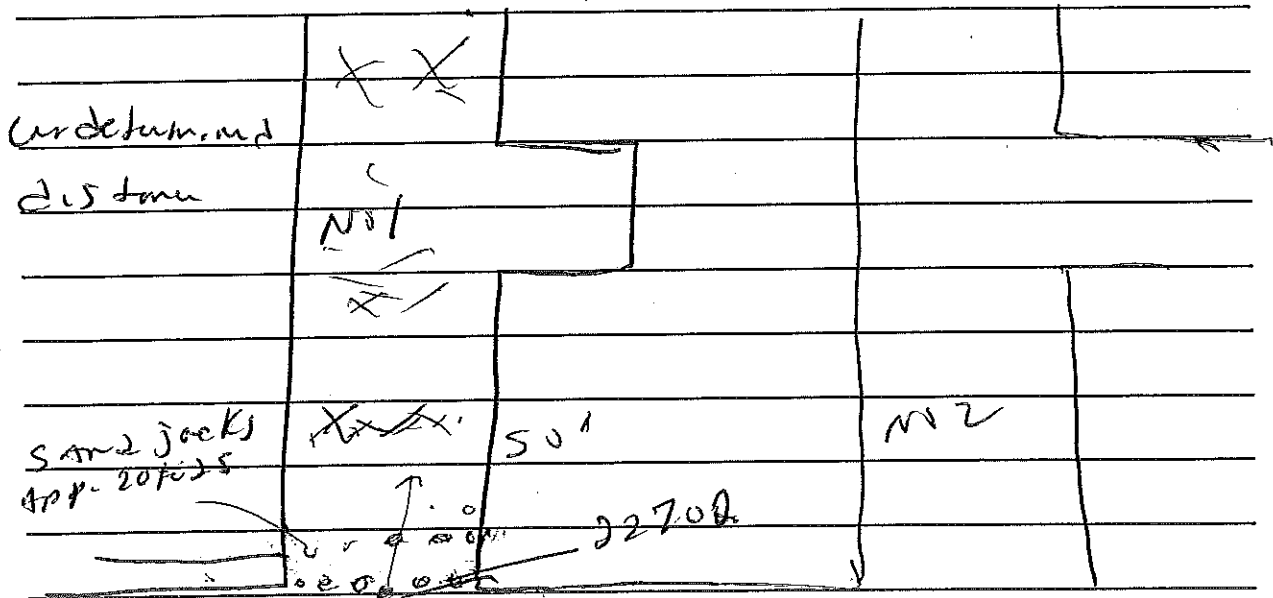
At approximately 6:00 AM on 09-30-08 on
the m.e.-night shift the fall occurred
the Fall beginning app. 50 feet in by Survey
Station # 22702 and extended in by for an
undetermined distance the Fall broke off
at the point where the cable bolt installation
had stopped

The Area had been supported with 6 steel
forged tension rod bolts the fall fell
above the anchorages of the bolts and was
approximately 8' in length the area had been
timbered off using SAND jacks, on the
Fall area there were some visible cracks present,
the Fall is laminated sandstone.

The entire section's roof was examined from the FACE(S) out by for 2 X-end no visible roof problems were observed. The roof was sound and was solid and sound overall mining height 72".

A plan on how to prevent a recurrence was discussed. The company said they would install ~~rod~~ bolts (10' feet) for the entire length of the roadway, install the incorporating cable into the bolt pattern with cable bolts in every other row.

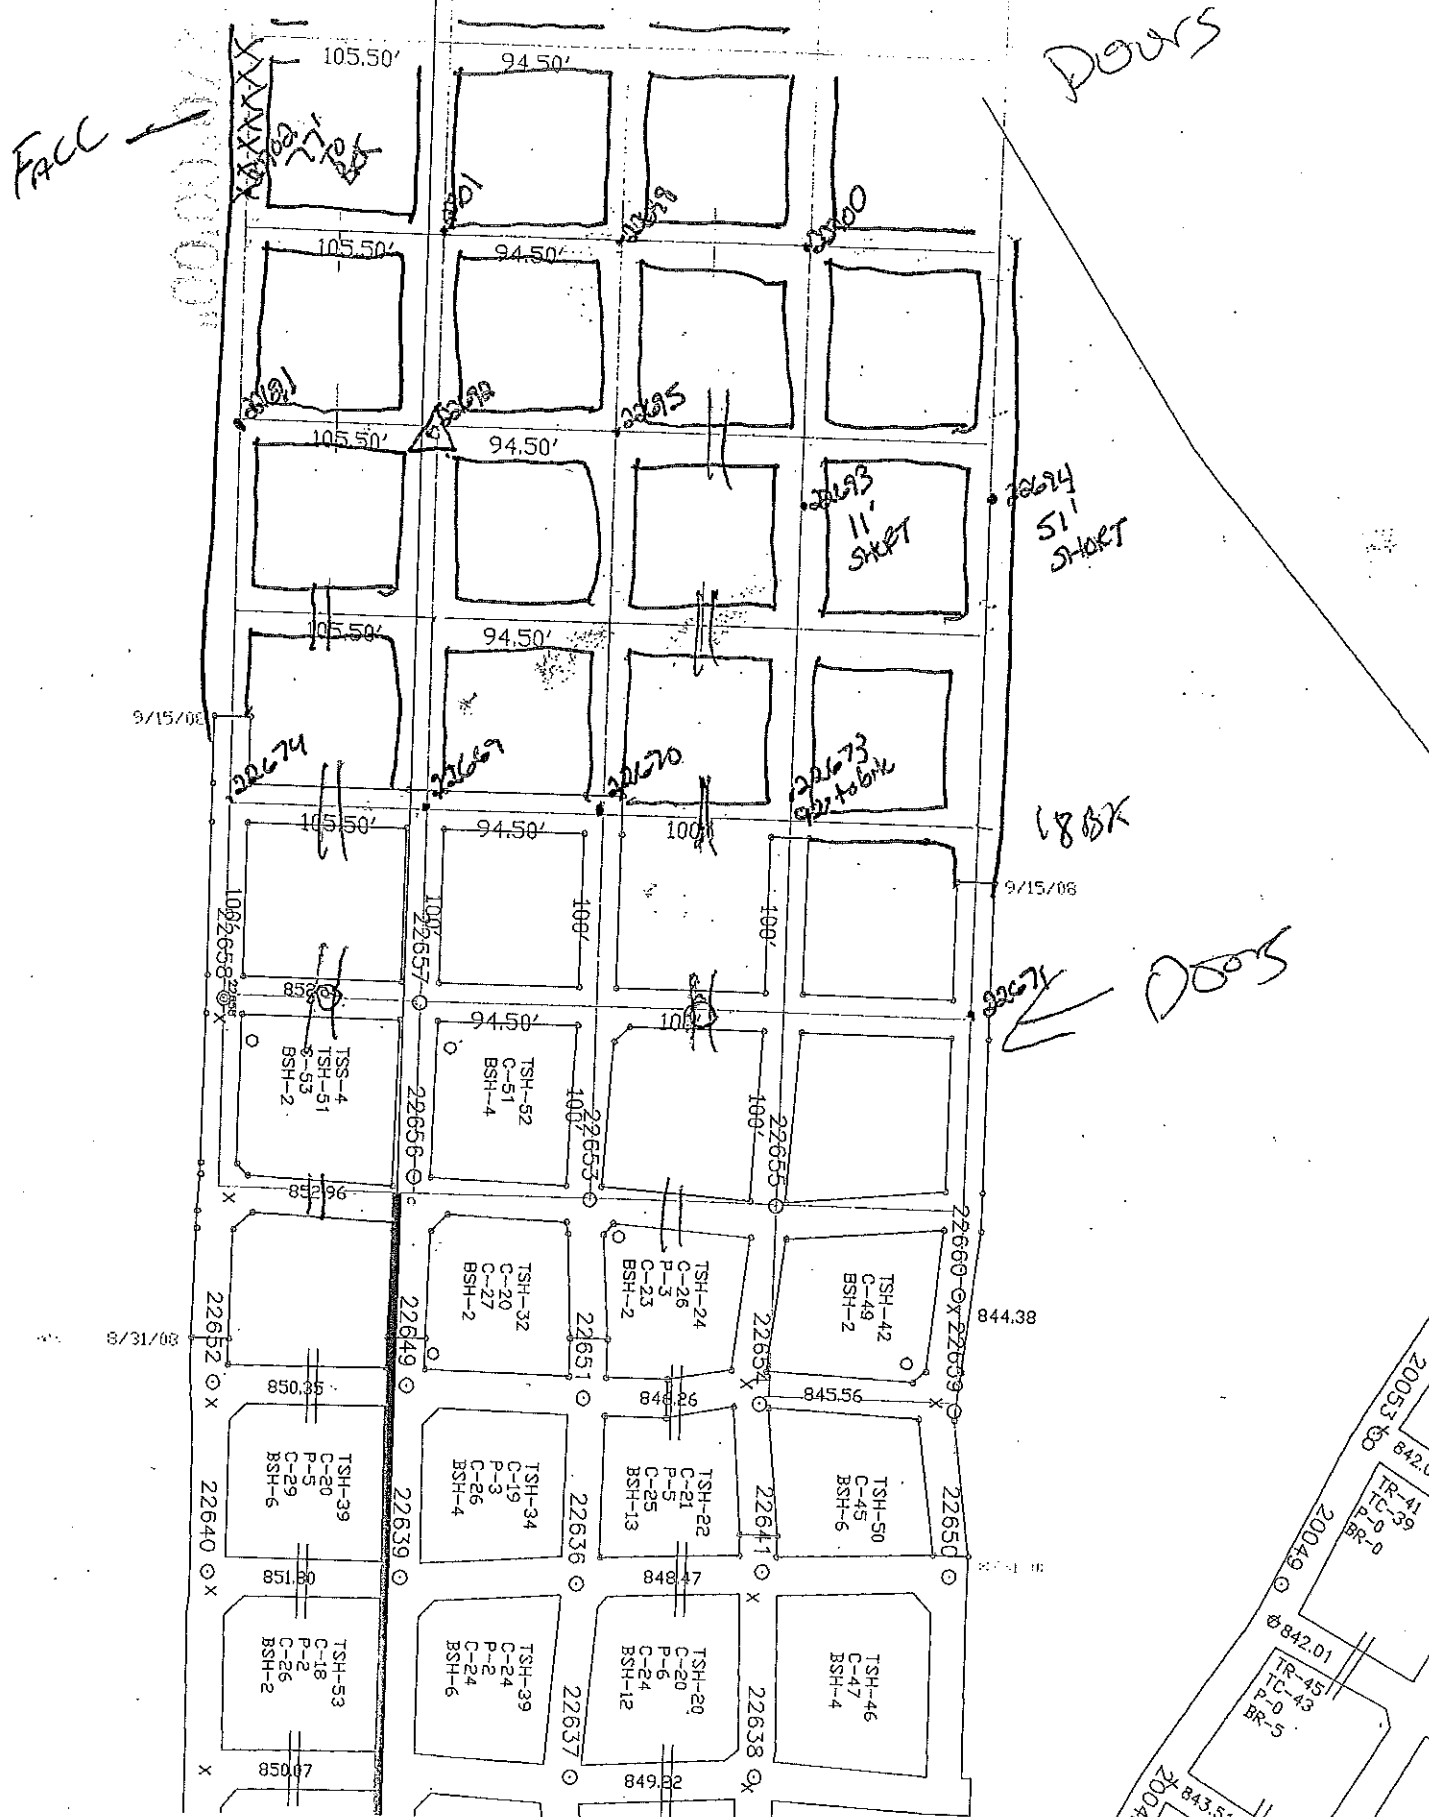
UBB #1 SECTION

A non-injury Accident (Roof fall) occurred at this operation on 09-30-08 in the low area of the NOI entry of M/L Section. This order prohibits Coal production until such time when a revision to the roof control plan can be submitted to the MSHA office at Mt Hope, W.V. and approved.
