# **RECENT UNITED STATES COAL MINE FIRES: LESSONS LEARNED**

**John E. Urosek, Dennis A. Beiter, Richard T. Stoltz and William J. Francart**  
**Mine Safety and Health Administration**  
**United States Of America**

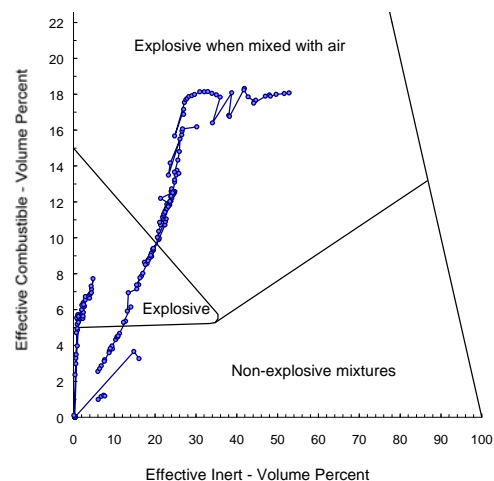
Figure 1. Explosibility Determination of Atmosphere

A 72-hour waiting period has usually been sufficient for the mine atmosphere to become settled following sealing of mine fires. Approach to mine openings is not permitted within the 72 hours or later if the environment is considered unstable. Generally, explosions after the 72 hour waiting period are not common. Explosibility determinations as shown in Figure 1 did not permit approach to the shaft area.

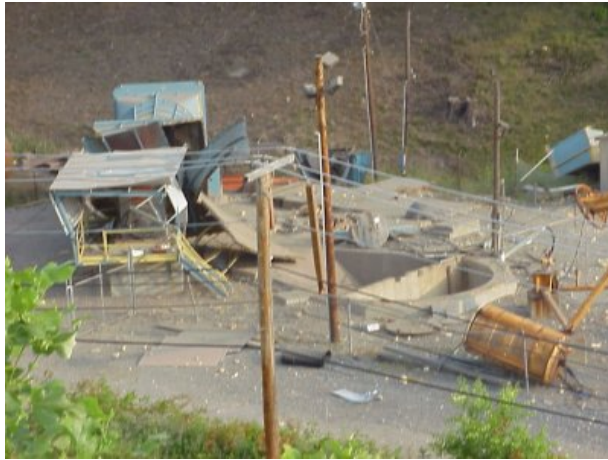
Figure 2. Damaged Surface Facilities

On June 26th, at 3:20 a.m., approximately 77 hours after the mine was sealed, an explosion occurred underground which damaged the temporary seal and fan installation at one of the ventilation shafts. The damaged shaft, shown in Figure 2, was more than 1.6 kilometers from the original fire area. The explosion caused little disturbance at a ventilation shaft much closer to the original fire area and was initially undetected at the other surface openings.

The damaged shaft was resealed later that day. Air samples from the old borehole located in by the original fire area revealed the gas concentrations in that portion of the mine to be oxygen - 12.39 percent, methane - 18.18 percent, carbon dioxide - 3.52 percent, carbon

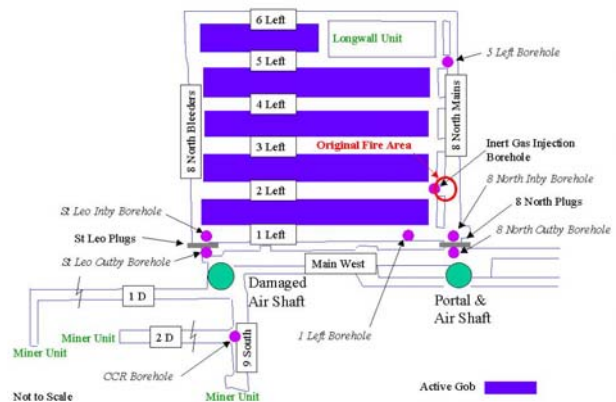
Figure 3. Remote Plugging Plan Detail

Mine management developed a plan to use remote plugs, injected through boreholes, to try to separate the fire area from the rest of the mine as shown in Figure 3. The ventilation plugs were completed on July 13, 1999. The total amount of material injected was approximately 900 metric tons. Continued sampling analysis revealed similar changes in gas trends on both sides of the plugs. These similarities indicated the effectiveness of the plugs was questionable. The ability of the plugs to isolate the fire area from the remainder of the mine was doubted. Successful installation of the plugs might have enabled the remainder of the mine to be re-ventilating more quickly. Recover operations settled in for a longer waiting period.

Exploration during recovery near the fire area confirmed the results indicated by the gas trends: the plugs were not effective. Also, exploration revealed the explosion had not originated in the fire area. The explosion source was located on one of the development section and was not related to the fire. Thus, the degree and extent of damage on the surface caused by the explosion was understandable. Completion of the mine recovery continues at the time this was written.

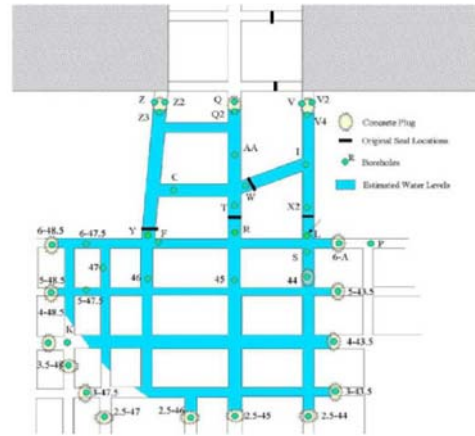
Figure 5. Final Plug Locations and Extent of Water

By May 8, drilling was completed and water had roofed much of the fire area as shown in Figure 5. Fire gasses had fallen to the lowest levels measured since the event started and continuous monitoring was stopped. A total of 43 boreholes were drilled during the recovery operation along with the installation of 17 remote plugs.
