GENERAL INFORMATION COVER SHEET

Company Name ANKER WEST VIRGINIA MINING CO.

Mine Name SAGO MINE

Mine I.D. Number 46-08791

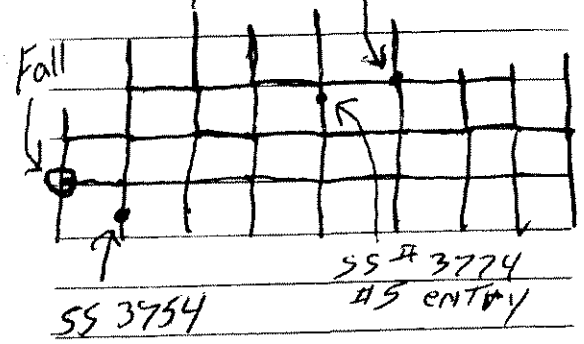
SS # 3763  
9 entry Super Section

(fall) 21 ft wide  
28 ft long  
6 ft high

5 foot length bolts  
torque tension are  
used on this main

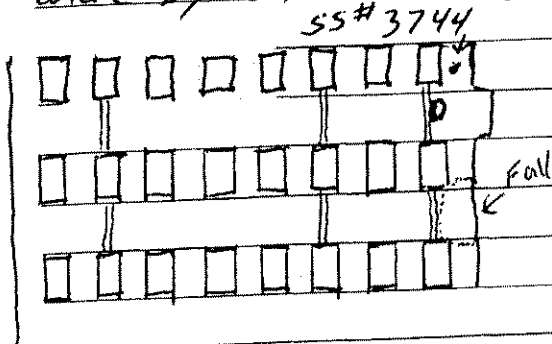
Fall occurred at 7:15 AM ON 4-19-05 approximately 85 feet out by SS#3744 in #9 entry Three way intersection.

The fall is approximately 25 feet long by 25 feet wide by 5 1/2 feet high.
