U.S. Department of Labor  
Mine Safety and Health Administration  
Technical Support  
Approval and Certification Center  
Electrical Safety Division

Remote Controlled Continuous Mining Machine Fatal Accident Analysis Report

Victim's Physical Location With Respect to the Machine

Original Report Dated April 26, 2002  
Updated June 4, 2015

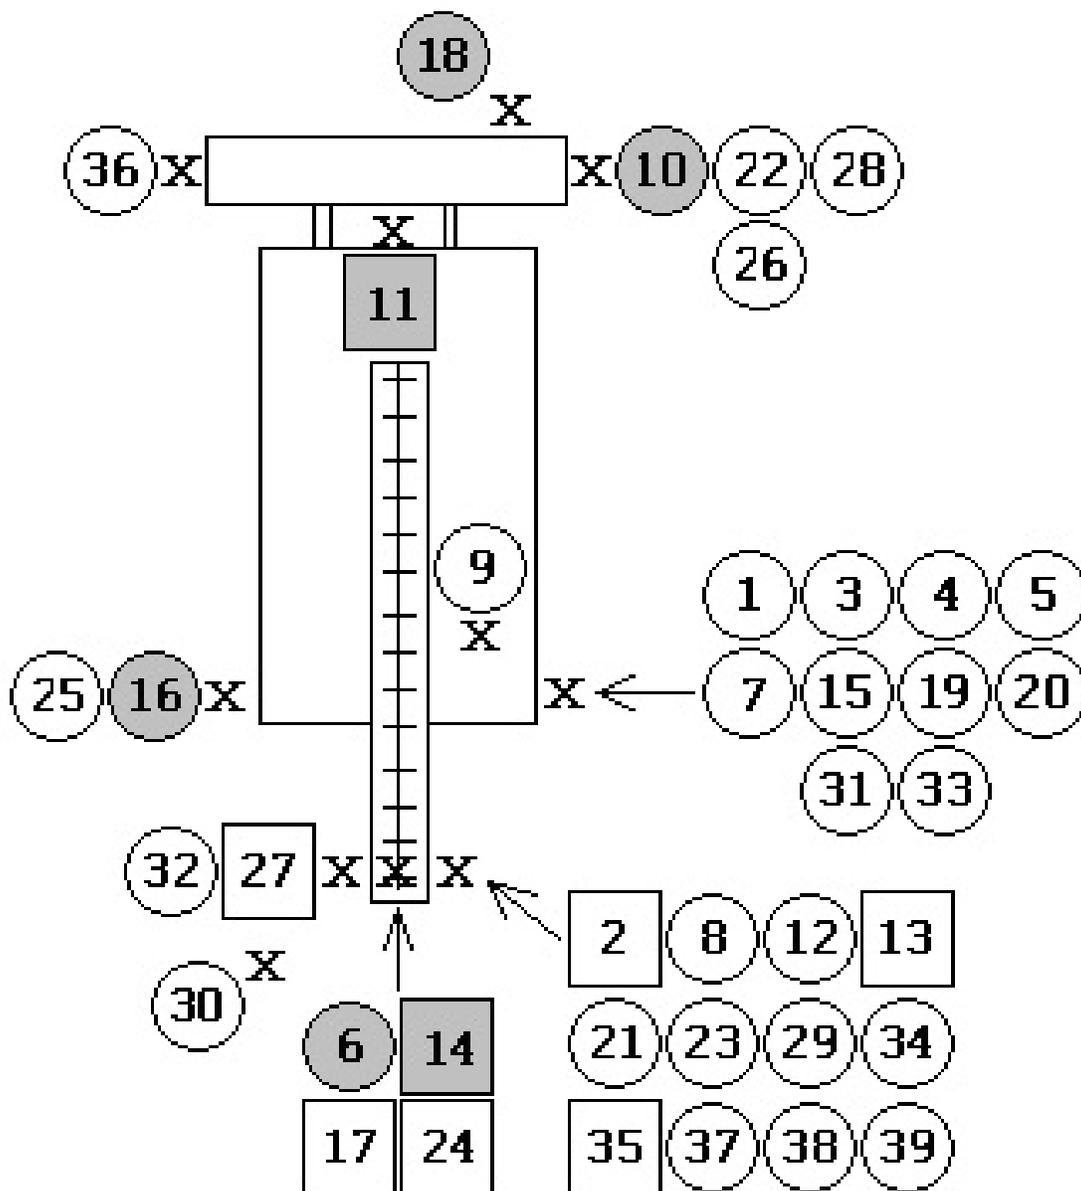
**Figure 1**

5. The machine operator was most at risk (30 out of 39 fatalities). The one exception to the number of circles in Figure 1 is accident number 21 since the operator was not trimming the machine at the time of the accident.

6. Most pinning and crushing accidents occurred on the right rear side of the machine (23 out of 39) with eleven fatalities occurring at the right rear machine corner and twelve occurring at the conveyor boom. The four operator fatalities occurring at the left side of the machine during non-maintenance work were with machines designed for left side operation.

### Location of Remote Control Victims With Respect to Machine

Technology has advanced and allowed new design safety features and design approaches that may protect the operating personnel even when safe work practices are not followed. One of these safety features, that may help prevent the type of accidents that have occurred, is proximity detection. This feature provides automatic proximity detection and machine shutdown to protect personnel from being crushed, struck, or pinned when they are inadvertently positioned in a hazardous area in close proximity to the machine. It is estimated that the use of proximity detection with machine shutdown could have been a preventative factor in 32 of the 39 fatal accidents (except 6, 9, 11, 14, 21, 27, and 30) analyzed above. The technology for proximity detection currently exists and its use on mobile mining machinery is recommended.
