SAFETY HAZARD ALERT

Plate Filter Presses

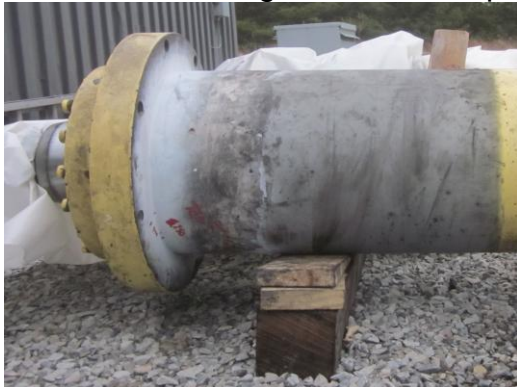
The two cylinders of the Jingjin 2000x2000x40 quick opening automatic membrane filter press failed simultaneously at their mounting flanges. The mounting flanges were located at the piston end of the cylinder (cylinder head). When the press was operating, high stresses were applied where the cylinder was welded to the mounting flange. Cracks developed at the cylinder-to-flange connection in a relatively short period of time. The press had been in operation for approximately 18 months. The photographs below show a flange on a second press at the mine with similar cracks in the cylinder.

Flange, cylinder, and piston

Due to the rapid development of the cracks and the resulting catastrophic failure of the cylinders, MSHA recommends that all mine operators inspect flange-to-cylinder weld areas for cracks on all similarly designed plate filter presses. Inspection of the mounting bolts and the frame mounts should also be conducted. The inspection should be performed by personnel with experience in non-destructive examination of metal components with suspected cracking. Noticeable flexing or other movement of the press superstructure strongly indicates likely cracking of the cylinder. A periodic inspection schedule should be implemented on all presses which utilize this or similar designs.

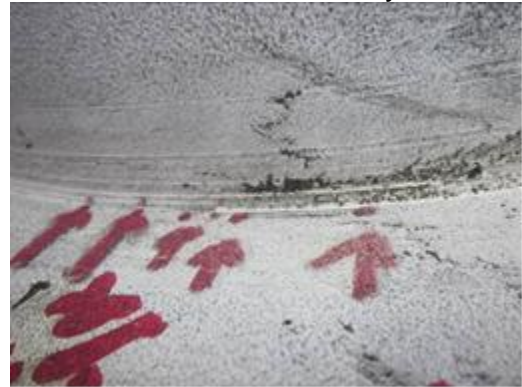
Cracks in cylinder body and flange
