METAL / NONMETAL

Near Miss Accident

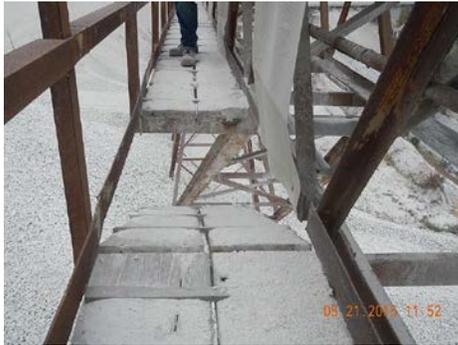
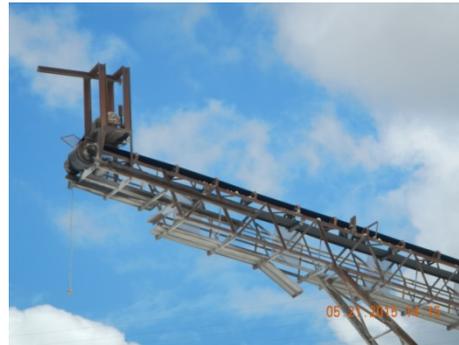
Surface Sand & Gravel - May, 2015 - An inspection party walked up the wood plank walkway to inspect the conveyor head pulley. As they started back down a section of the walkway unexpectedly dropped out from beneath the miner leading the the party. He escaped the 30 foot fall to the ground by holding onto the handrail.

- Examine your work places for all possible hazards and correct them before you perform work.
- Conduct structural inspections periodically.
- Look, listen & feel for abnormalities in walkways.
