# Appendix 3

Report of Investigation

Fatal Other Accident

Storm Exploration Decline  
Barrick Goldstrike Mine Inc.  
Elko, Eureka County, Nevada

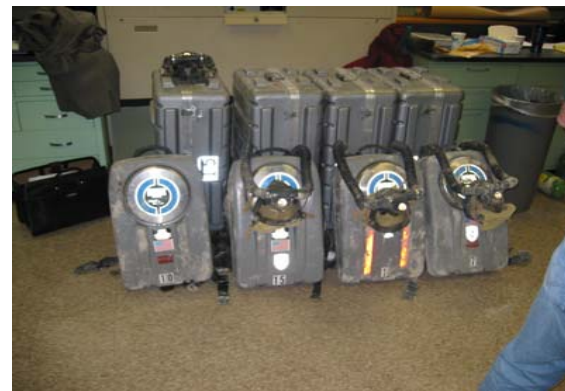
| Spreadsheet 1: Visual Inspection | # 1 | # 7 | # 10 | # 15 |
|---|--|---|---|---|
| 6) Check if there are any worn, missing or loose parts/damage. | a) Small dent in scrubber cannister, b) Botton clip on scrubber housing not engaged. | 2 large dents in scrubber cannister | a) Small dent on scrubber cannister, b) Cylinder strap reversed | Oxygen cylinder not secured. |

Figure 1a: (From left-to-right.) Apparatus #10, #15, #1 and #7.

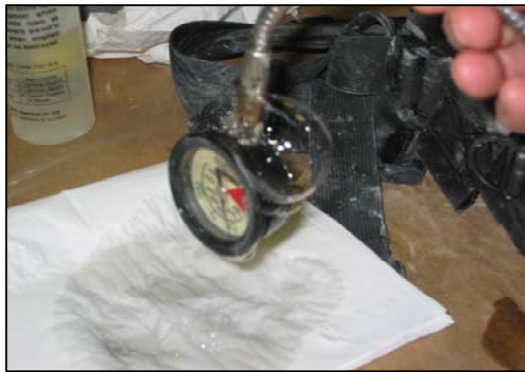
| Spreadsheet 6: Bench Testing Summary | # 1 | # 7 | # 10 | # 15 |
|---|---|---|---|--|
| High pressure leak test | OK | OK | OK | Failed. Leak at T-connection and chest guage. (See engineering drawing.) |

Figure 6a: Leak at chest gauge.on Apparatus #15

| Apparatus | Exh Press, mm H2O | Inh Press, mm H2O | Avg Inh O2, % | Avg Inh CO2, % | Min Inh CO2, % | DB Temp, C - F | | Exceptions |
|---|---|---|---|---|---|---|---|--|
| #15 | 62 | 11 | 88 | 1.4 | 0.2 | 30 | 86 | Audible leak from chest guage. (See Note.) |

Note: Chest guage leak rate was later measured at 243 ml/min.

Note: "T" connection tightened with a 1/2 turn. Chest guage replace with a new one.

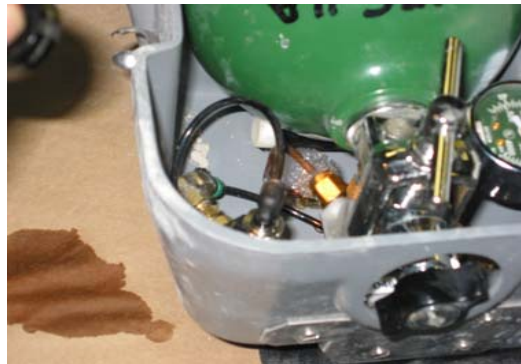
Figure 6c: Leak at T-connection on Apparatus #15

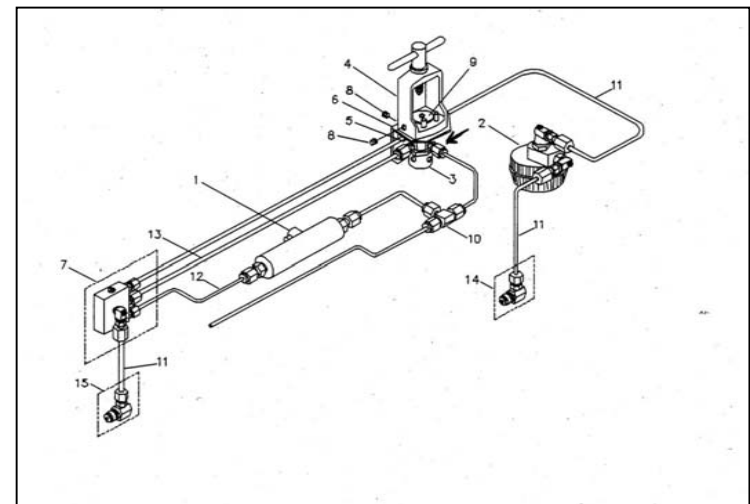
Figure 6b: Engineering drawing showing the location (at arrow) of the leak at the T-connection on Apparatus #15

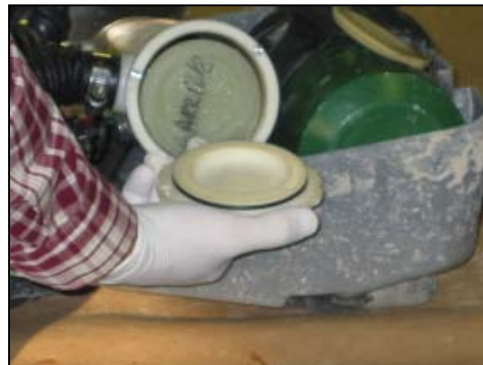
Figure 4c: Apparatus #1 with GelPak installed

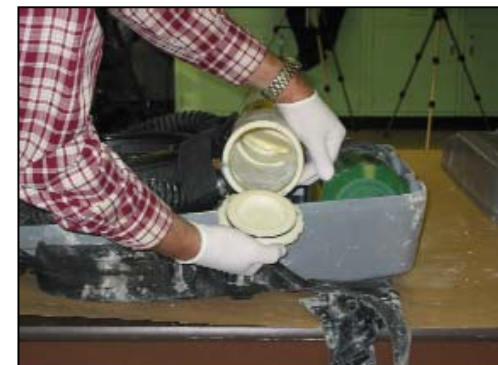
| Spreadsheet 4a: Restoration of Oxygen and Scrubber | # 1 | # 7 | # 10 | # 15 |
|--|--|---|---|---|
| 9) Gel Tube freeze form | OK | OK | Missing | Missing |

Figure 4b: Apparatus #10 with GelPak missing

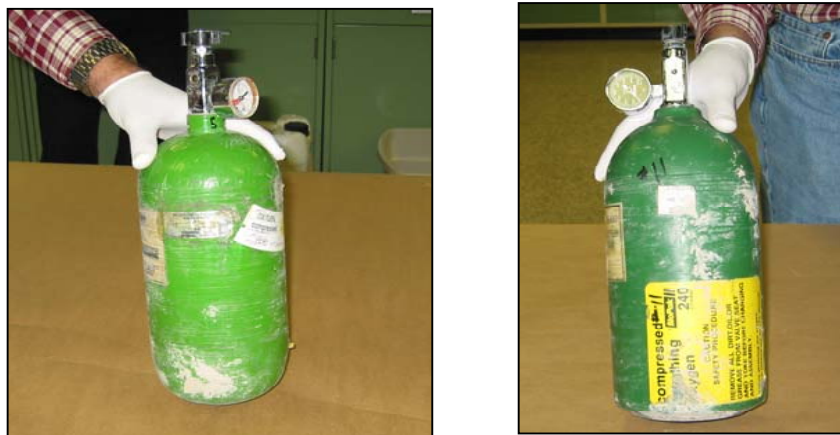
Note: Apparatus #1, Item 15: Cylinder guage is different from the other 3. Manufactured by ERIE.

Figure 2: Cylinder BA253, with a non-standard gauge, next to cylinder WJ173, with standard gauge.
