## Coal Mine Fatal Accident 2003-25-26

| Operator: | Progress Coal (Massey Energy Company) |
| Mine: | Twilight MTR Surface Mine |
| Accident Date: | September 17, 2003 |

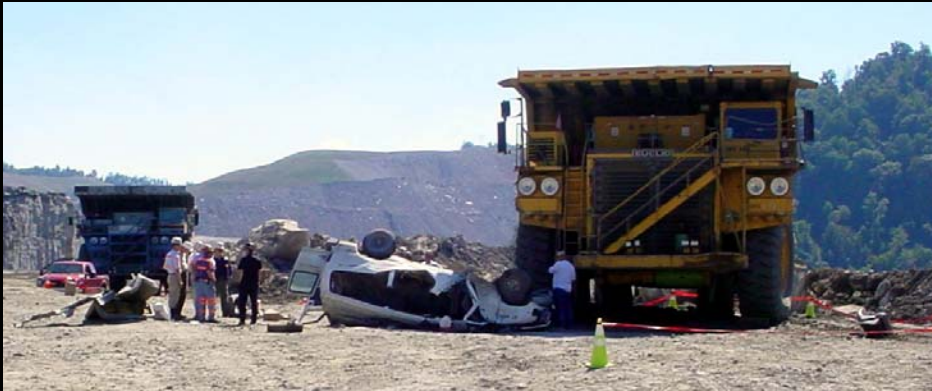
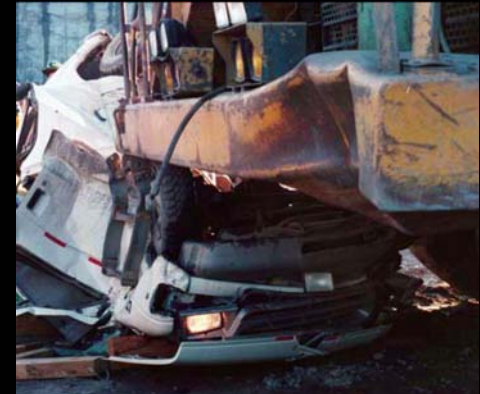
- The rock truck driver looked toward the track-hoe (which the van driver was scheduled to operate that shift), saw its illuminated dome light, and assumed that he had called from the track-hoe.
- He moved forward with the intent of going to the track-hoe to pick up his supplies, driving his right front bumper and tire into the portal van.
- The driver of the rock truck behind the van heard the radio transmission, looked toward the other truck, saw the van being shoved sideways, and shouted over the radio for the rock truck to stop.
- By the time the truck stopped, the van had rolled over onto its roof and was crushed under the rock truck's bumper/frame and right front tire.

- As the rock truck continued forward, the van rolled over onto its roof and was crushed under the truck's bumper/frame and the right front tire. Tire tracks indicated the truck moved forward ~32' before stopping (~1 truck tire revolution).

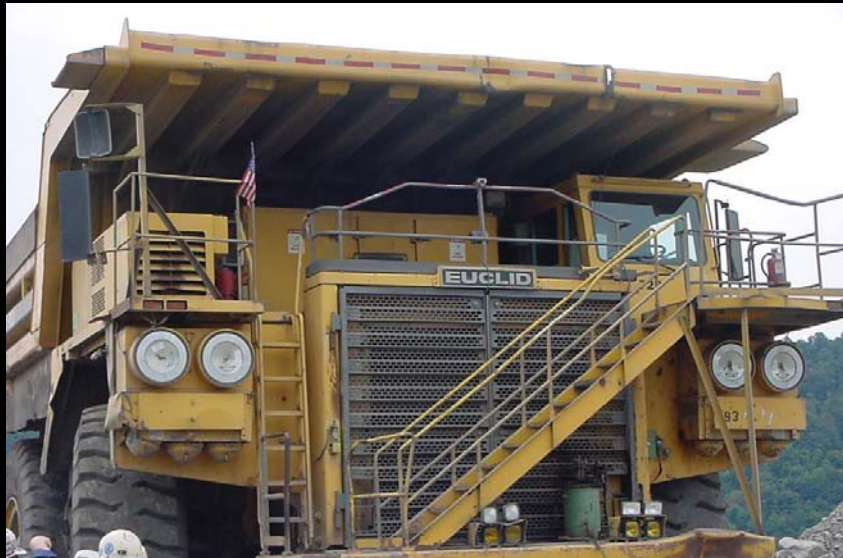
# EUCLID R190 ROCK TRUCK

- A blind spot extended ~60' to the ground on the truck's front, right side.
- Another blind spot extended ~240' directly to the driver's right side.
- A camera system was installed on the truck consisting of 3 cameras and a monitor.
- The cameras provided a view of the blind areas to the front, off-side, and rear.

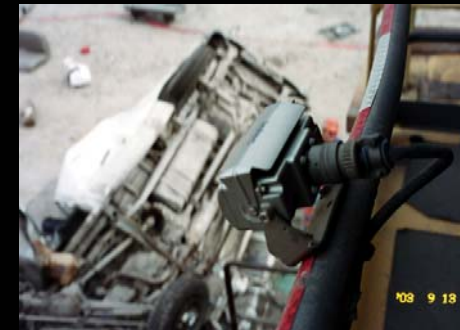
Front Camera shown overlooking crushed van.

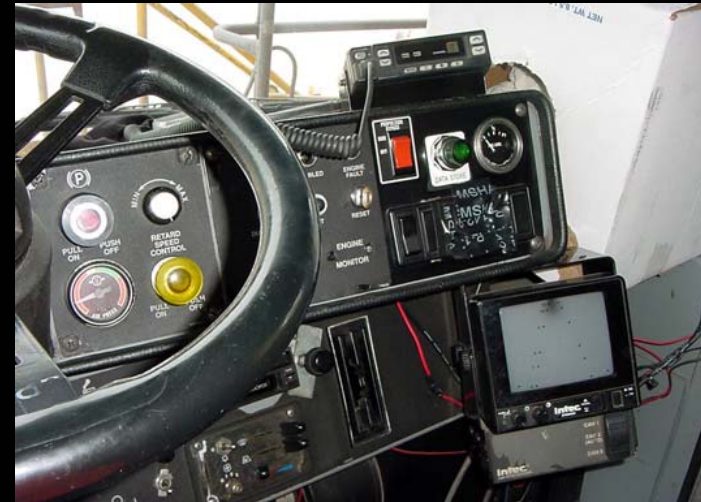
- Since the truck was moving straight forward, the front camera view should have been selected to show the intended direction of travel. However, since the camera system was in standby mode, the monitor remained off as the truck moved forward.

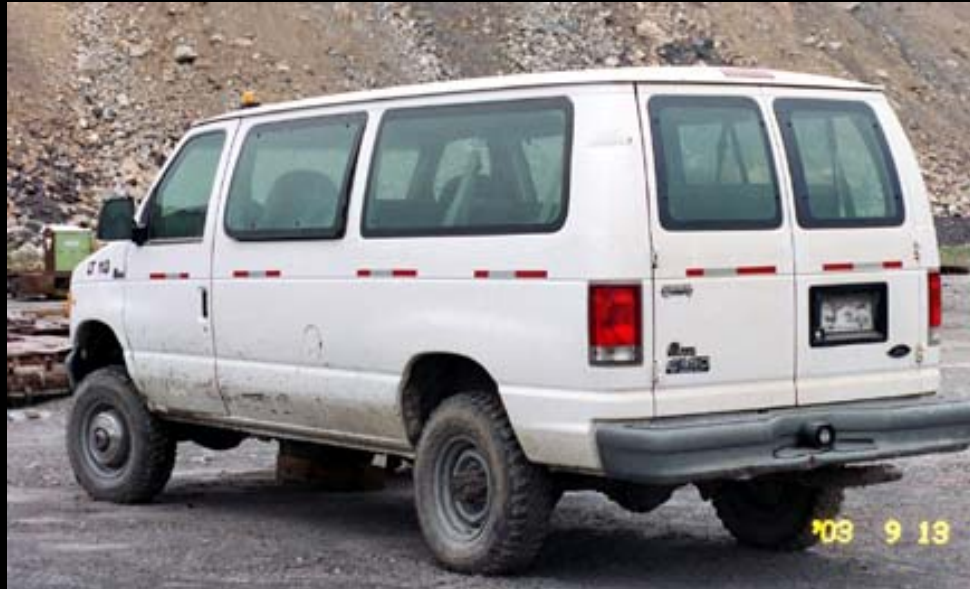
# FORD E-350 PORTAL VAN

- The portal van involved in the accident was a 1999 Ford Model E-350 XL Super Duty, 12-passenger van, licensed for highway use in West Virginia.
- The portal van was white and had a strip of reflective tape on the sides.
- Progress Coal equipped the portal van with a roof-mounted strobe light.
- The strobe light did not have an on/off switch; but received power when the ignition was switched on.
- Two witnesses indicated that the strobe light was not working on the day of the accident.

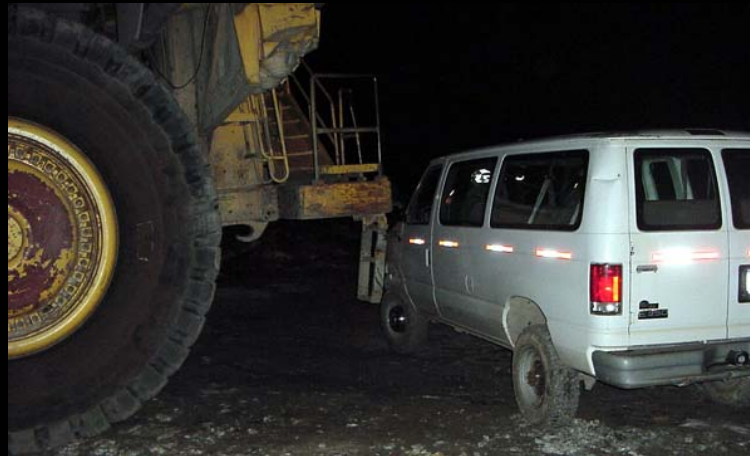
- A re-creation of the conditions and events leading up to the accident was conducted using the rock truck involved in the accident and an identical van.
- The re-creation was conducted at ~6:00 a.m., at which time outdoor conditions were dark and the weather was clear, similar to the morning of the accident.
- The van approached the parked rock truck from the off-side and stopped in front of the truck, simulating the path of the van involved in the accident.
- The van's headlights were visible from the rock truck driver's seat. When the strobe light was used, flashes on the truck's handrail were also visible from the cab of the rock truck.

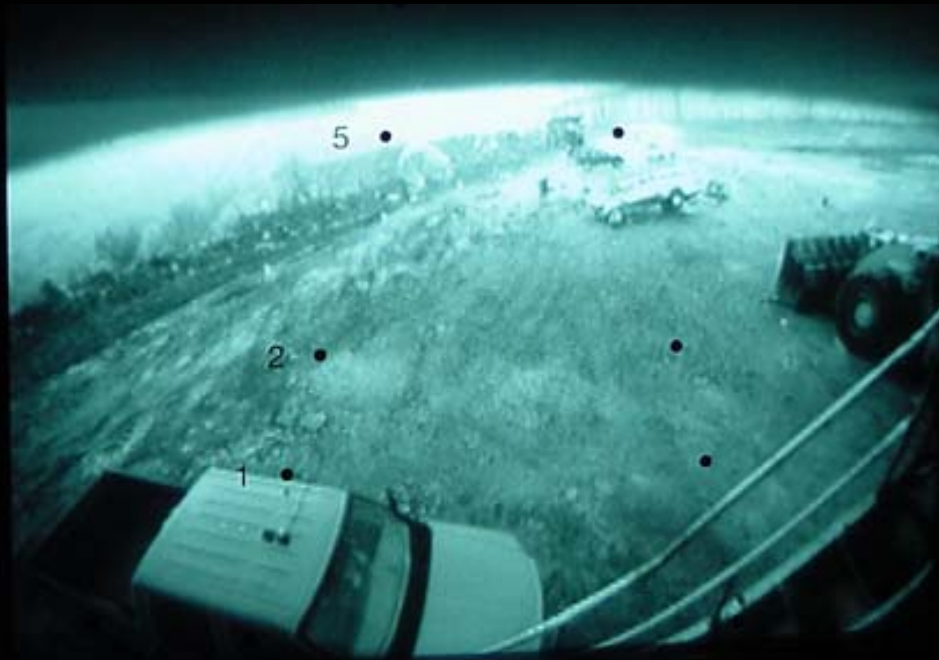
- After portal van stopped, it was clearly visible on the monitor in the front camera view. Use of the strobe light enhanced this view.
- Radio communications between the van and truck functioned properly.
- The dome light of the track-hoe was clearly visible from the truck cab.
- The rock truck horn operated properly.
