## Coal Mine Fatal Accident 2003-30

Operator:	T & W Enterprises, LLC
Mine:	No. 1
Accident Date:	September 09, 2003
Classification:	Machinery
Location:	District 6, Sitka, KY
Mine Type:	Surface
Employment:	3
Production	50 tons/day from 2 Coal Seams

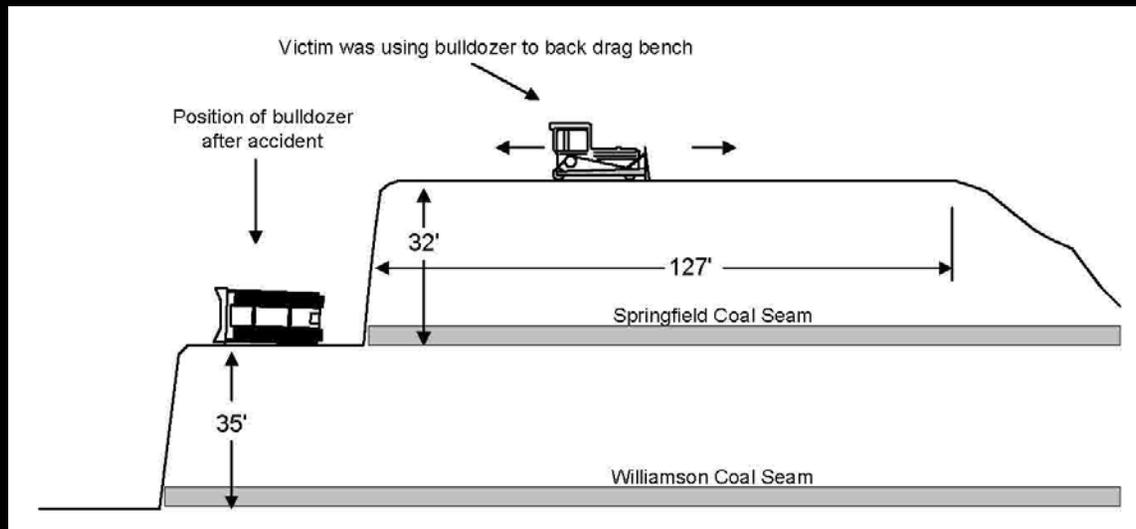
- As he was turning the front end loader around, the mine foreman heard the backup alarm on the bulldozer continuously beeping. As he approached the location where the sound was originating, he saw the bulldozer lying on its side on the upper coal seam bench.
- The mine foreman ran to the bulldozer and checked the operator for vital signs and found none. He returned to his vehicle and called 911. He then called an agent for the operator, who notified MSHA and the Kentucky Department of Mines and Minerals at approximately 8:35 a.m.
- Shortly thereafter, personnel from the sheriff's office and the local ambulance service arrived at the mine. The County Coroner's office was contacted and the Coroner's presence was requested. The victim was recovered from the bulldozer and transported to the State Medical Examiner's Office.
