REPORT OF INVESTIGATION

Fatal Fall of Person Accident
Occurred: February 20, 2003
Date of Death: February 25, 2003

Black Thunder Mine
Thunder Basin Coal Company, L.L.C.
Wright, Campbell County, Wyoming
ID No. 48-00977

**FATAL FALL OF PERSON ACCIDENT
BLACK THUNDER MINE, ID NO. 48-00977
THUNDER BASIN COAL COMPANY, L.L.C.
WRIGHT, CAMPBELL COUNTY, WYOMING
OCCURRED: FEBRUARY 20, 2003
DATE OF DEATH: FEBRUARY 25, 2003**

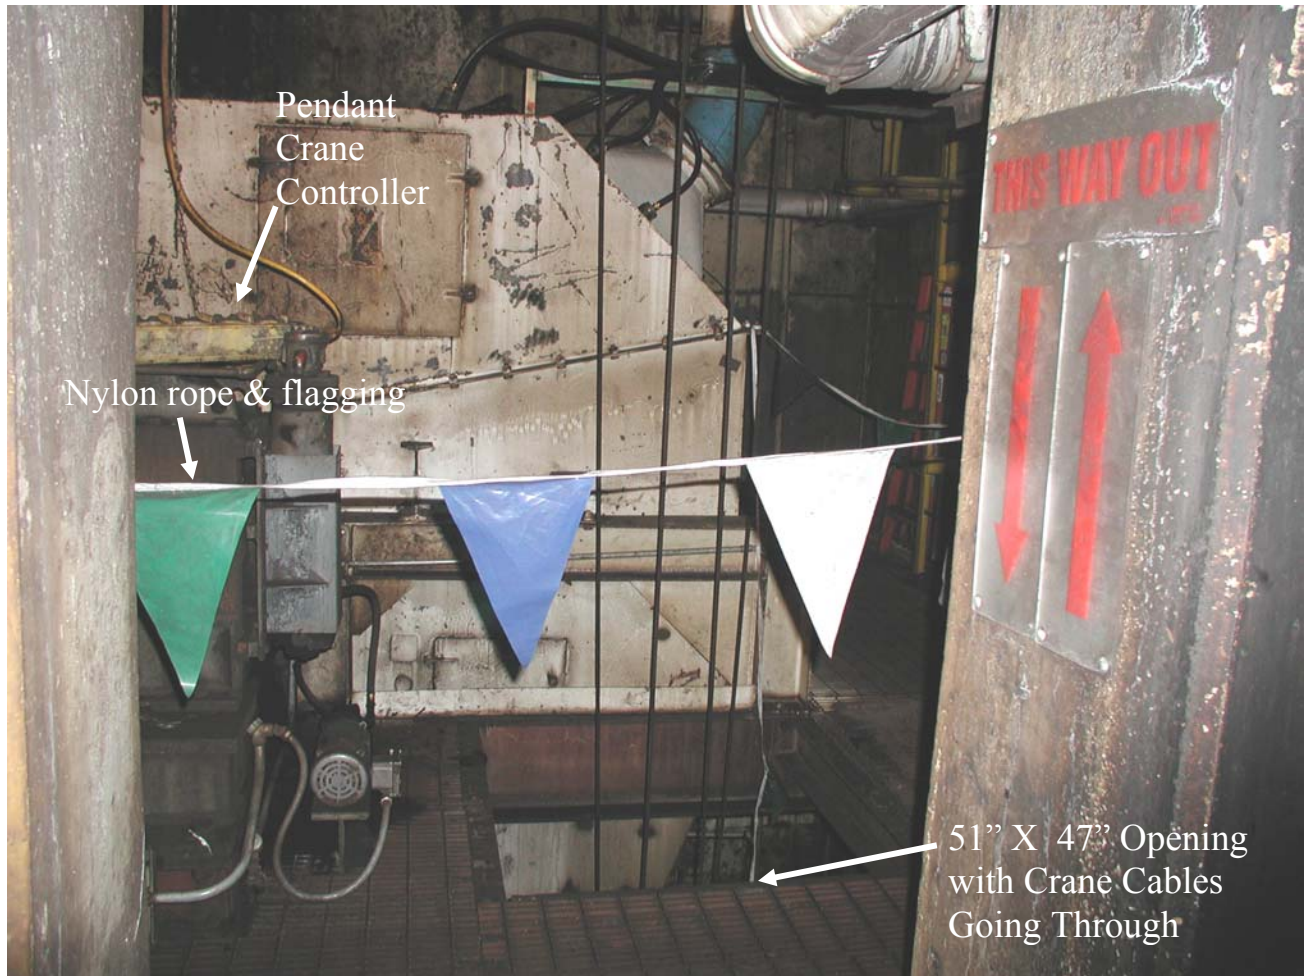
Prior to removing the grating, Carroll placed flagging across all three access routes to the area. He used flagging that had been left in the area for that purpose (see Picture on page 1 for view of flagging). Carroll, working within the flagged area and in close proximity to the opening in the floor, used the crane to lower the steel parts to Ralls who unhooked them on the 614 level. After lowering the parts, Carroll joined Ralls. He left the hole open with the crane ropes down through it, as they still

2. Prior to removing the floor grating, flagging was installed waist to chest high across all three access routes to the area. These routes were: the doorway from the stairway area, the walkway at the back of the 612 belt transfer chute hood, and the walkway along the 612 belt conveyor (see Appendix C for location of flagging). The access doorway was approximately 4.5 feet from the opening. The flagging consisted of a single length of white plastic roping with multi-colored triangular flags attached. It was stored in the area and was routinely used for that purpose.

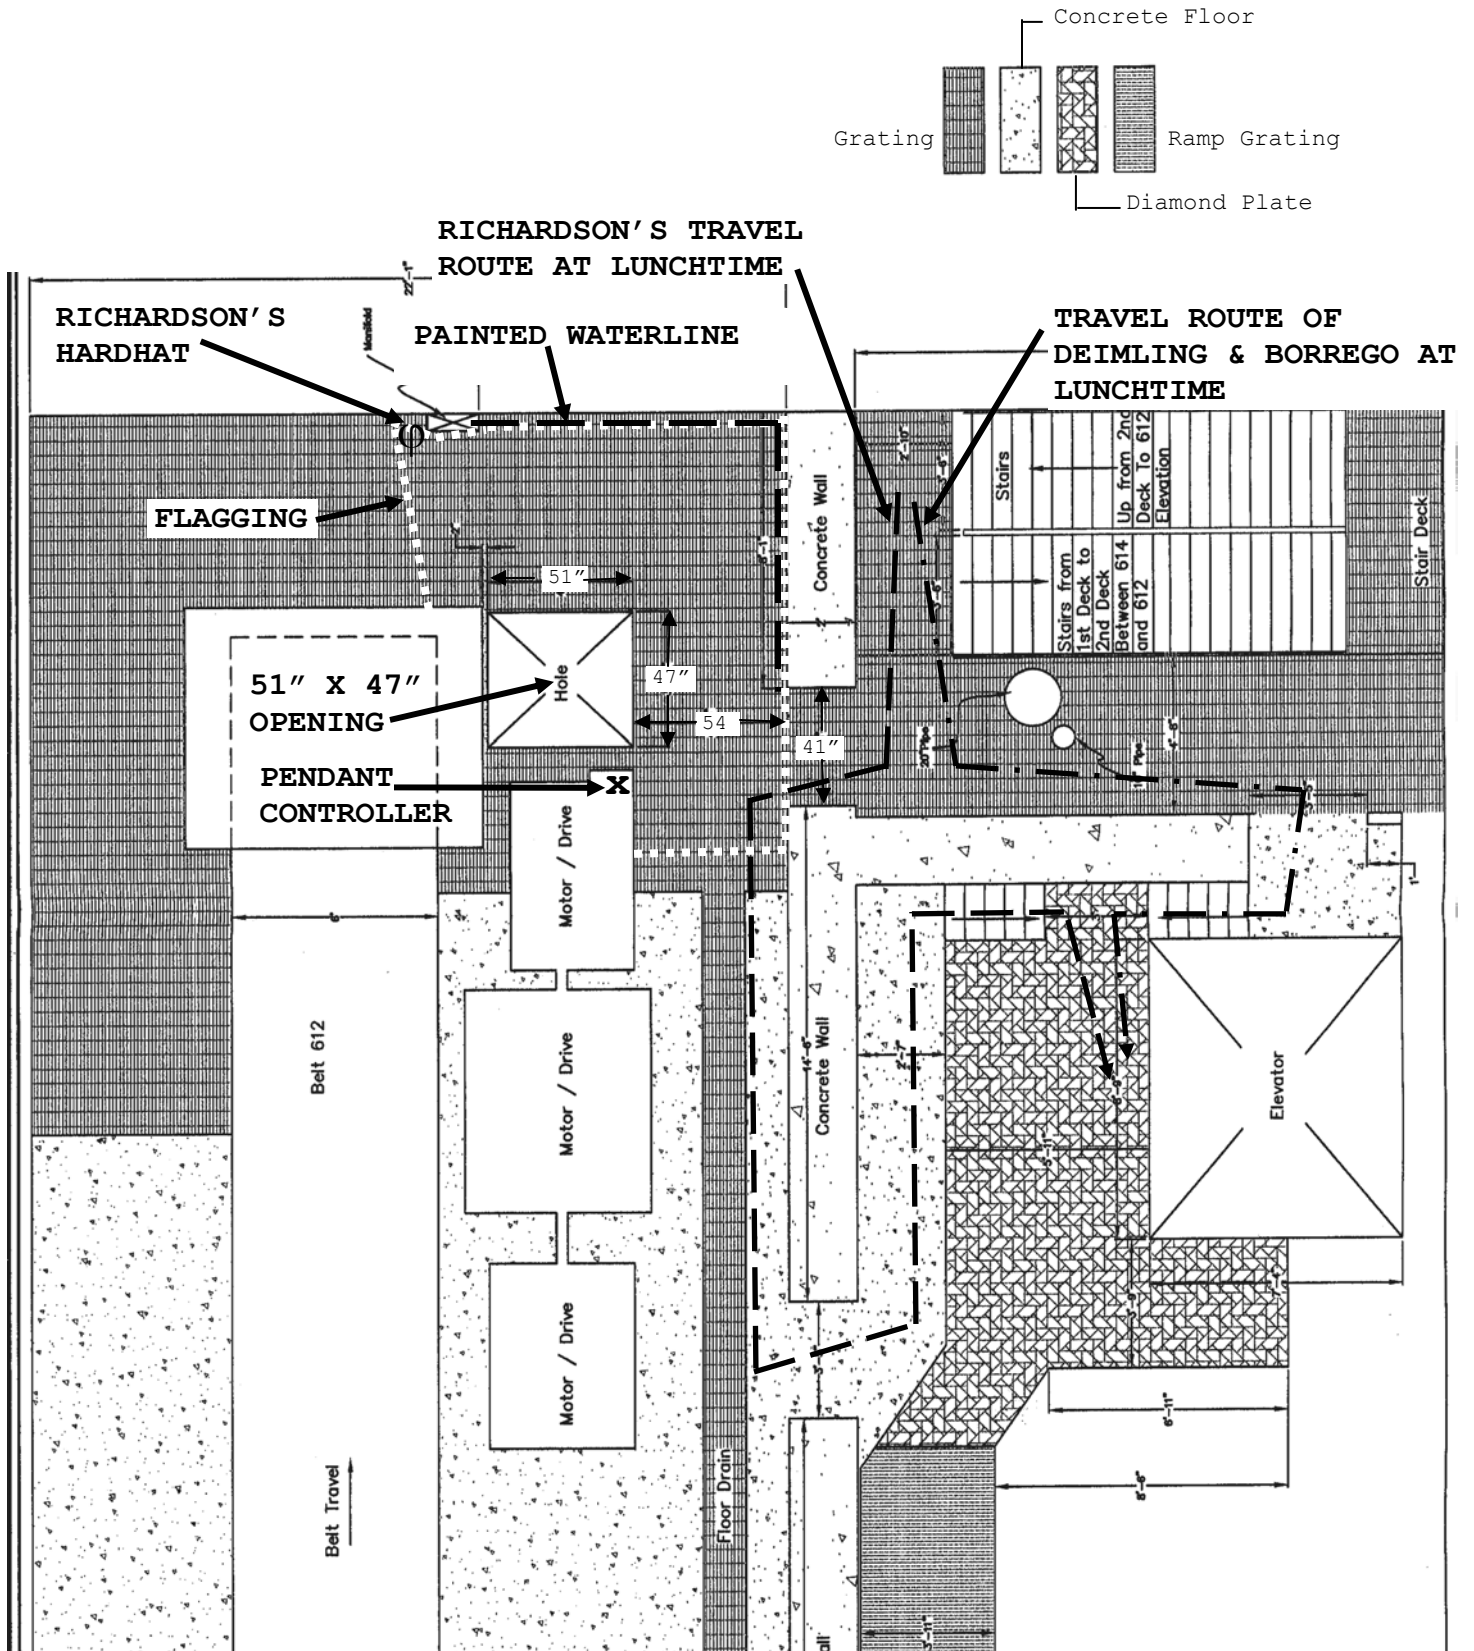
FATAL FALL OF PERSON ACCIDENT
 BLACK THUNDER MINE, ID NO. 48-00977
 OCCURRED 2/20/2003; DEATH 2/26/2003
 612 BELT - FLOOR PLAN SHOWING OPENING IN FLOOR
 NOT TO SCALE

At approximately 1:00 p.m., Michael Lucy, a millwright who worked for Richardson, started painting a newly installed waterline located on the floor along the wall inside the flagged area on the 612 level (see Appendix C for waterline location). Lucy worked in the area approximately 30 minutes. He was within a few feet of the opening and did not wear any fall protection or restraint system. Lucy also washed down the area at the beginning of the shift for the "burn" permit, but this was prior to the floor grating being removed on the 612 level.

1. The accident occurred in the transfer tower of the slot storage facility. Two sections of metal floor grating were removed on the 612 level to allow steel parts for the dust control hood to be lowered to the 614 level. This resulted in an opening approximately 51 inches by 47 inches in the

11. Richardson's safety hat was found on the 612 level floor. It was located against the far wall approximately six feet away from the opening (see Appendix C for location of safety hat). His safety glasses were found on the 614 belt conveyor.

Corrective Action: TBCC installed a removable metal railing around the opening on the 612 level as a temporary corrective action until a proper safety assessment could be completed and implemented.
