**UNITED STATES
DEPARTMENT OF LABOR
MINE SAFETY AND HEALTH ADMINISTRATION
Coal Mine Safety and Health**

Report of Investigation

**Fatal Powered Haulage Accident
April 4, 2003**

**Preparation Plant
Perry County Coal Corporation
Hazard, Perry County, Kentucky
Mine I.D. No. 15-05485**

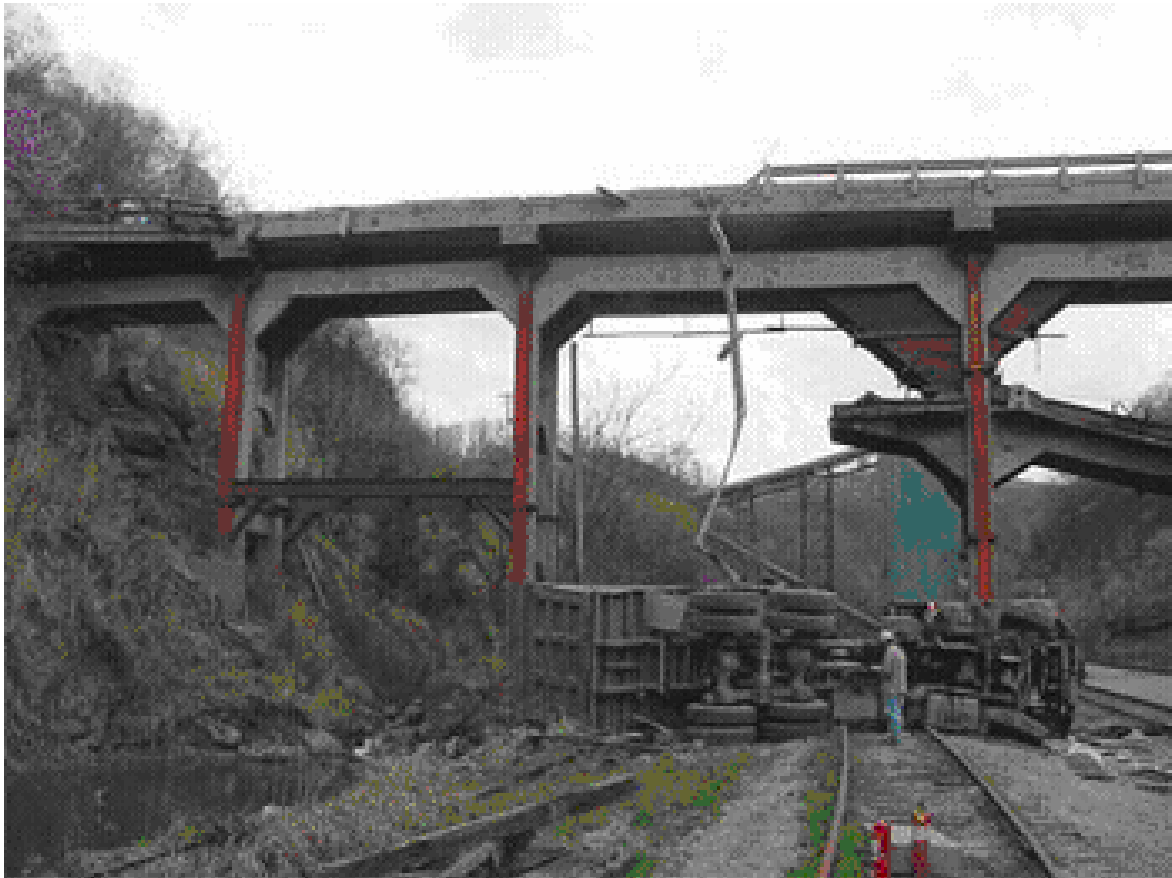
Accident Site

This image shows the location where the truck came to rest, 43 feet below the bridge decking. The area where the truck fell through the guardrails is also visible.

11. The accident occurred in an area of the descending haul road that was 41 feet wide and that turned 90 degrees onto a 14-foot wide bridge.
12. The orange guardrail preceding the bridge was nine feet long, 27 inches high, constructed of six inch I-beam posts with channel steel side rails and a four inch round top rail. The I-beam was deteriorated at ground level.

13. The bridge guardrail measured 72 feet long and 25 inches high was in good repair prior to the accident. Forty-nine feet of the guardrail was torn out when the accident occurred.

Corrective Action: Mine Management should issue policy that all guardrails be constructed and maintained on elevated roadways.
