REPORT OF INVESTIGATION

Fatal Ignition of Gas Accident  
April 27, 2003

Rish Equipment Company (CFD)  
Bluefield, West Virginia

PC WV SYNTHETIC FUEL #1 LLC  
COSI SYNFUELS WV#1 INC  
Cabin Creek, Kanawha County, West Virginia  
I.D. No. 46-08773

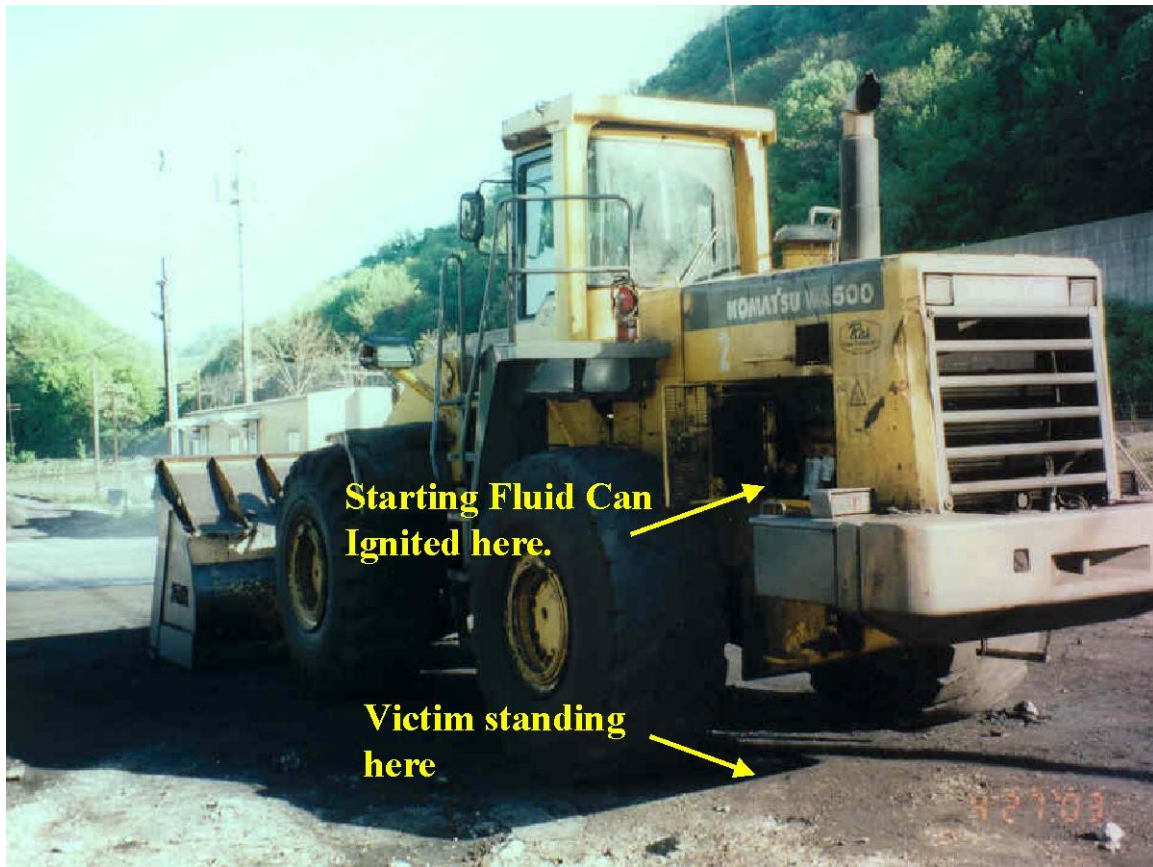
**Figure 1: Photograph of the accident site.**

14. The victim had the aerosol spray can of Hot Shot Starting Fluid in his hand at the time of the accident. He was working inside the left rear access opening to the engine compartment of the end loader when the can ignited. The top of the mounting bracket for the battery relay was approximately 2 inches from the top of the exposed energized terminal of the relay. The mounting bracket was common to the grounding system of the front-end loader.

18. The only ignition source determined to exist inside the engine compartment or near the victim where he was located at the time of the accident was the exposed, energized battery relay terminal.

2. Causal factor: The cap (rubber insulating boot) provided to cover the energized battery relay terminal located inside the engine compartment of the Komatsu WA 500 front-end loader (Co. No. 2 and PIN A70287) was deteriorated (swollen from age and exposure to heat and oils) and was not covering the terminal. This condition failed to prevent contact between the exposed, energized, electrical terminal and the base of the can of starting fluid. When the side of the can touched the grounded mounting bracket of the relay, a high amperage arc occurred burning the hole into the side of the can and igniting the starter fluid.

The accident occurred because a flammable fluid was being used near potential ignition sources. The ignition source, an energized battery relay terminal, was exposed because its insulating cap had deteriorated over time. When the side of the pressurized can containing the flammable liquid contacted both the energized terminal and the grounded mounting bracket, a high amperage electrical arc occurred that melted a hole through the side of the can. The starting fluid ignited and sprayed through the hole onto the victim, causing fatal burn injuries to his upper body.

Corrective Action: A new cap was installed on the energized, electrical terminal of the battery relay preventing accidental contact with the bare terminal. All personnel were made aware of the hazards associated with the energized battery relay terminal on the Komatsu WA 500 front-end loader. They were also informed of the importance of maintaining the cap on the terminal. Examinations of front-end loaders now include a weekly examination conducted by a qualified electrician.
