REPORT OF INVESTIGATION

Fatal Electrical Accident
June 13, 2003

#1 Mine
Mountain Spring Coal Company
Shippingport, Beaver County, Pennsylvania
ID No. 36-08725

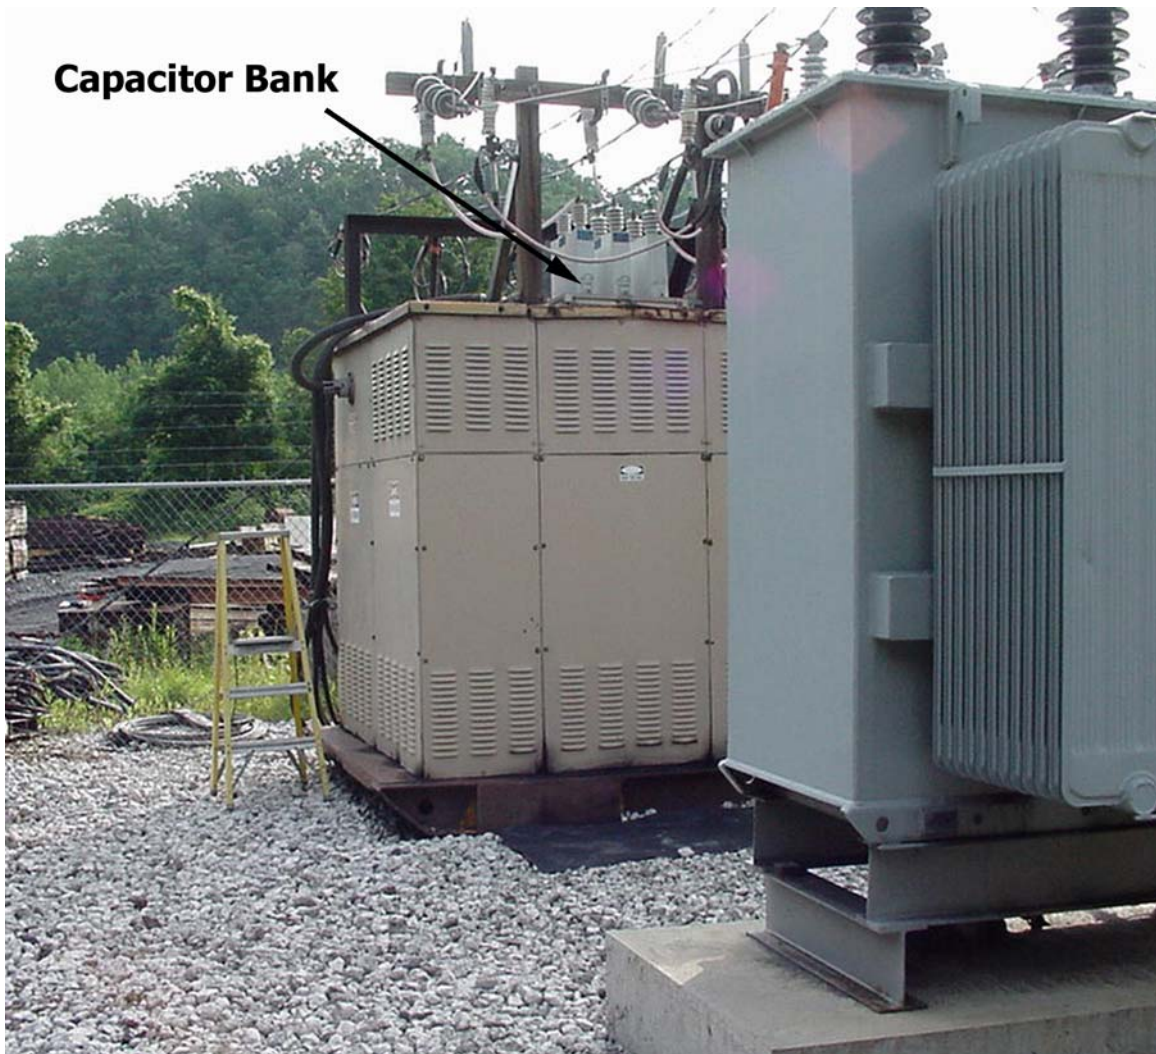
Mountain Spring Coal Company
#1 Mine, I.D. No.36-08725
Beaver County, Pennsylvania
Enclosed Unit with Capacitor Bank

St. Clair noticed that the fuse in the center phase disconnect for the capacitor bank appeared to be blown. He pointed out to Hensley and Lambert that a length of fuse link material was hanging out of the fuse. The three fused disconnects were installed above the capacitor bank which was located on the roof of the enclosed unit. They discussed opening the main disconnects so that the capacitor disconnect fuse could be checked. Hensley and Lambert decided to wait until they completed checking the 480 volt circuits.

6. In November of 2001, Tom Stitt, an independent contractor, recommended that a capacitor bank be installed at the substation to improve the mine power factor. Mine personnel, including Hensley and St. Clair, installed a capacitor bank on the roof of the enclosed unit. The capacitor bank was not secured to the roof. Because of the location of the capacitor bank disconnects, the capacitor bank had to be pushed forward 6 to 8 inches to allow removal of the fuse from the center disconnect.

A 104(d)(1) Order (7081763) was issued for a violation of 30 CFR 77.516. The high voltage capacitors installed on the roof of the enclosed unit in the surface substation did not comply with the provisions of the 1968 National Electric Code. Article 710-34 (f) of the NEC states “Unguarded live parts above working space shall be maintained at elevations not less than required by the following table: Table 710-34 (f) Voltage between phases 11001 – 22000, Minimum Vertical Clearance of Unguarded Parts 9 foot 3 inches”. The high voltage capacitor disconnect switches were mounted forty-four inches above the roof of the enclosed unit. The capacitor bank and terminals were located below the disconnects. This contributed to a fatality that occurred on June 13, 2003.

Corrective Action: When and if the capacitor bank is reinstalled it will be completed in accordance with the National Electrical Code. The use of hotsticks shall be discussed in the retraining of qualified electrical personnel.

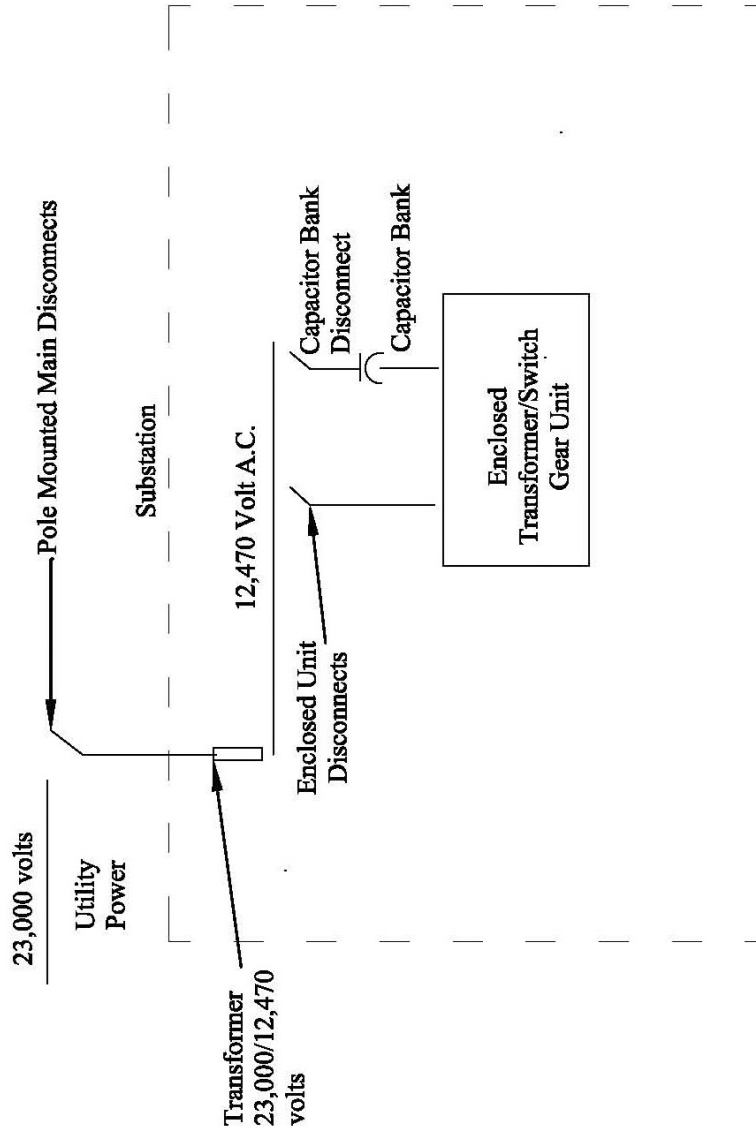
High Voltage One-Line Diagram of the Substation

1. In June 2000, the mine power supply system was switched from a diesel generator to utility power. A 23,000 to 12,470 volt main transformer fed the enclosed unit containing a 12,470 to 4,160/480 volt transformer and high voltage switchgear. (See Appendix II).
