**REPORT OF INVESTIGATION

UNDERGROUND COAL MINE**

**FATAL MACHINERY ACCIDENT
October 22, 2003**

**VICC No. 7 Mine
Paramont Coal Company Virginia, LLC
Coeburn, Dickenson County, Virginia
ID No. 44-06503**

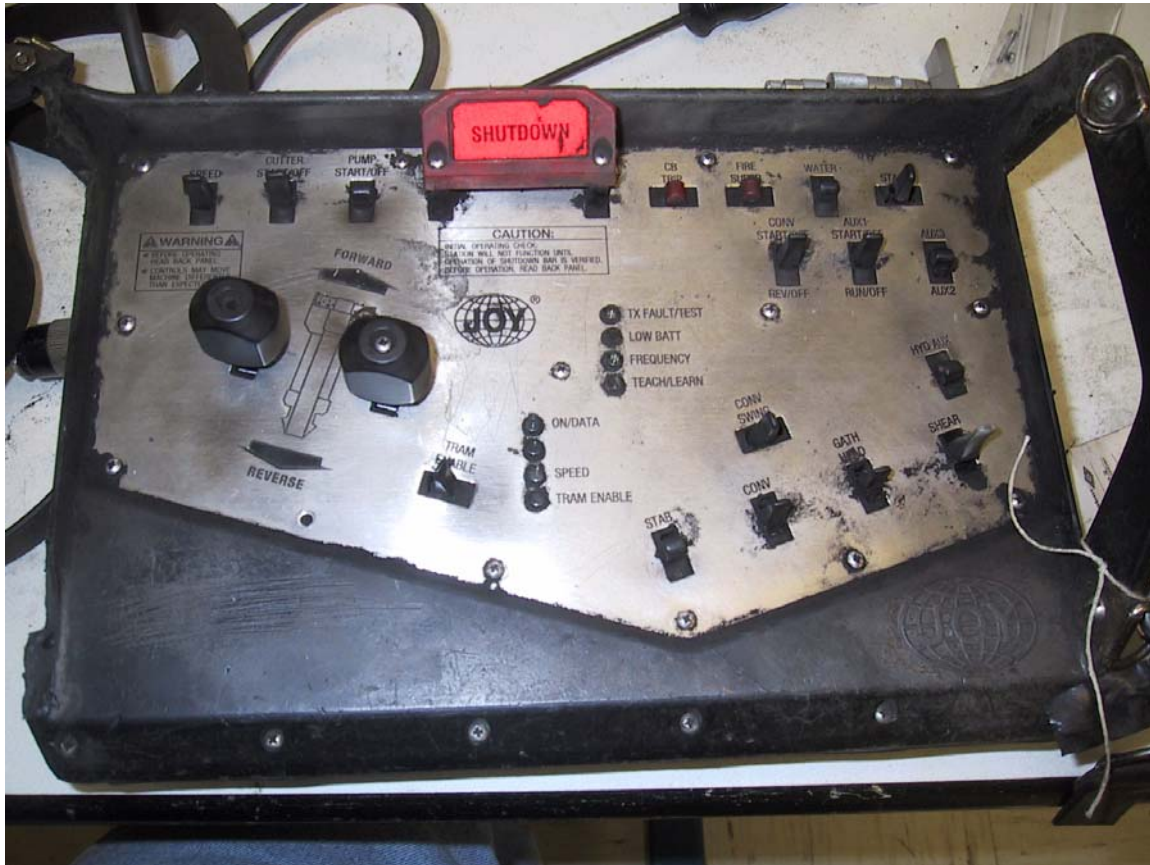
Figure 1. PE-1 Transmitter Front Panel

9. The victim was operating the continuous mining machine via a Joy Mining Machine Remote Controller; model TX3, serial number 75203AC02313. An inspection of the remote controller revealed the following defects. The circuit breaker trip (CB trip) button on the box would de-energize the machine, but not de-energize a circuit breaker. Engaging this button would stop the machine, but leave the control circuits on the machine energized. The remote controller has handles on top of the box at both ends. Not only are these handles used for carrying the box, they also protect the controls from damage. The left handle was broken off the box. Each of the 2 tram levers on the box, used to operate the 2 tracks on the machine, consists of a bi-directional lever with a knob attachment. The knob on the left tram lever was not attached.

Several discrepancies were found between the PE-1 and the MSHA approved design of the unit. The most significant were: the inclusion of the rubber gasket between the cover plate and case; and the fact that the internal antenna and hardware were loose.

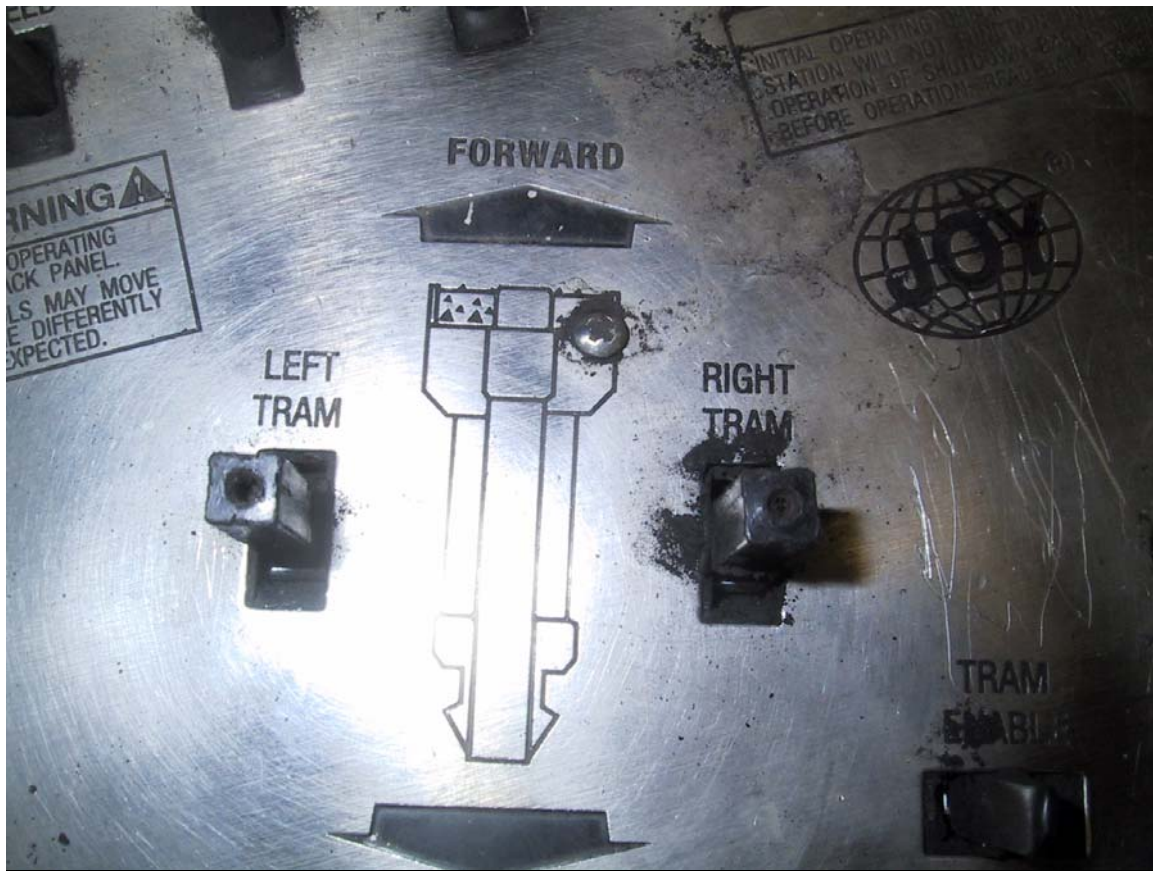
Figure 2, PE-1 Transmitter, tram levers with knobs removed

Inspection of the knob and left tram lever revealed no damage to the internal threads of the lever or to the screw hole through the knob. Additionally, the inspection revealed that the socket for the left tram lever was packed with coal dust, as was the socket for the right tram lever, albeit to a lesser extent. A rubber gasket was found between the cover plate over the switch actuators and the case. The areas of the gasket around the tram levers, and especially the left tram lever, were not tight against the actuator stems. The lever measured 6.25 mm x 6.25 mm, and the opening in the cover plate was 15.65 mm x 7.93 mm. The gap between the lever and the cover plate allowed an accumulation of dust in the sockets for the tram levers. The gasket material was not effective for excluding dust and other contamination at the area of the tram levers.

- 1.1.4 The right side carrying handle was broken off; this most likely occurred during the accident.
 - 1.1.5 The knob for the left tram lever was not on the lever and its securing screw was missing. There was no evidence that its securing screw was broken or that the threads inside the lever were stripped.

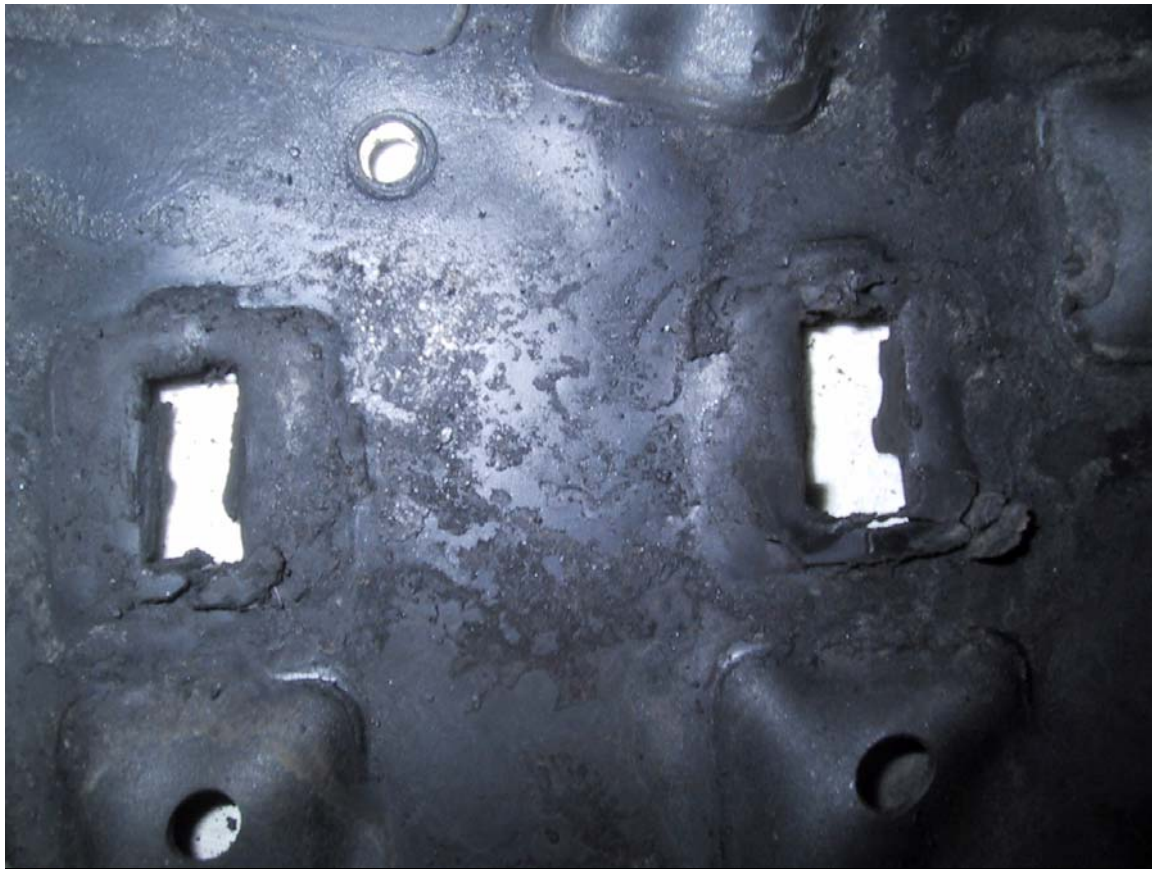
Figure 3. PE-1 Transmitter, Front Panel cover plate, gasket side view, detail, tram lever openings

The inspection and testing of the control components revealed that one fault which could have allowed the left tram function to continue upon release of the tram lever. A rubber gasket was found between the cover plate over the switch actuators and the case of the remote control transmitter seen in Figure 1 in Attachment 4. The areas of the gasket around the tram levers, as shown in Figure 2 in Attachment 4, did not conform to the actuator stems. The tram levers measured 6.25 mm x 6.25 mm, and the openings in the cover plate were 15.65 mm x 7.93 mm. As shown in Figure 3 of Attachment 4, the margins of the gasket material at the opening for the tram levers were uneven and did not occupy the space between the lever and cover plate. This allowed an accumulation of dust in the sockets for the tram levers, as shown in Figure 4 of Attachment 4. The socket for the left tram lever was nearly full of dust and dirt, restricting its free travel. The results of the switch calibration test seemed to verify this, as the full range of the

output of the left tram switch was only 78% of that of the right tram switch. This accumulation could have also caused the left tram lever to fail to return to its centered position. This could have then caused a forward signal to continue to be transmitted to the continuous mining machine after the tram lever was released.

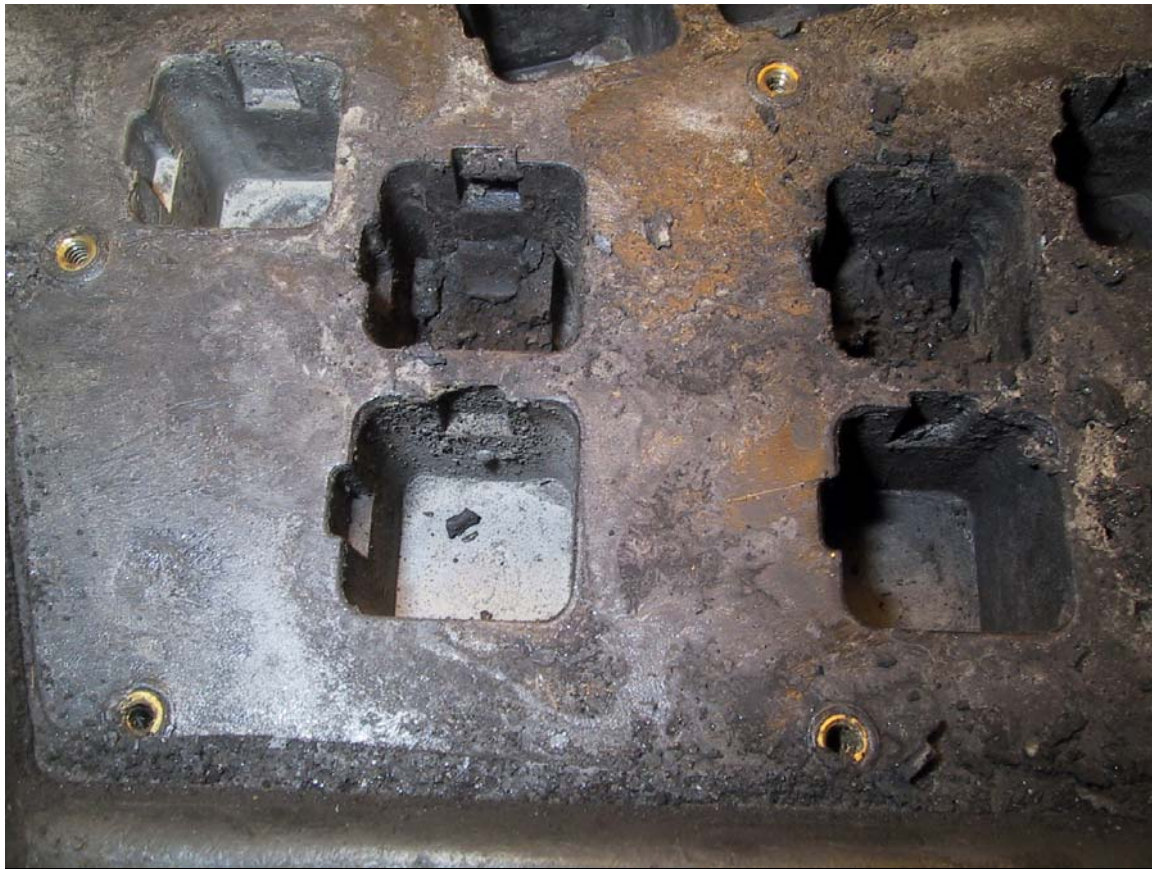
Figure 4. PE-1 Transmitter, tram lever sockets (two in center top)

- 1.1.3 Note 6 indicates that "Enclosure connectors and switches are dust-tight." Varying amounts of dust were found in the sockets for the switch actuators.

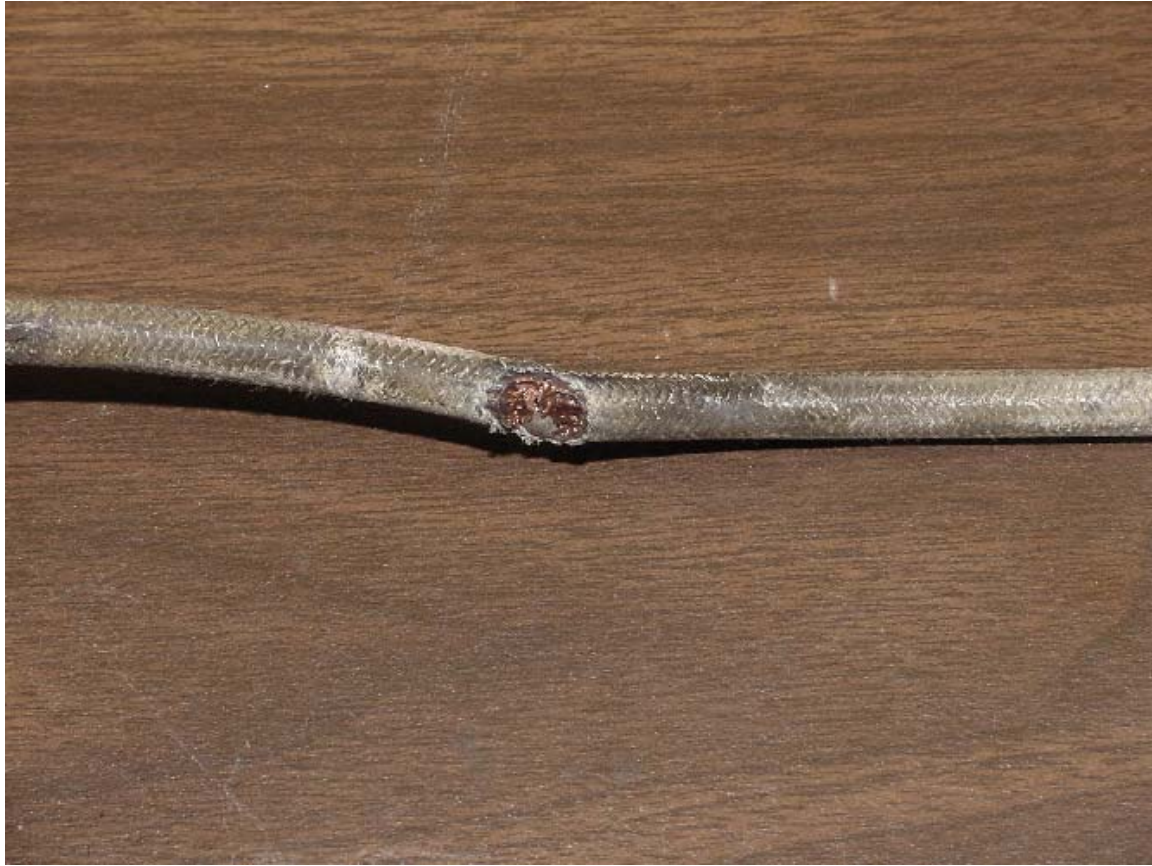
5. Damaged Area of B-Phase Power Cable

- 3.5 B-Phase Cable, PE-17. The cable had a damaged area that had conductor strands that appeared to be fused or melted together, having a copper-like appearance. The insulation material in the immediate vicinity of the damaged area appeared to be discolored. The effect of grounding the damaged area of the cable was tested by bringing it into continuous contact, and intermittent contact, with the grounded machine frame at the mine site. The left tram function did not continue to operate after the tram levers were released during this testing. Tests were also conducted on a similar machine, with the PE-8 firing package, and the PE-13 and PE-14 SCR bridges installed, by intermittently grounding using controlled contacts at higher frequencies, with no continuation of left tram function.

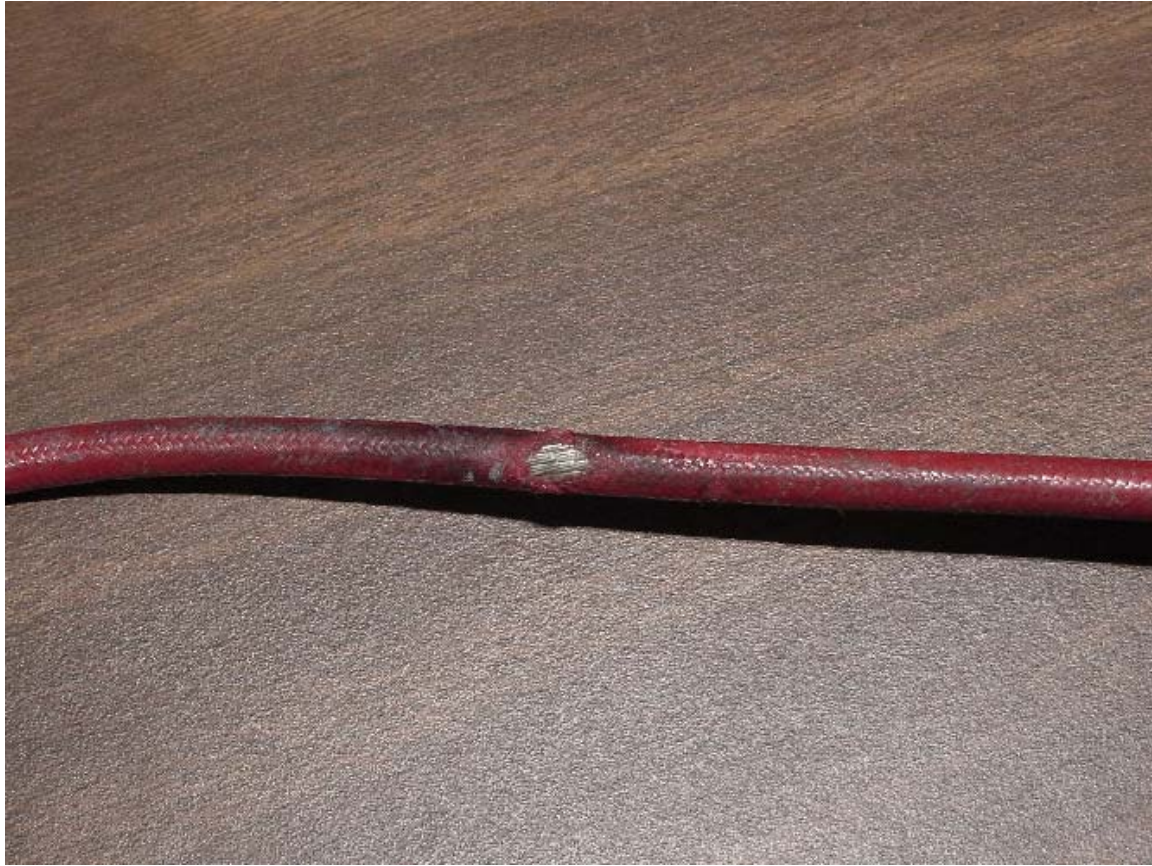
6. Damaged Area of C-Phase Power Cable

- 3.6 C-Phase Cable, PE-18. The cable had insulation damage in one area. The conductor strands did not appear to be fused. The wire strands had a silver-like appearance. The insulation material in the immediate vicinity of the damaged area did not appear to be discolored.
