**REPORT OF INVESTIGATION**

**Fatal Fall of Roof Accident  
October 24, 2003**

**Hacker's Creek Mine No. 1  
Roblee Coal Company  
Buckhannon, Upshur County, West Virginia  
I.D. No. 46-08820**

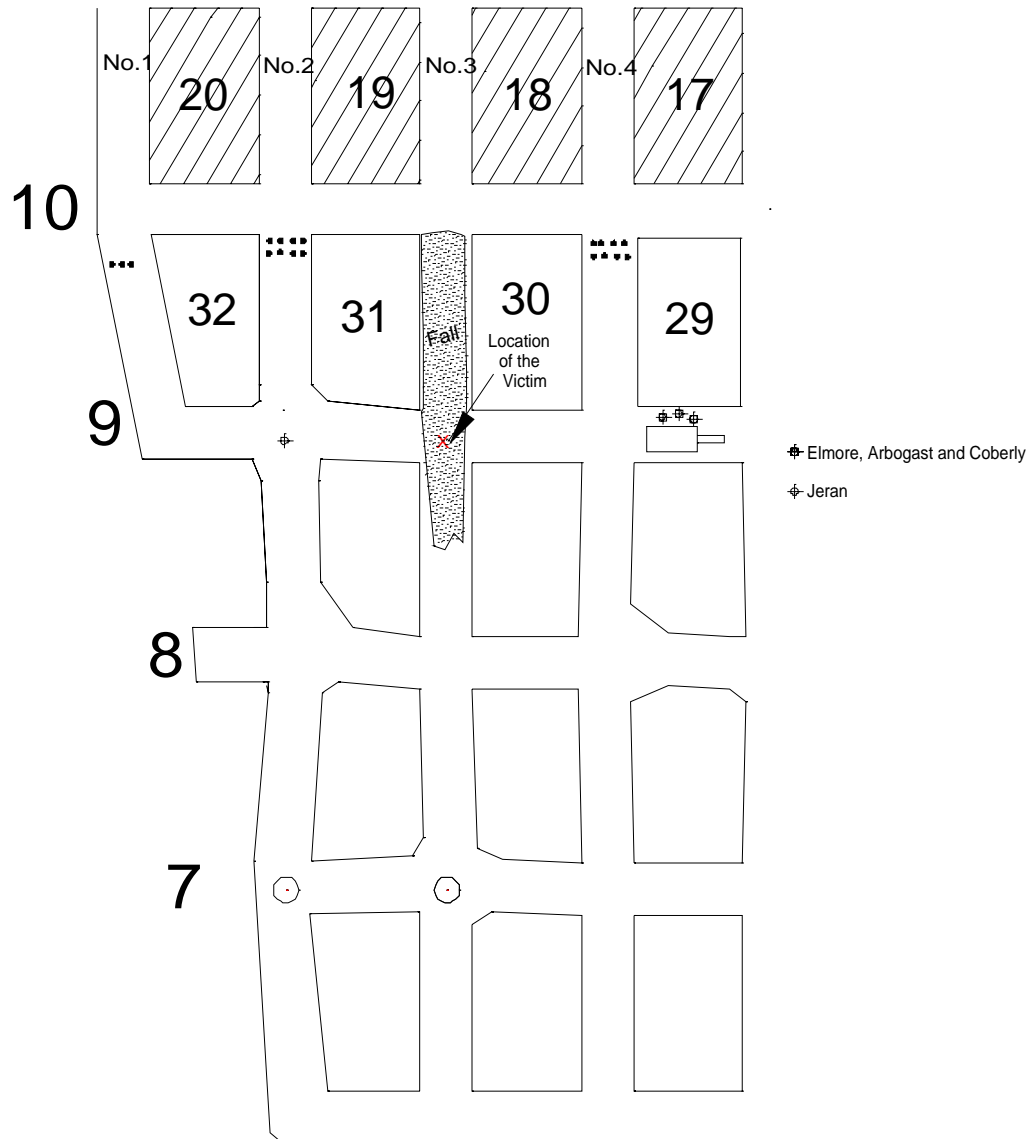
## SKETCH OF ACCIDENT SITE

The fall extended outby from the pillared area and measured 96 feet long, 14 feet wide, and 5 feet high. The fallen material was composed of thinly laminated dark gray shale and sandstone which predominately remained intact as one massive block. In the days following the accident, more material fell from the inby portion of the fall cavity toward the pillared area.

The left side of the fall was bounded by a near vertical, weathered stress-relief joint, often referred to as a hillseam or surface crack. As observed from the left side crosscut (from No. 2 entry to No. 3 entry), this joint was approximately 3 to 5 inches wide and had been in-filled with rock and soft, clay-like material. There was also considerable iron-oxide staining visible. The presence of this extensive joint essentially resulted in a detached block, cantilevered from the opposite side pillar. Abutment pressures from second mining overloaded the cantilevered beam and caused the failure in conjunction with a fall that originated within the pillared area. This same joint continued outby the fall area for approximately 120 feet where it angled over a coal pillar.

The right side of the fall broke along the outside bolt row in the entry, and while generally vertical in profile, was more jagged than the smooth vertical surface on the weathered-joint side of the fall. The outby side of the fall was also somewhat jagged, and feathered out.
