**REPORT OF INVESTIGATION**

**Fatal Machinery Accident  
September 09, 2003**

**T & W Enterprises, LLC  
No. 1  
Sitka, Johnson County, Kentucky  
ID No. 15-18661**

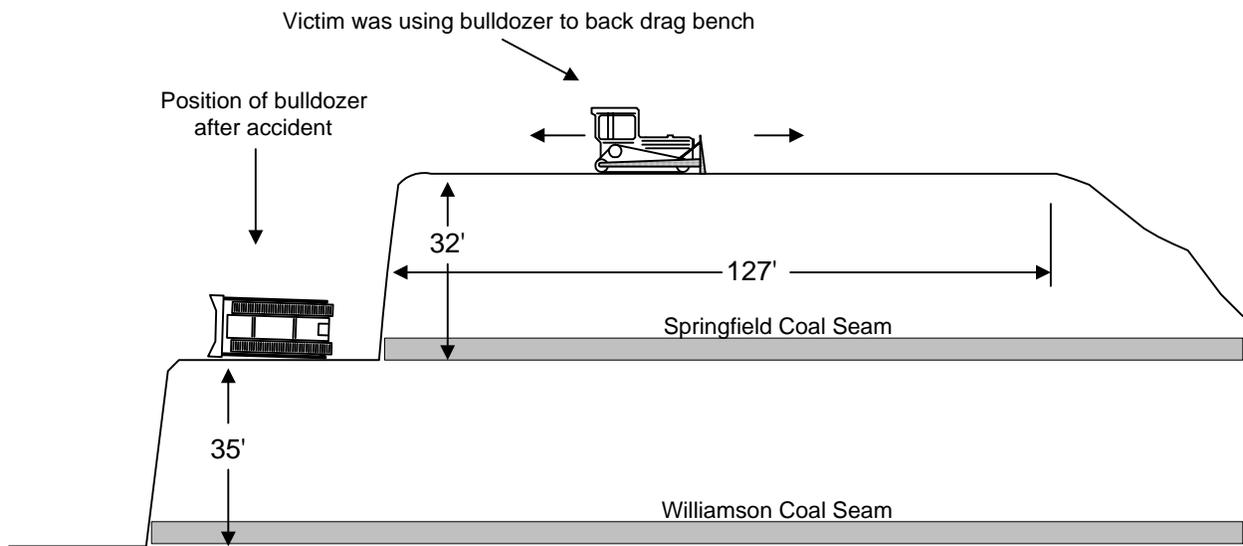
Fatal Machinery Accident  
 T & W Enterprises, LLC  
 No. 1 (15-18661)  
 Sitka, Johnson County, Kentucky  
 September 09, 2003

On Tuesday, September 09, 2003, at approximately 8:15 a.m., bulldozer operator Preston Lee Dye, age 73, was fatally injured when the Caterpillar D8-L bulldozer he was operating went over a 32-foot highwall. Dye had 42 years of mining experience operating heavy equipment, and approximately 16 weeks experience at this mine. There were no witnesses to the accident. The accident occurred as Dye was back-dragging the strip mine bench in preparation for drilling operations.

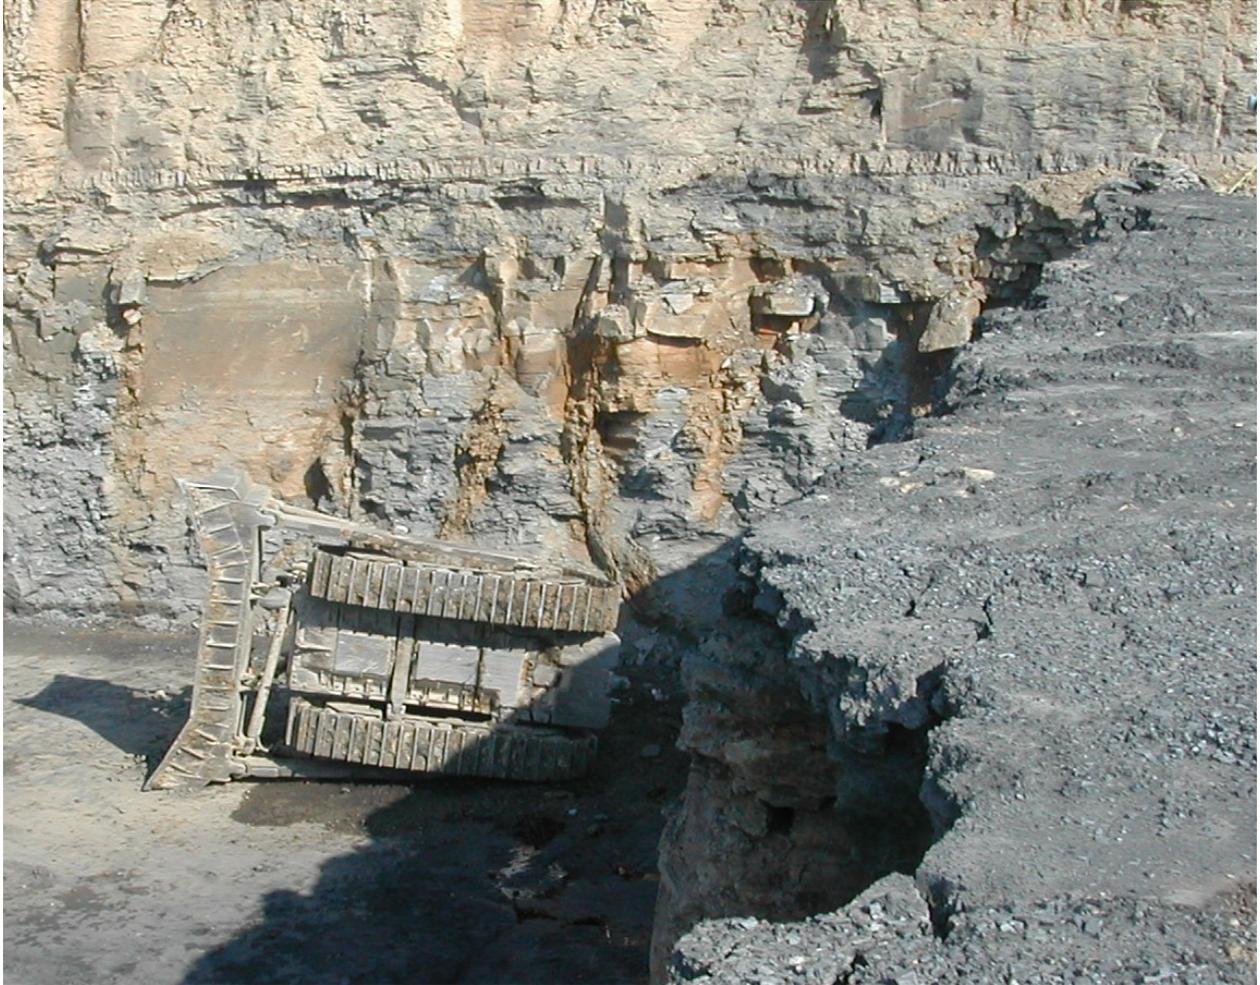
Photograph of Accident Scene  
Fatal Machinery Accident  
T & W Enterprises, LLC  
No. 1 (15-18661)  
Sitka, Johnson County, Kentucky  
September 09, 2003

At approximately 8:15 a.m. on September 9, 2003, a 73-year old bulldozer operator with 42 years of mining experience traveled off a highwall in heavy fog while back-dragging the bench. The bulldozer operator was fatally injured during the 32-foot fall from the highwall. Based on information gathered during the investigation, the most likely cause of the accident was a misjudgment or inability to see the edge of the highwall due to heavy fog. The fog made visibility difficult. This misjudgment or inability to see the highwall edge may have been aggravated by a lack of any visible point of reference.

Corrective Action: Continual focus on work activities, and adherence to all safety factors related to the task being performed. A procedure should be established to prohibit activities when visibility is inadequate to permit safe operation.

Corrective Action: Adequately marking the edge of the highwall, or performing other, less hazardous duties until weather conditions/visibility improve. A procedure should be established to prohibit activities when visibility is inadequate to permit safe operation.
