Report of Investigation

Slip or Fall of Person

January 13, 2003

**Lebec Cement Plant
National Cement Co of California, Inc.
Lebec, Kern County, California
ID No. 04-00213**

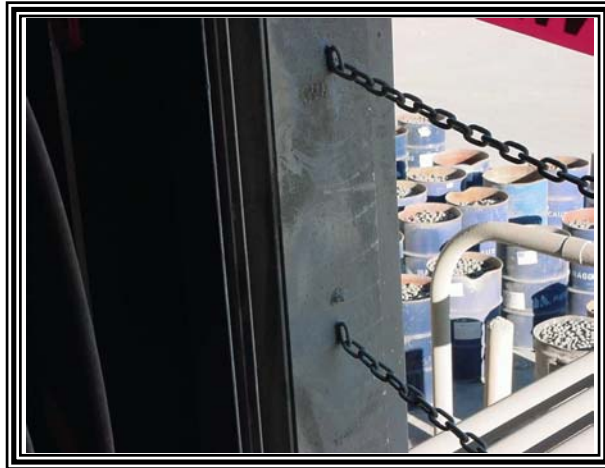
Fixed End of Chain Handrails

The chains were welded in place on the north end. The south end of the chains were removable by use of grab hooks that were welded in the vertical position. The fixed ends of the chains were mounted 27 inches and 43 inches, respectively, from the floor with the removable end fixtures / hooks being mounted $26 \frac{5}{8}$ inches and $42 \frac{5}{8}$ inches, respectively, from the floor. All measurements were taken from the floor surface to the bottom of the slot in the hook. Since the chain had no markings, the investigators concluded that it was a grade 30 welded chain with a workload limit of 1,250 pounds. The grab hooks were marked "forged," " $\frac{1}{4}$," and "China." Based on this information, the investigators then concluded that the grab hooks were $\frac{1}{4}$ inch grade 40 with a workload limit of 2,600 pounds.

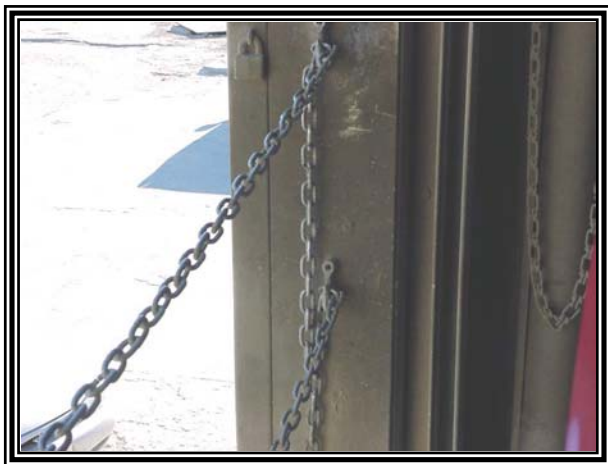
Removable End of Chain Handrails

According to witnesses, the chains were normally fixed in such a manner that the center of the span of the top chain was 34 inches from the floor with the center of the lower chain being $23 \frac{1}{2}$ inches from the floor. Witnesses also commented that, at times, the top chain was stretched tight, which resulted in the center of the span rising to a point 41 inches from the floor. The weld points appeared to be in good condition with no visible defects. The grab hooks were manufactured in what is termed a flat profile with a point on the open end and a 0.400" – 0.365" slot which is designed to provide a secure hold on the chain when pulled along the grab hook's vertical axis. Measurements indicate the top grab hook mounted 10 degrees off vertical leaning towards the outside.

Causal Factor: The design and installation of the chain railing did not provide adequate protection. The open hook attachment did not allow a positive locking connection and, when combined with the movement of the chain from the unsupported span of 13 feet, allowed the chain link to “walk” out of the open hook.

Corrective Action Required: The operator should implement a policy that ensures handrails, barricades, and other personnel protective devices are adequate to protect persons. Work areas requiring these devices should first be reviewed through a risk analysis program to identify hazards and to aid in the design of controls that will effectively eliminate them.

This citation was terminated on January 16, 2003. The mine operator designed, fabricated, and installed a rigid steel pipe handrailing system that was securely mounted in the open doorway, and posted signs warning of the fall hazard.

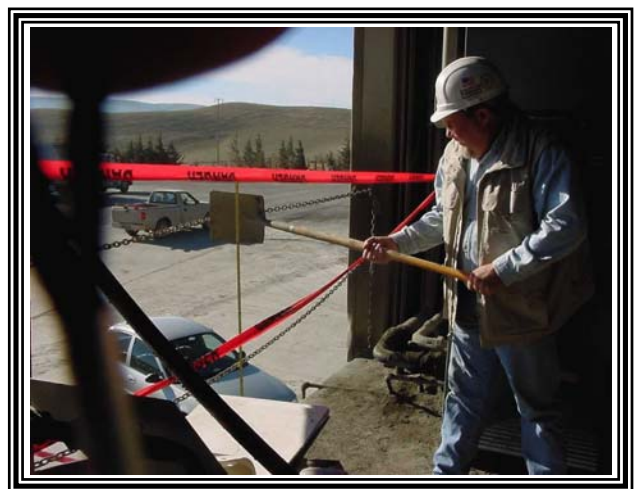
Push Test of Chain Handrail

The top railing was bounced by slapping it lightly to simulate hitting the chain while passing the shovel or bucket of used oil dry over the chain. This test demonstrated that the removable end of the chain would "walk" up and off the hook. When horizontal force was applied to the top chain at the point where the victim had been standing, the chain came out of the grab hook with an estimated force of less than 20 pounds being applied. The chain dislodged when the center of the chain handrail reached a height of

approximately 43 ½ inches from the floor. The same results were observed while conducting the tests with the chain set at 34 and 41 inches from the floor at mid-span.

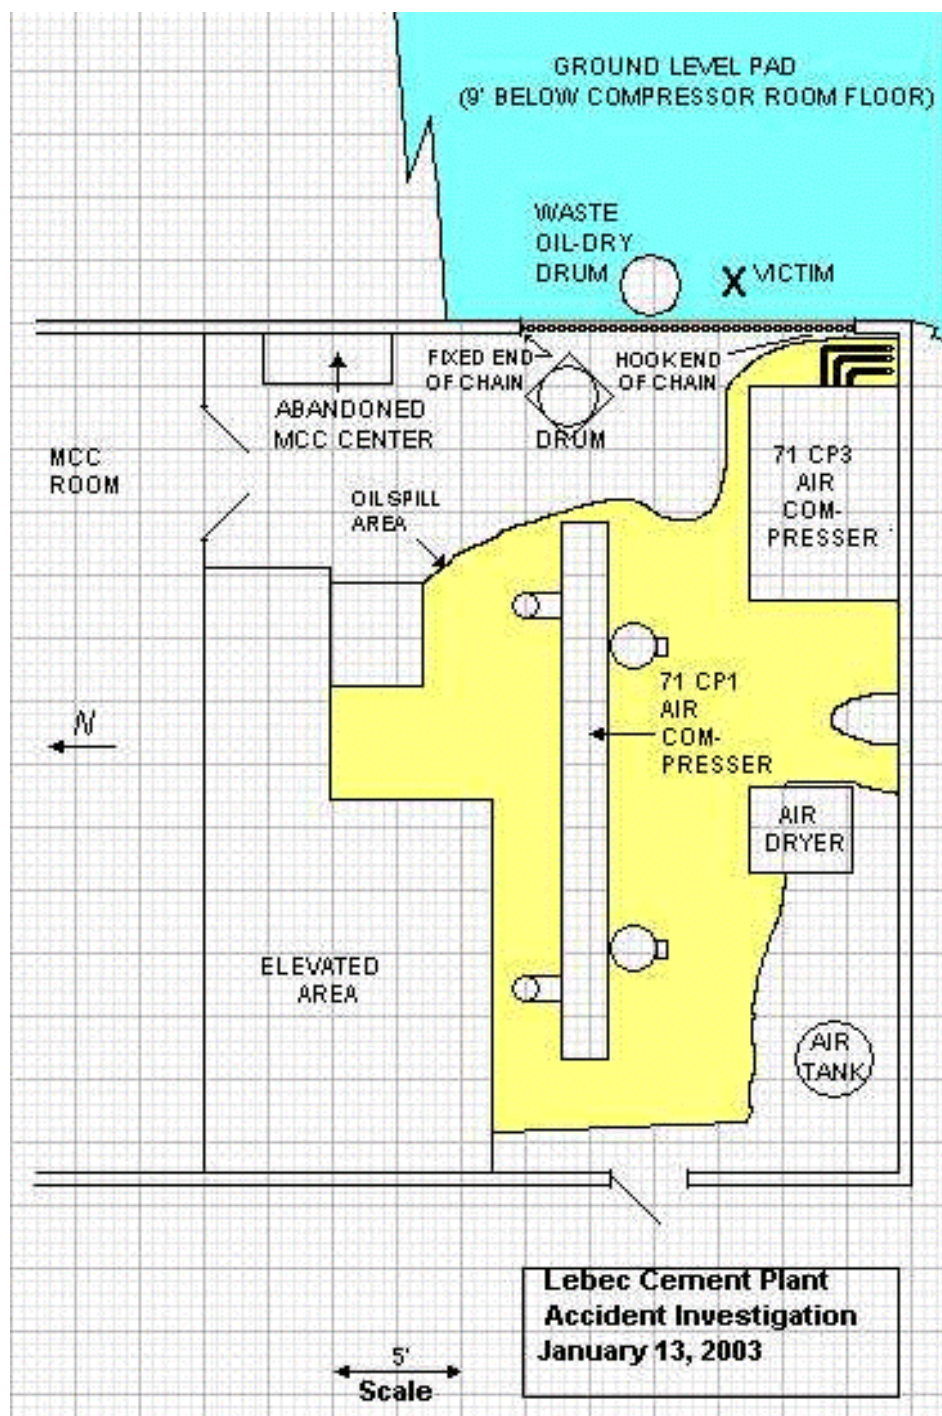
No.1 Mill Compressor Room

The accident occurred at the loading dock in the compressor building for the mill. The loading dock was 9 feet above the lower ground level, had a concrete floor, and an open bay doorway. A concrete pad comprised the ground below the loading dock.

The rollup door opening was 156 inches wide. The chain handrail was composed of two strands/rails of $\frac{1}{4}$ inch welded chain, a middle rail at $23 \frac{1}{2}$ inches from the floor and a top rail at 34 inches from the floor.
