Report of Investigation

Fatal Machinery Accident

August 21, 2003

Delight Plant
Hanson Aggregates West, Inc.
Delight, Pike County, Arkansas
I.D. No. 03-01587

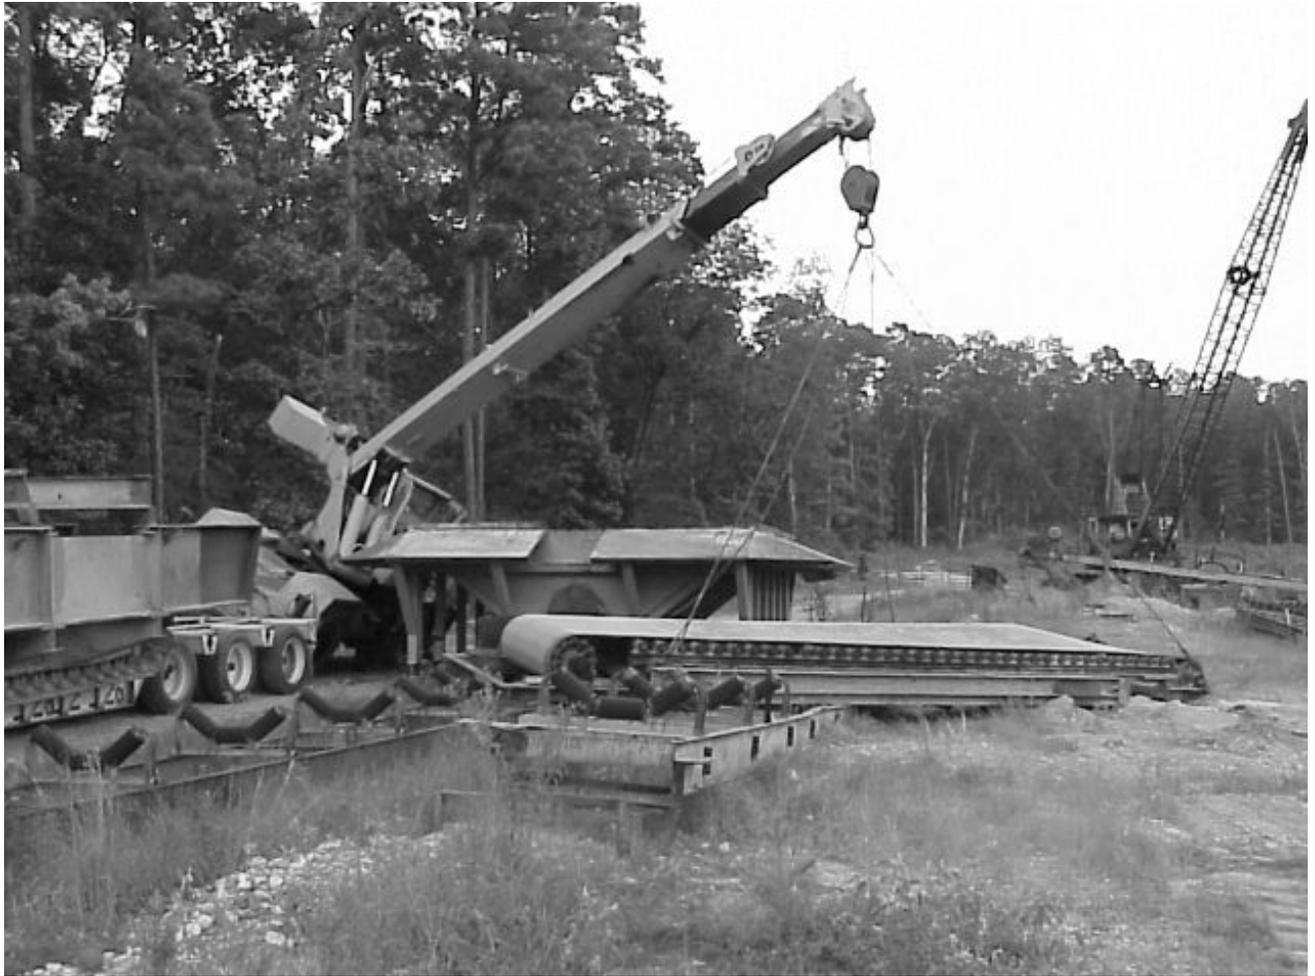
On August 21, 2003, Daniel R. Young, mechanic, was fatally injured when he was struck by a 30 feet long section of conveyor suspended from a rubber tired mobile crane. Young was standing near the crane that was lifting the conveyor on a lowboy trailer. While the load was being positioned, the crane became unstable and tipped over. The falling load struck the victim.

The accident occurred because the procedures used to load the conveyor were inadequate. Persons were not positioned clear of the suspended conveyor. The weight of the load exceeded the rated lift capacity of the crane with the outrigger configuration used at the time of the accident.
