ACCIDENT DESCRIPTION

ROOT CAUSE ANALYSIS

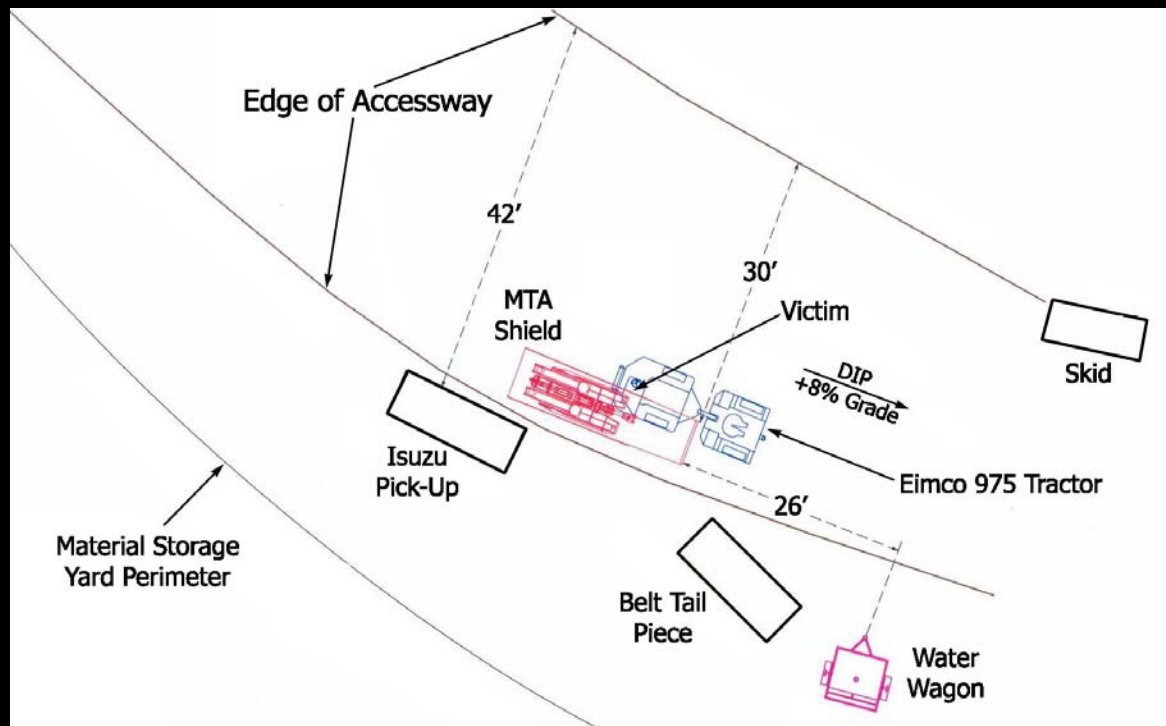
- On January 22, 2004, a 29-year old laborer (victim), began his night shift at 9:00 p.m. and was assigned to water the underground roadways at the Aberdeen Mine.
- He obtained an Eimco 975 utility tractor, which had just been brought out of the mine by another miner, attached to an empty low-boy trailer.
- He proceeded to the upper material storage yard, where he parked the low-boy trailer and hooked a 650-gallon water trailer to the tractor. However, the water in the trailer was frozen.
- He then drove to the lamp house, with the water trailer attached, where the shift foreman told him to use another trailer that was parked in the mine.

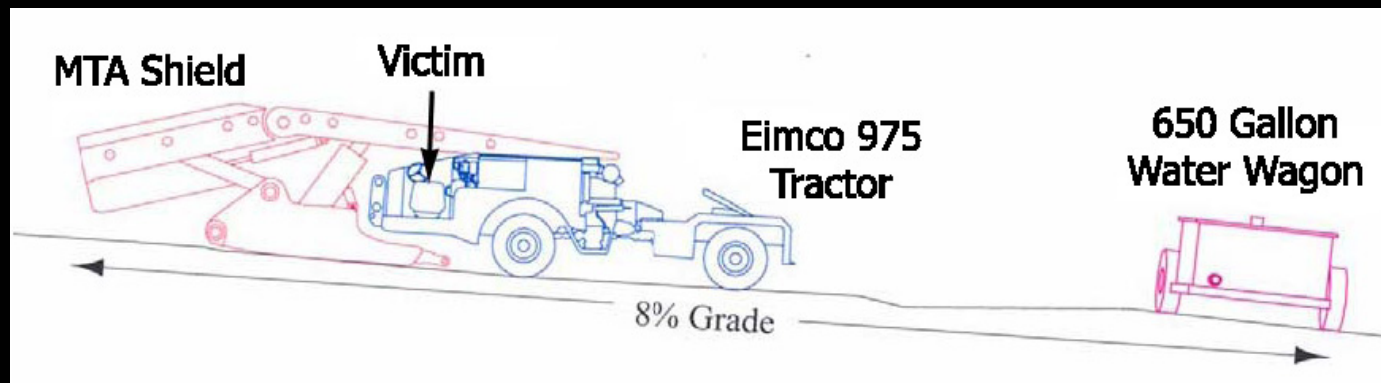
ACCIDENT SITE

Causal Factor: The shield involved in the accident was stored in a manner that the canopy tip faced toward the access way through the storage yard such that vehicles could travel under the shield canopy.

The accident occurred because the shield was stored in an unsafe manner that allowed the tractor to drive under the canopy tip creating a pinch point with the top of the tractor. The absence of a protective structure for the operator's compartment on the tractor contributed to the accident. The operator's apparent lack of awareness that he was moving toward the shield after dropping off the trailer also contributed to the accident.

Corrective Actions: Management should evaluate and assure the safe storage of equipment at the upper material storage yard. Equipment should be stored and located so as not to present a hazard to vehicle operators traveling through the storage yard.
