Coal Mine Fatal Accident 2004-06

Operator:	Brooks Run Mining Company, LLC
Mine:	Brooks Run Processing Plant No. 1
Accident Date:	March 2, 2004
Classification:	Sliding Material
Location:	District 4, Webster County, WV
Mine Type:	Surface
Employment:	51

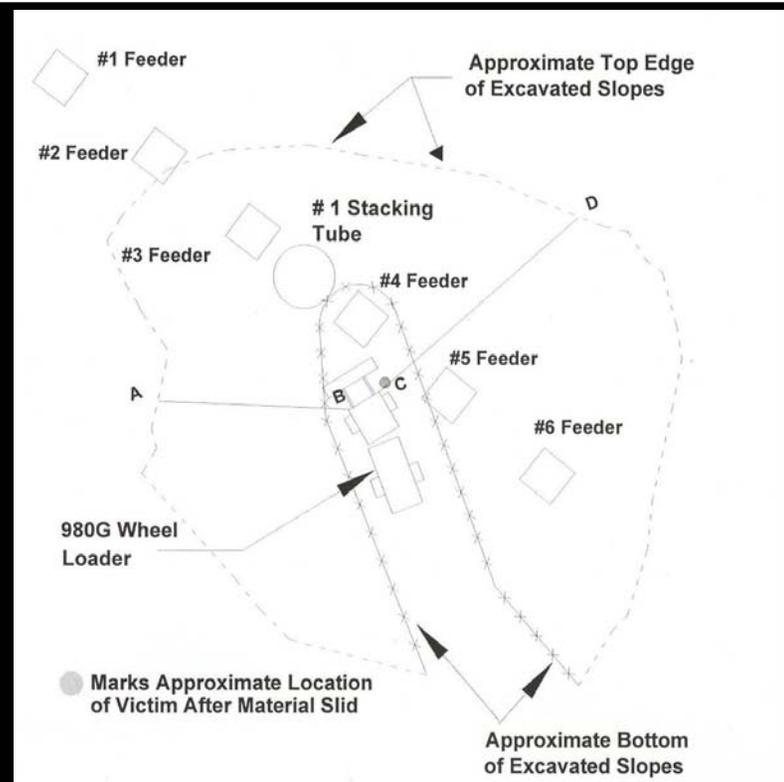
- At the beginning of the day shift on March 2nd, a foreman and three laborers were assigned to replace the No. 4 feeder's vibratory feeder with a new mass-flow feeder.
- The No. 4 feeder was located at the meeting point of the Nos. 1 and 2 clean coal piles.
- To prepare the feeder to be worked on, the feeder was opened so that the coal above it could be loaded onto a train. Once this was done, a large area had been cleared above the feeder.
- The victim, who was also a foreman, along with another foreman, directed two employees to remove coal from the No. 1 clean coal pile and above the feeder opening to complete the cleaning process.

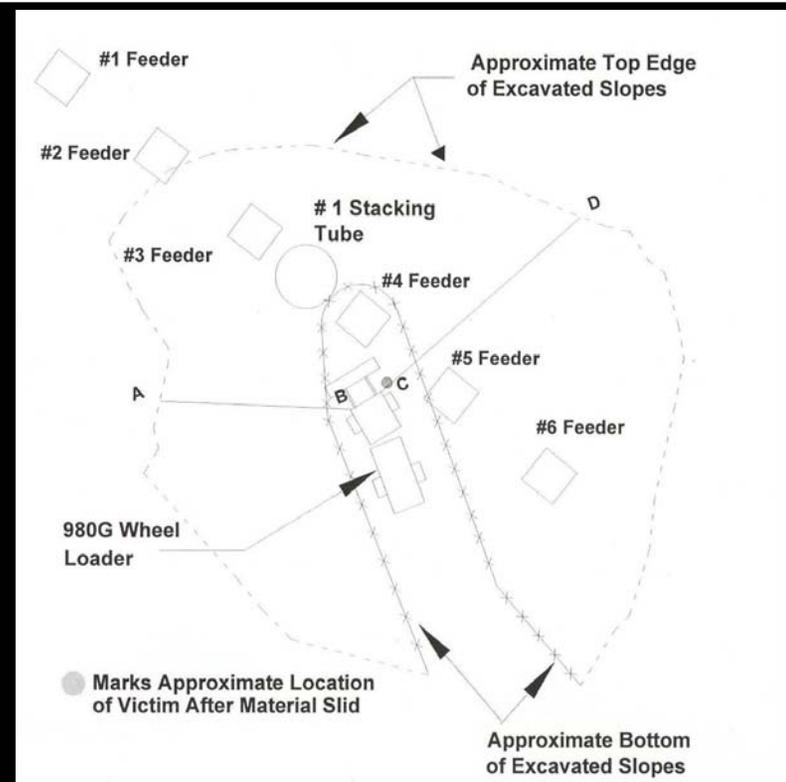
- The victim told two laborers to bring two plates to cover the No. 4 feeder.
- As the first plate was being installed, it hit the concrete that surrounds the opening and bent.
- The plate was removed and the end loader was used to remove coal that fell from the piles onto the feeder.
- Both foremen decided that a sufficient amount of coal had been removed from above the feeder.
- The foreman who was not the victim, twice examined the steeply sloped banks of clean coal and reached a conclusion that no hazardous conditions existed.
- The victim then examined the same area, and did not discuss any hazards with anyone.

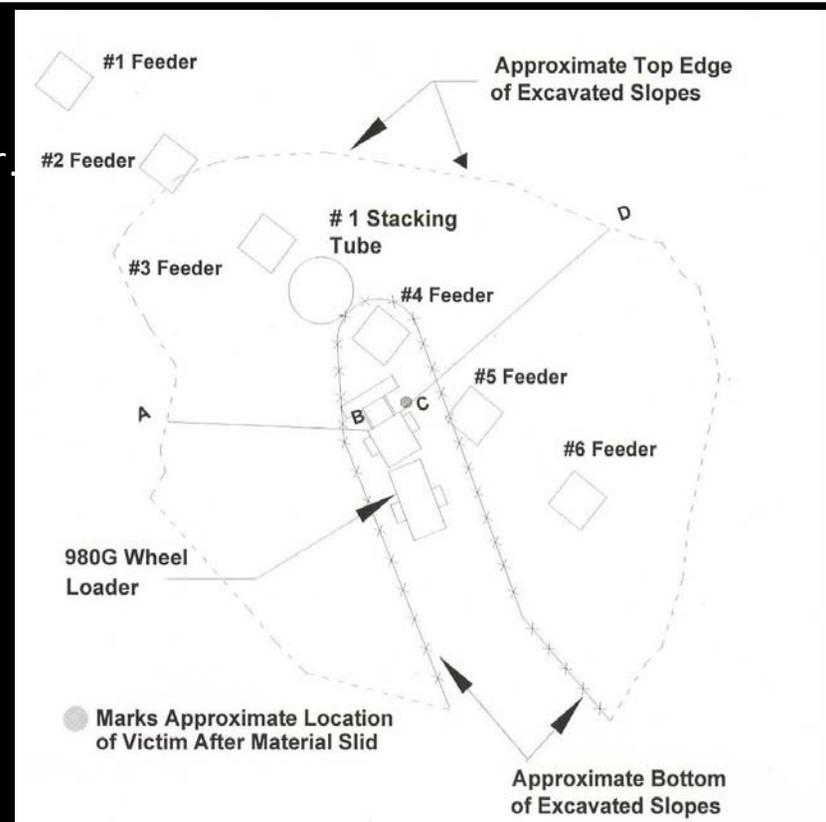
- During the examinations, both examiners observed coal continually falling from the coal piles to the feeder.
- The decision was made to quickly install the second plate before more coal fell onto the feeder.
- An experienced bulldozer operator asked the victim to allow him to knock down one of the piles because it was obvious to him that it posed a sliding material hazard.
- The victim told him the pile was ok.
- While the second plate was being prepared for installation, the experienced bulldozer operator again asked the victim to allow him to knock down one of the piles.
- Again the victim told him that it was ok.

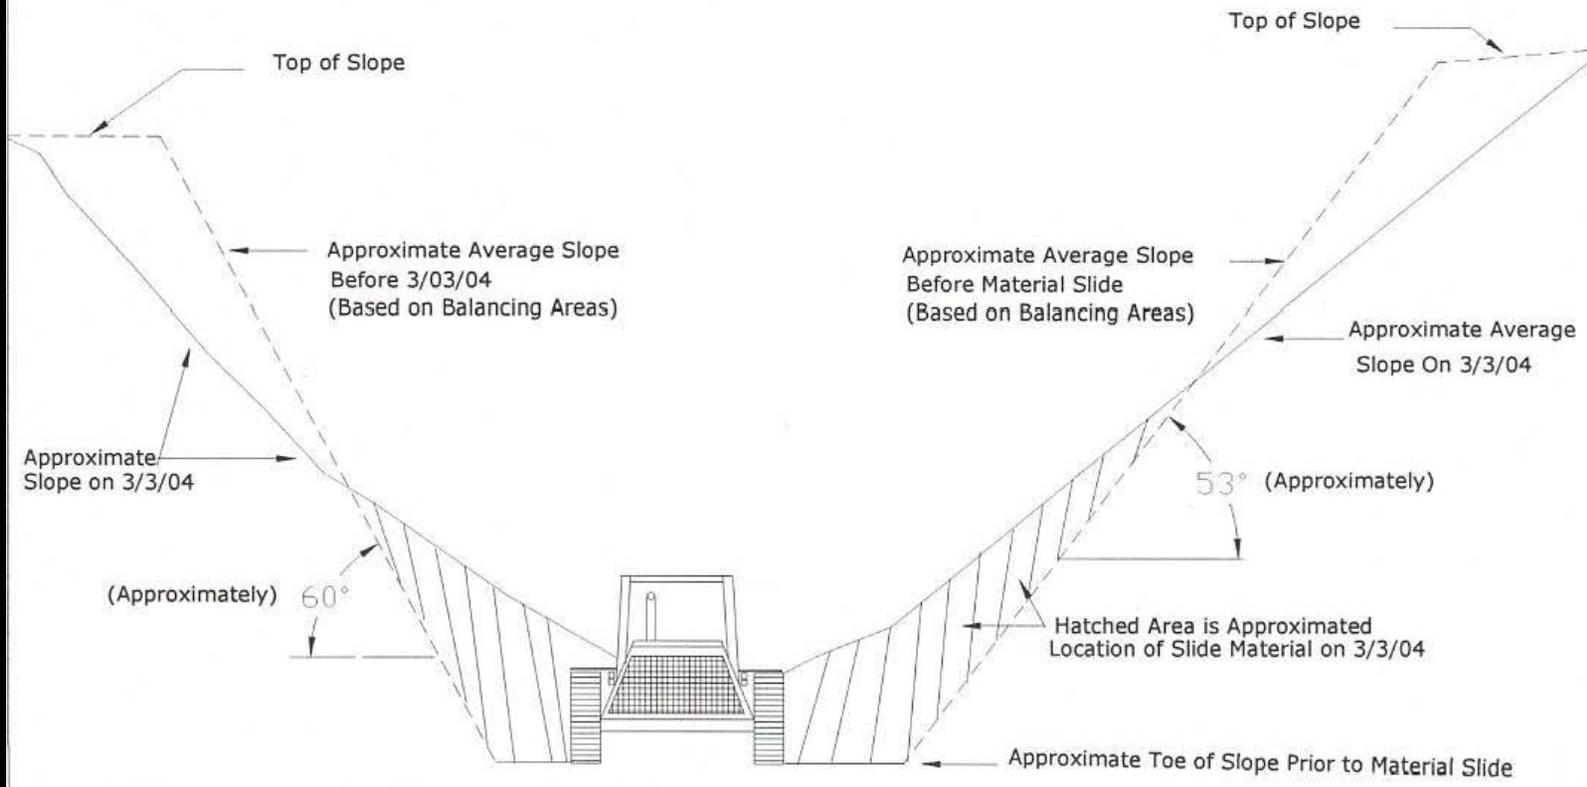
- The victim positioned himself between the piles and beside the end loader to help guide the installation of the second plate.
- During this process, coal slid from one of the piles causing three feet of coal to cover the victim.
- The victim was fatally crushed under the coal.

Causal Factor: Work was performed in a hazardous location. The victim was working on the ground near the No. 2 clean coal storage pile, where he was exposed to the hazard of loose coal sliding from the unstable banks. This condition was developed in the stockpile by the reclaiming operations of the bulldozer and end loader while uncovering the No. 4 feeder.

Corrective Action: The company developed a "Stockpile Area Maintenance Plan" that designates work zones for persons working near any coal storage pile at the mine. The Plant supervisors use Abney Hand Levels to determine the projected toe of a pile, based on its natural angle of repose. Eighteen feet of distance is added to the projected toe to establish the work zone limit. This point on the ground is marked by cones, danger tape, or other visible means. No one is allowed to work, while on foot, between the limit of the work zone (marked by the cones, danger tape, etc.) and the toe of the coal storage pile.
