Coal Mine Fatal Accident 2004-10

Operator:	Colony Bay Coal Company, Inc.
Mine:	Colony Bay Surface Mine
Accident Date:	February 10, 2004
Classification:	Powered Haulage
Location:	District 4, Boone County, WV
Mine Type:	Surface
Employment:	38

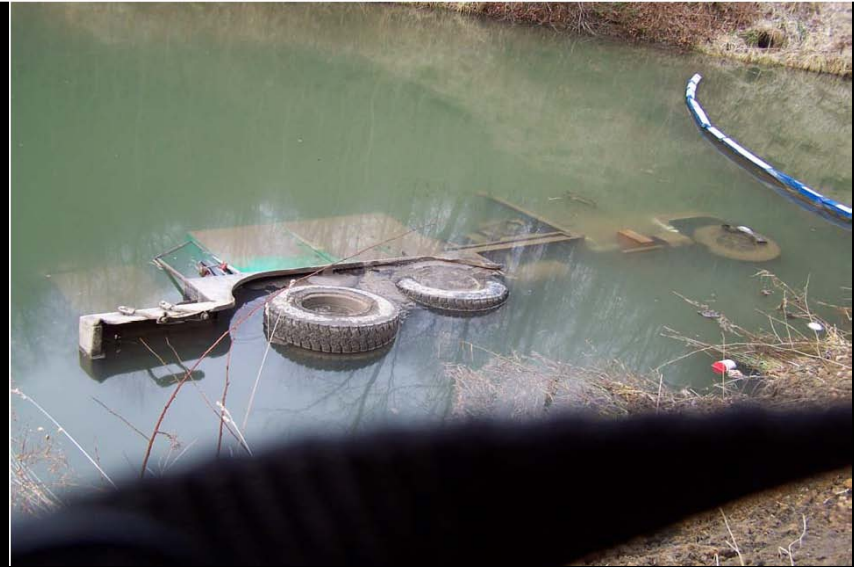
- At 6:30 p.m., on Tuesday, February 10, 2004, Robert Littreal, a 54-year old truck driver with more than 22 years of mining experience received serious injuries while descending the main access road in a 1993 Chevrolet (Kodiak) service truck.
- While making the decent, the truck braking system failed. The brake system failure resulted in the truck traveling approximately 680 feet down a 10% grade, hitting a 24-inch pipe and berm beside a sediment pond, traveling an additional 75 feet up the pond access road and sliding into the pond.
- The service truck landed on the driver's side in approximately ten feet of water, causing the driver to be submerged 2 to 3 minutes before being rescued. The driver died on February 26, 2004.

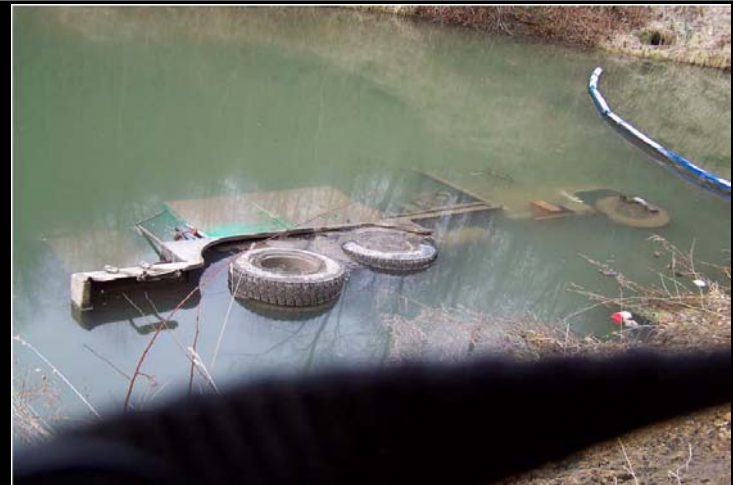
- During the second shift, the victim was assigned to cut a piece of metal off of an excavator.
- During the cutting operation, a hydraulic hose was burned and needed to be replaced.
- The victim and another miner made several trips in a mechanics truck from the excavator to the shop in order to locate and make the correct hose and fitting.
- Afterwards, the miner stayed at the shop to complete the hose and fitting, while the victim started down the main access road in the service truck to refill the excavator with hydraulic fluid.
- The repair work had caused fluid to be lost.

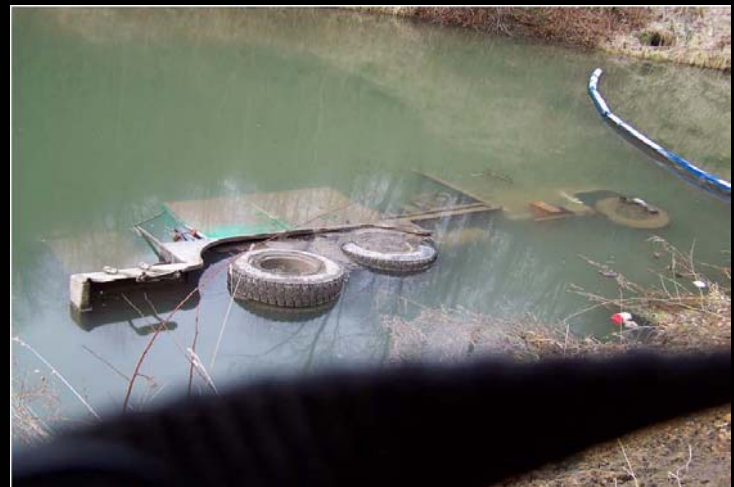
- Shortly before 6:30 p.m., two miners were sitting in a rock truck when the victim yelled over the CB radio, and asked if anyone was coming up the hill.
- When a miner answered "No", he replied, "I've lost my brakes. I'm going to ride it out."
- The two miners saw the service truck coming at a high rate of speed.
- From their vantage point it appeared that the truck turned sharply to the right at the sediment pond, hit the berm, traveled the pond road, and slid into the sediment pond.
- The service truck landed on the driver's side in approximately ten feet of water.
