Coal Mine Fatal Accident 2004-15

Operator:	Reedy Coal Company, Inc.
Mine:	Mine No. 25
Accident Date:	August 2, 2004
Classification:	Fall of Roof
Location:	District 7, Knott County, KY
Mine Type:	Underground
Employment:	64

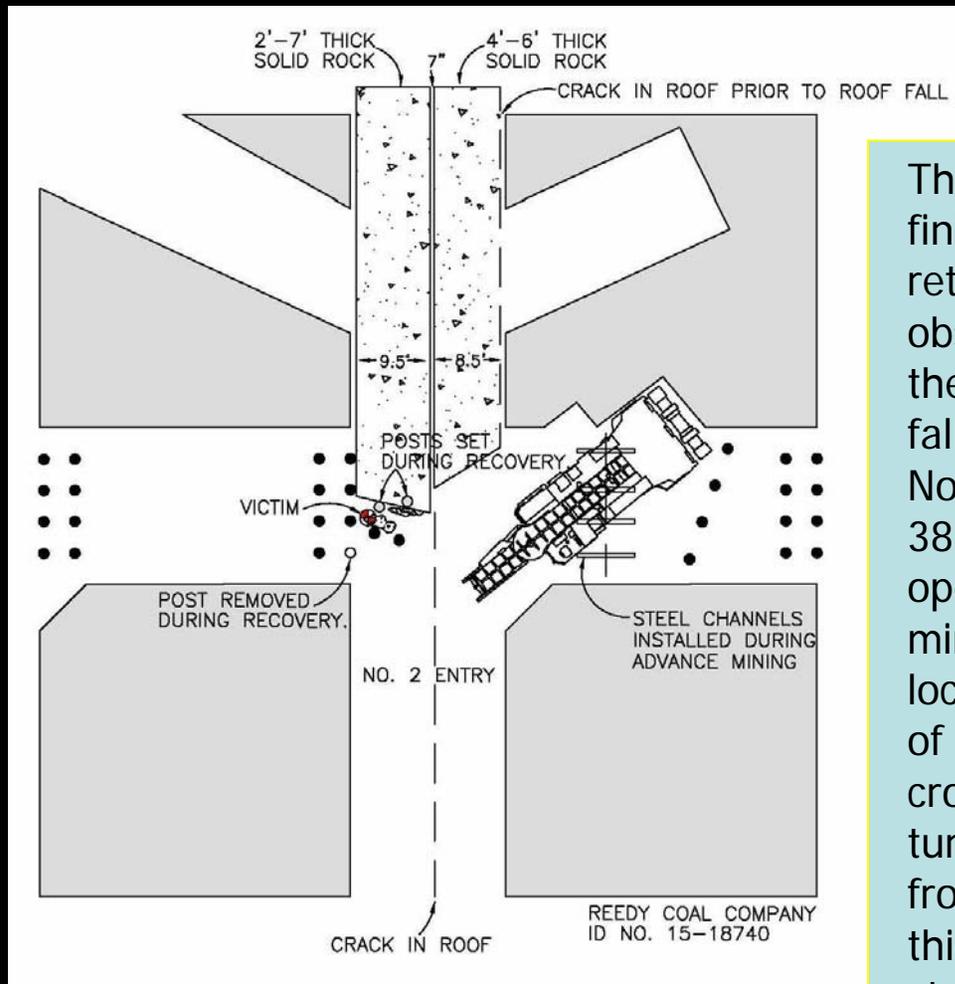
The section crew had just finished setting timbers for retreat mining and were observing the roof during the final push out, when a fall of roof occurred in the No. 2 entry. The victim, a 38-year old roof bolter operator with 14 years of mining experience, was located in the intersection of the No. 2 entry, at crosscut No. 20, inby the turn posts. The fall ranged from 0-60 inches in thickness, 18 feet wide, and started at the center of the No. 2 entry intersection and extended inby for an undetermined distance.

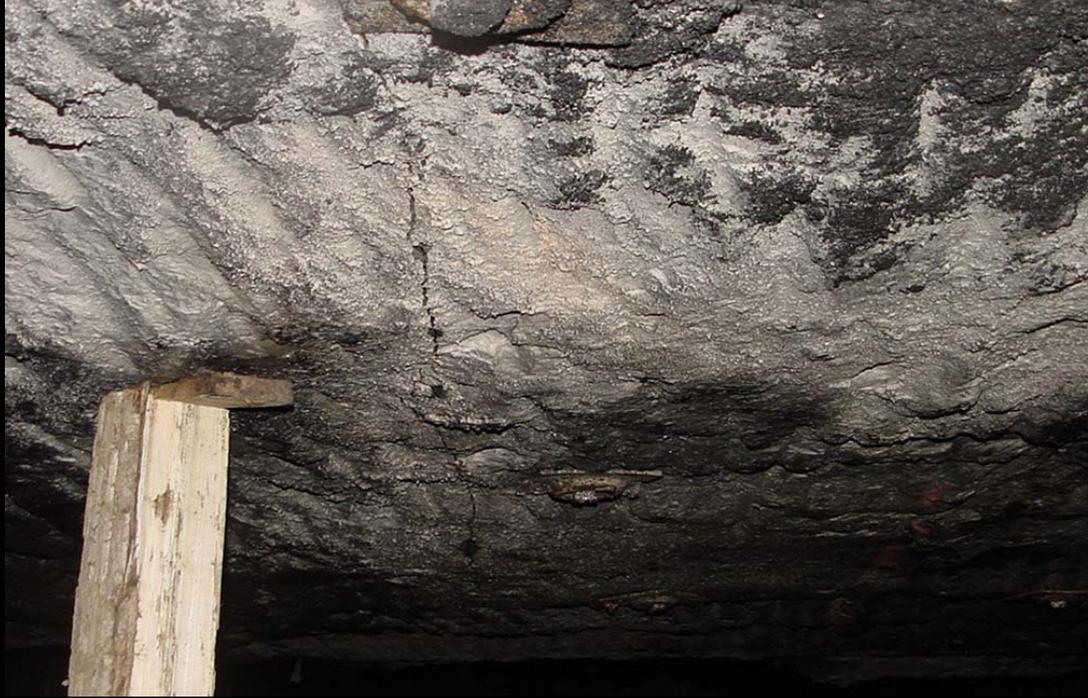
The accident occurred as a result of hazardous roof conditions on the working section not being corrected. An elongated crack, parallel with the right rib, extended into the No. 2 entry intersection. A hillseam was present in the right crosscut running parallel with the No. 2 entry. The parallel joints, combined with the extraction of coal, allowed the roof fall to initiate inby the pillar line and to propagate outby to the No. 2 entry intersection at crosscut 20. The contributing factors were: Failure to follow the approved roof control plan; the victims position was prohibited by the provisions of the approved roof control plan. The day shift mine foreman failed to alert the oncoming shift of the hazardous condition by not recording hazardous conditions found.

Corrective Actions: Mining practices and procedures should be reviewed to ensure that during retreat mining no one is allowed inby the continuous mining machine. The mine operator should reinstruct all affected personnel in the approved roof control plan and ensure compliance with its provisions.

Corrective Actions: The certified persons making the examinations should properly identify, make the appropriate corrections, and record all hazardous conditions. Mine management should develop and follow procedures to identify and correct any and all hazardous conditions and to notify all persons affected by the condition.
