Coal Mine Fatal Accident 2004-16

Operator:	McElroy Coal Company
Mine:	McElroy Mine
Accident Date:	August 17, 2004
Classification:	Fall of Rib
Location:	District 3, Marshall County, WV
Mine Type:	Underground
Employment:	639
Production	6.7 Million Tons/Year

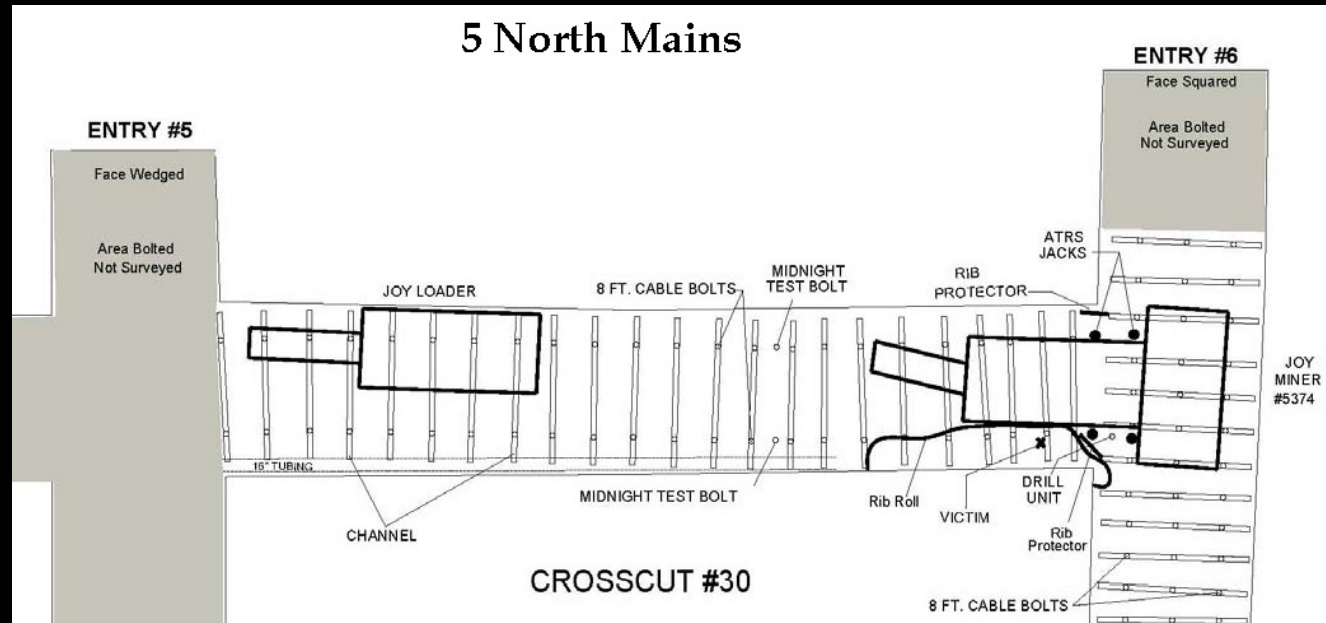
A 57-year old Continuous Mining Machine Roof Bolter Operator was fatally injured in a rib roll accident on the right side of the 5-North Mains section. The crew had mined through the No. 30 crosscut between the No. 5 and No. 6 entries when the roof bolters started to install the last strap. The miner operator warned the victim that the rib was beginning to work. The victim withdrew approximately 3 feet toward the No. 5 entry (rear of the mining machine) when he stopped and placed his hand on the rib. The coal and rock rib (~20' long by 5' wide and up to 10" thick) collapsed and pinned the victim against the continuous mining machine causing fatal injuries.

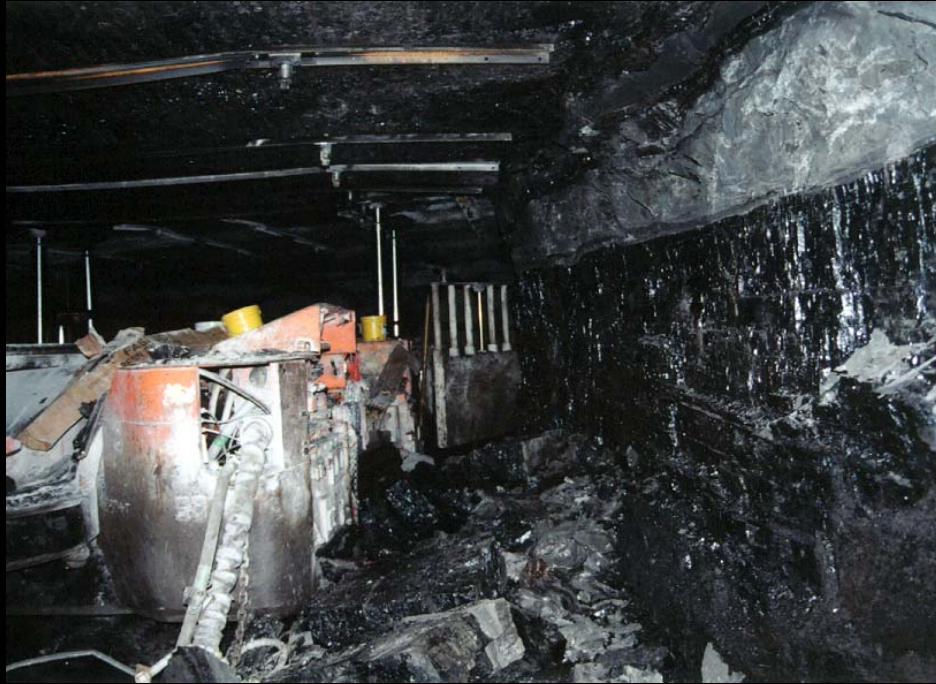
The accident was caused by failure to effectively control the rib at the work area which exposed the victim to a hazardous condition. The hazardous condition was a result from what appeared to be mining induced loading in the No. 30 crosscut between the No. 5 and No. 6 entries. Stress redistribution resulting from the completion of the crosscut shed an additional load on the surrounding pillar ribs. The additional load caused the pillar block to expand and the rib line adjacent to the right side of the continuous mining machine to fracture. Contributing to the accident was equipment incapable of installing rib support, an insufficient roof control plan, and failure to reevaluate changing conditions relative to equipment, mining procedures and practices.
