## Coal Mine Fatal Accident 2004-18

Operator:	Cumberland River Coal Company
Mine:	Fork Ridge Mine
Accident Date:	September 24, 2004
Classification:	Electrical
Location:	District 5, Wise County, VA
Mine Type:	Underground
Employment:	39
Production	~1,300 Tons/Day

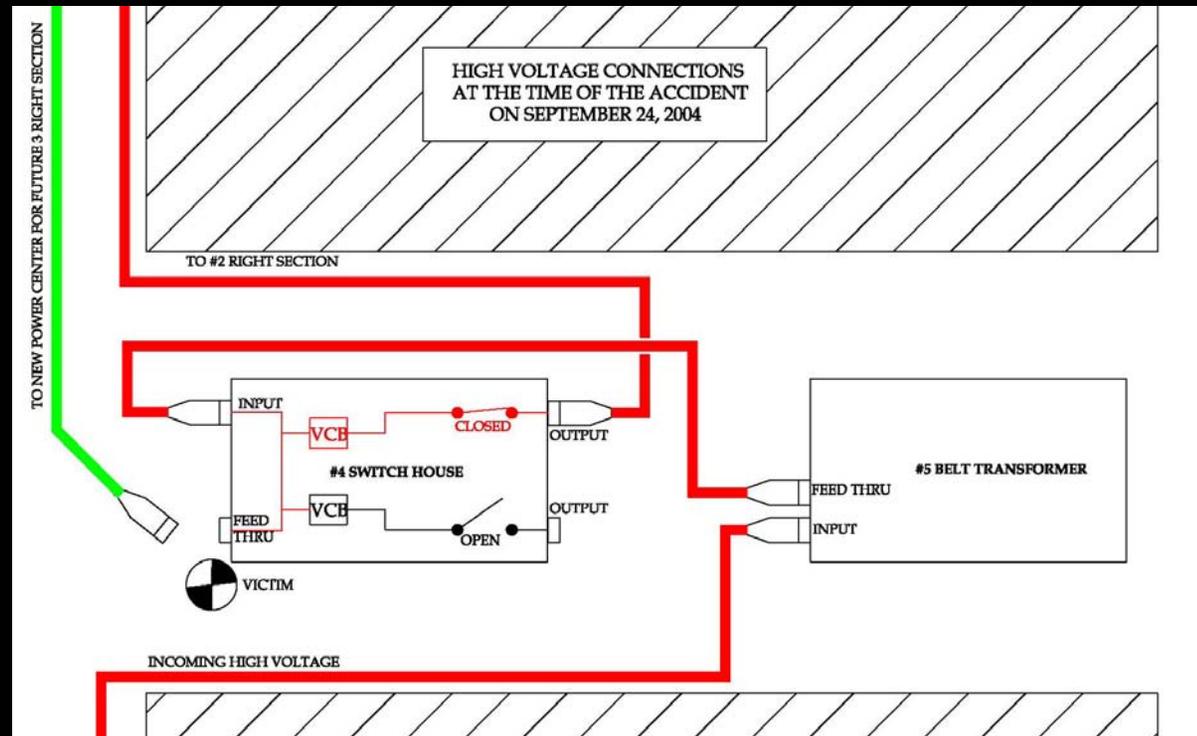
On September 24, 2004, at approximately 8:40 p.m., a 46 year-old face equipment operator with 30 years mining experience was fatally injured in an underground coal mine. The victim and a qualified electrician were preparing to connect a high-voltage coupler to a receptacle labeled "FEED THROUGH" on a 7,200 VAC high-voltage switch house. The electrician thought the receptacle was incorrectly labeled and that it was actually an output receptacle. After opening the visual disconnect and cleaning the coupler, he went to the personnel carrier. When he heard the victim cry out, the electrician turned and saw him within arms reach of the exposed receptacle. The victim suffered an electrical shock resulting in the fatality.

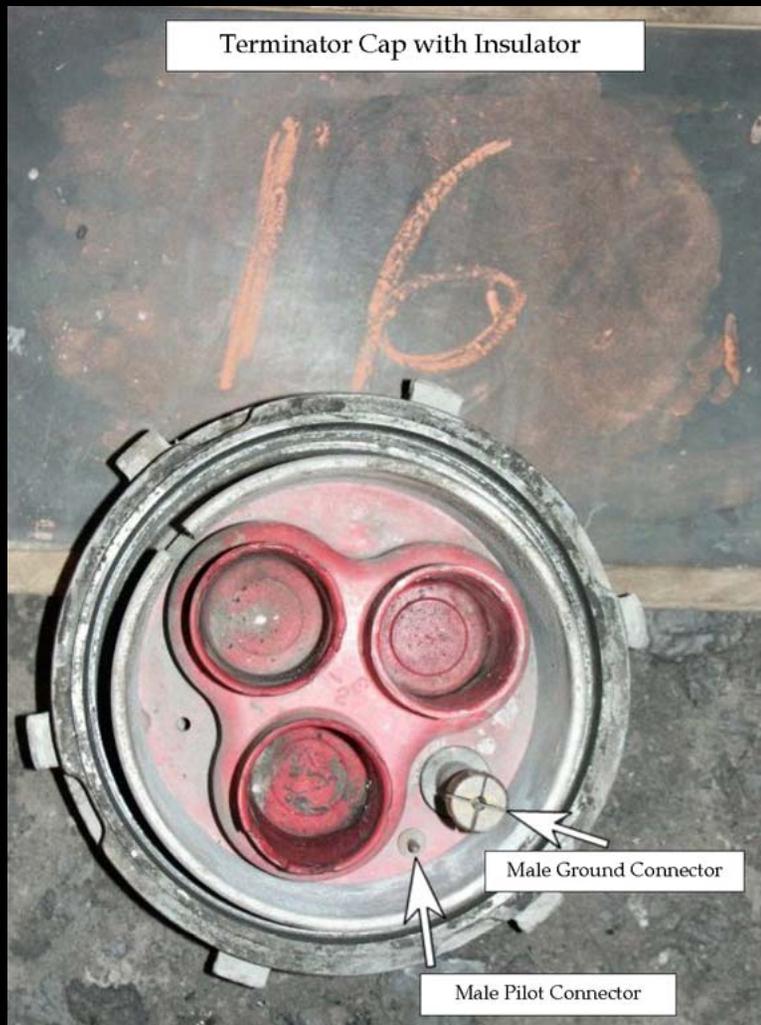
*Causal Factor:* A dust cap was located on the feed-through receptacle and a terminator cap was located on the output receptacle .

*Corrective Actions:* All electricians and helpers were retrained on appropriate caps for feed-through and output receptacles. Also, more extensive retraining occurred at the annual electrical retraining.

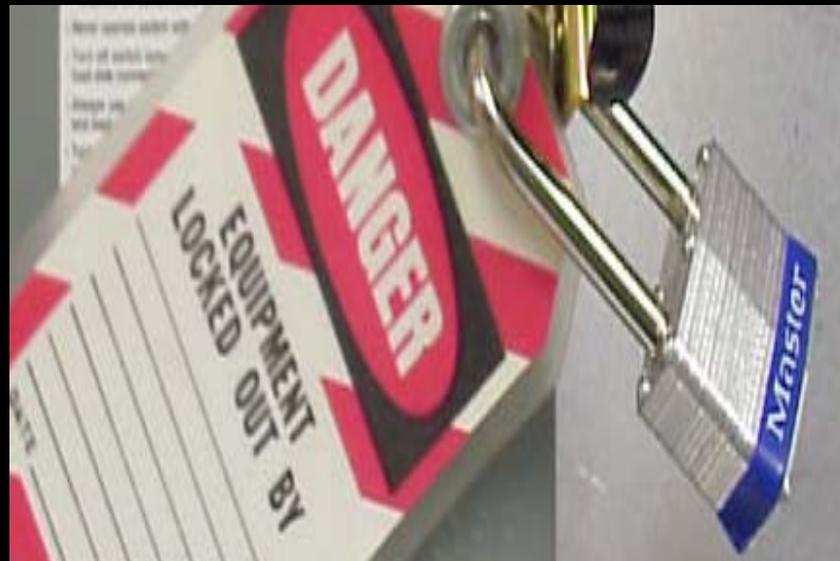
Causal Factor: The appropriate circuit was not locked and tagged out.

Corrective Actions: An action plan has been submitted and implemented by the company. The plan required immediate retraining of all electricians and helpers on the on appropriate operation of VCB's and tag and lockout procedures.

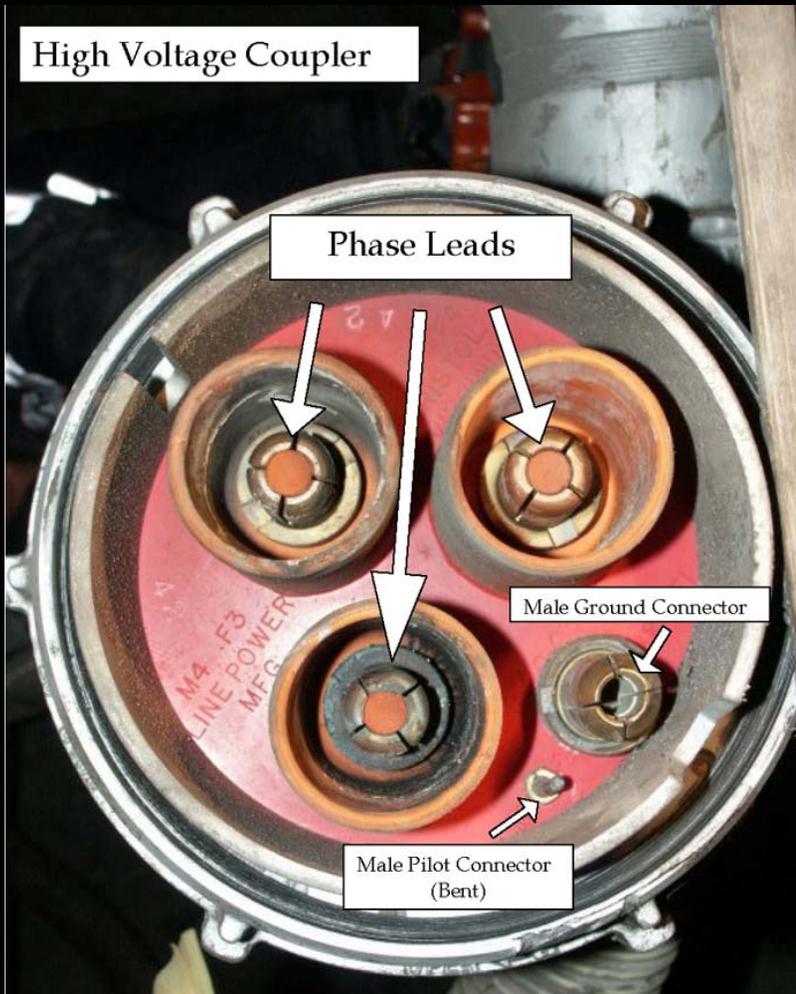
Causal Factor: The pilot (monitor) pin, in the high-voltage coupler attached to the No. 5 Belt Power Center, was bent, short-circuiting the fail safe ground check circuit.

Corrective Actions: An action plan has been submitted and implemented by the company. The plan requires more extensive retraining of all electricians and helpers in high-voltage system testing, operation and maintenance.

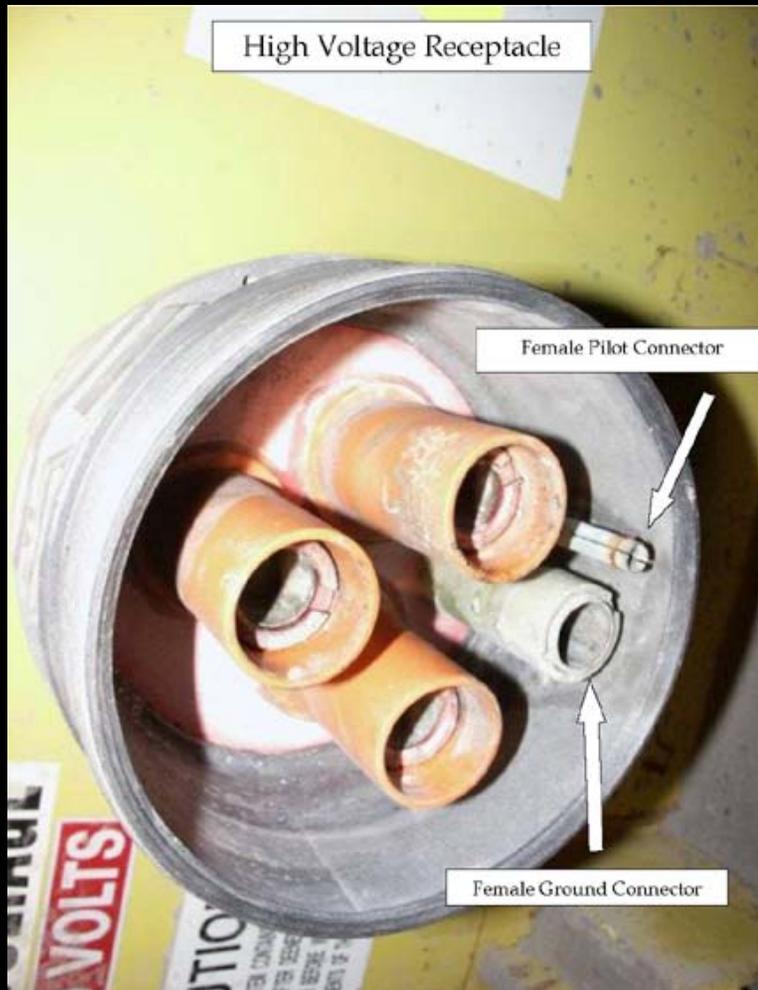
*Causal Factor:* A guide screw (alignment pin) for the No. 5 Belt Power Center Feed-Through Receptacle was not maintained.

*Corrective Actions:* An action plan has been submitted and implemented by the company. The plan required all electrical high-voltage receptacles to be inspected for the presence of guide pins. If pins are missing or inoperative, new guide pins will be reinstalled. All cathead receptacles will be inspected and corrected within 60 days, if repairs are needed.
