Coal Mine Fatal Accident 2004-25

Operator:	Endurance Mining
Mine:	Red Cedar Surface Mine
Accident Date:	November 20, 2004
Classification:	Fall of Highwall
Location:	District 4, Boone County, WV
Mine Type:	Surface
Production	6,000 Tons/Day

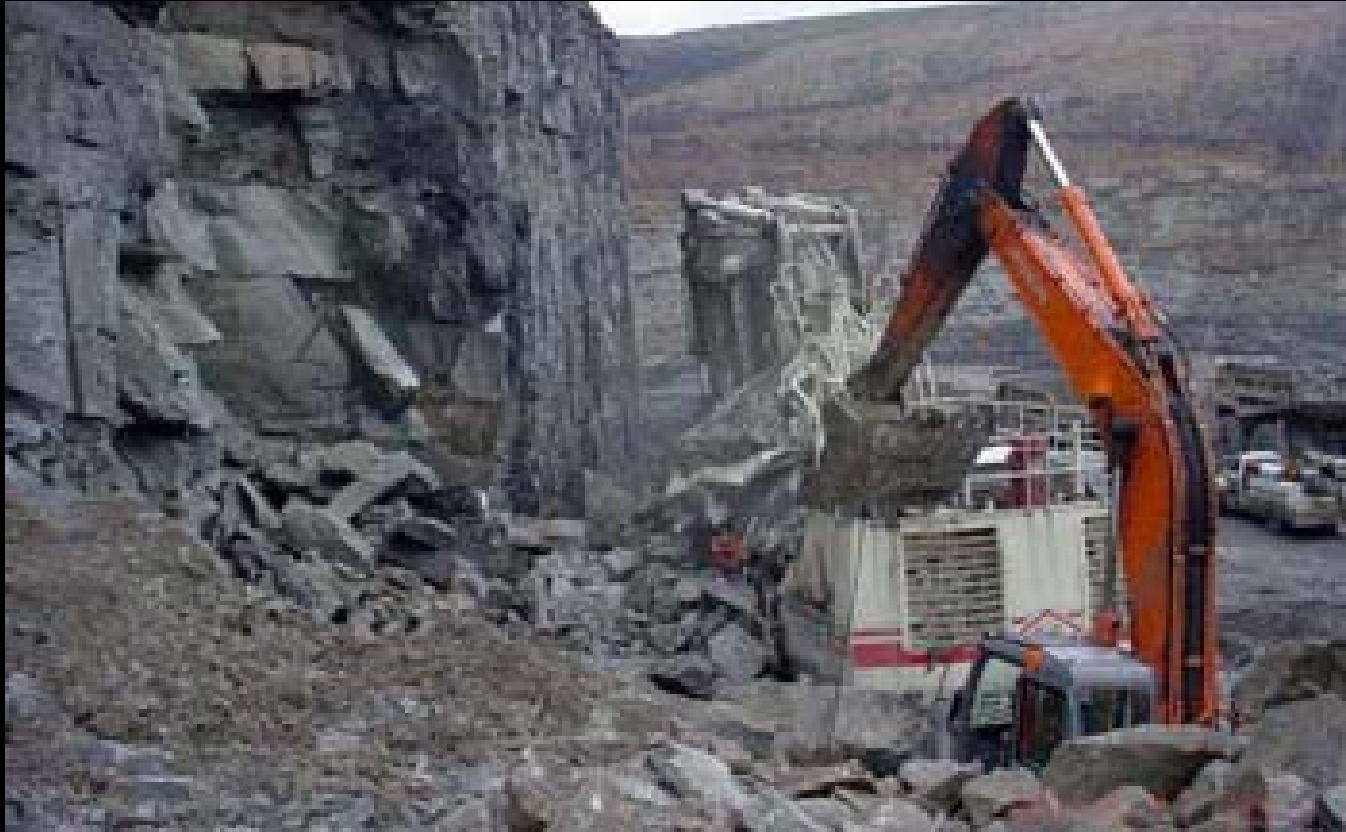
A 41-year old equipment operator with seven months of mining experience was fatally injured while operating an excavator near the highwall, loading spoil into trucks. The excavator was positioned with the cab on the highwall side. The highwall collapsed causing rocks to cover the operator's cab.

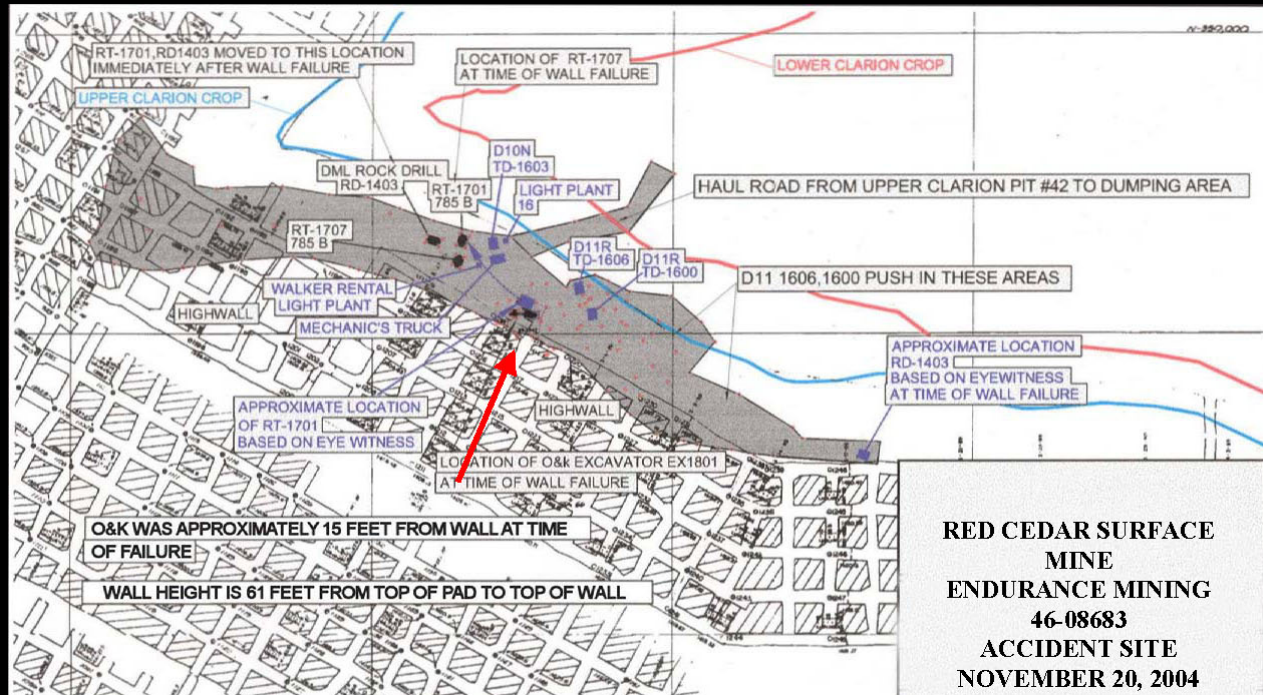
Causal Factor: Surface mining was developed into abandoned, pillared, underground mine workings where subsidence had occurred, resulting in unstable highwall conditions.

Corrective Actions: The mine operator revised the ground control plan to require drilling in advance of contour mining adjacent to old underground mine works. The revised plan also required a bench to be left above the pit floor, away from the outermost edge of old underground mine works. This resulted in highwall development away from the old mine workings to prevent subsidence from affecting the stability of the highwall.
