MNMM Fatal 2004-07

- Machinery Accident
- March 24, 2004 (Oklahoma)
- Crushed Stone Operation
- Driller
- 41 years old
- 22 years experience

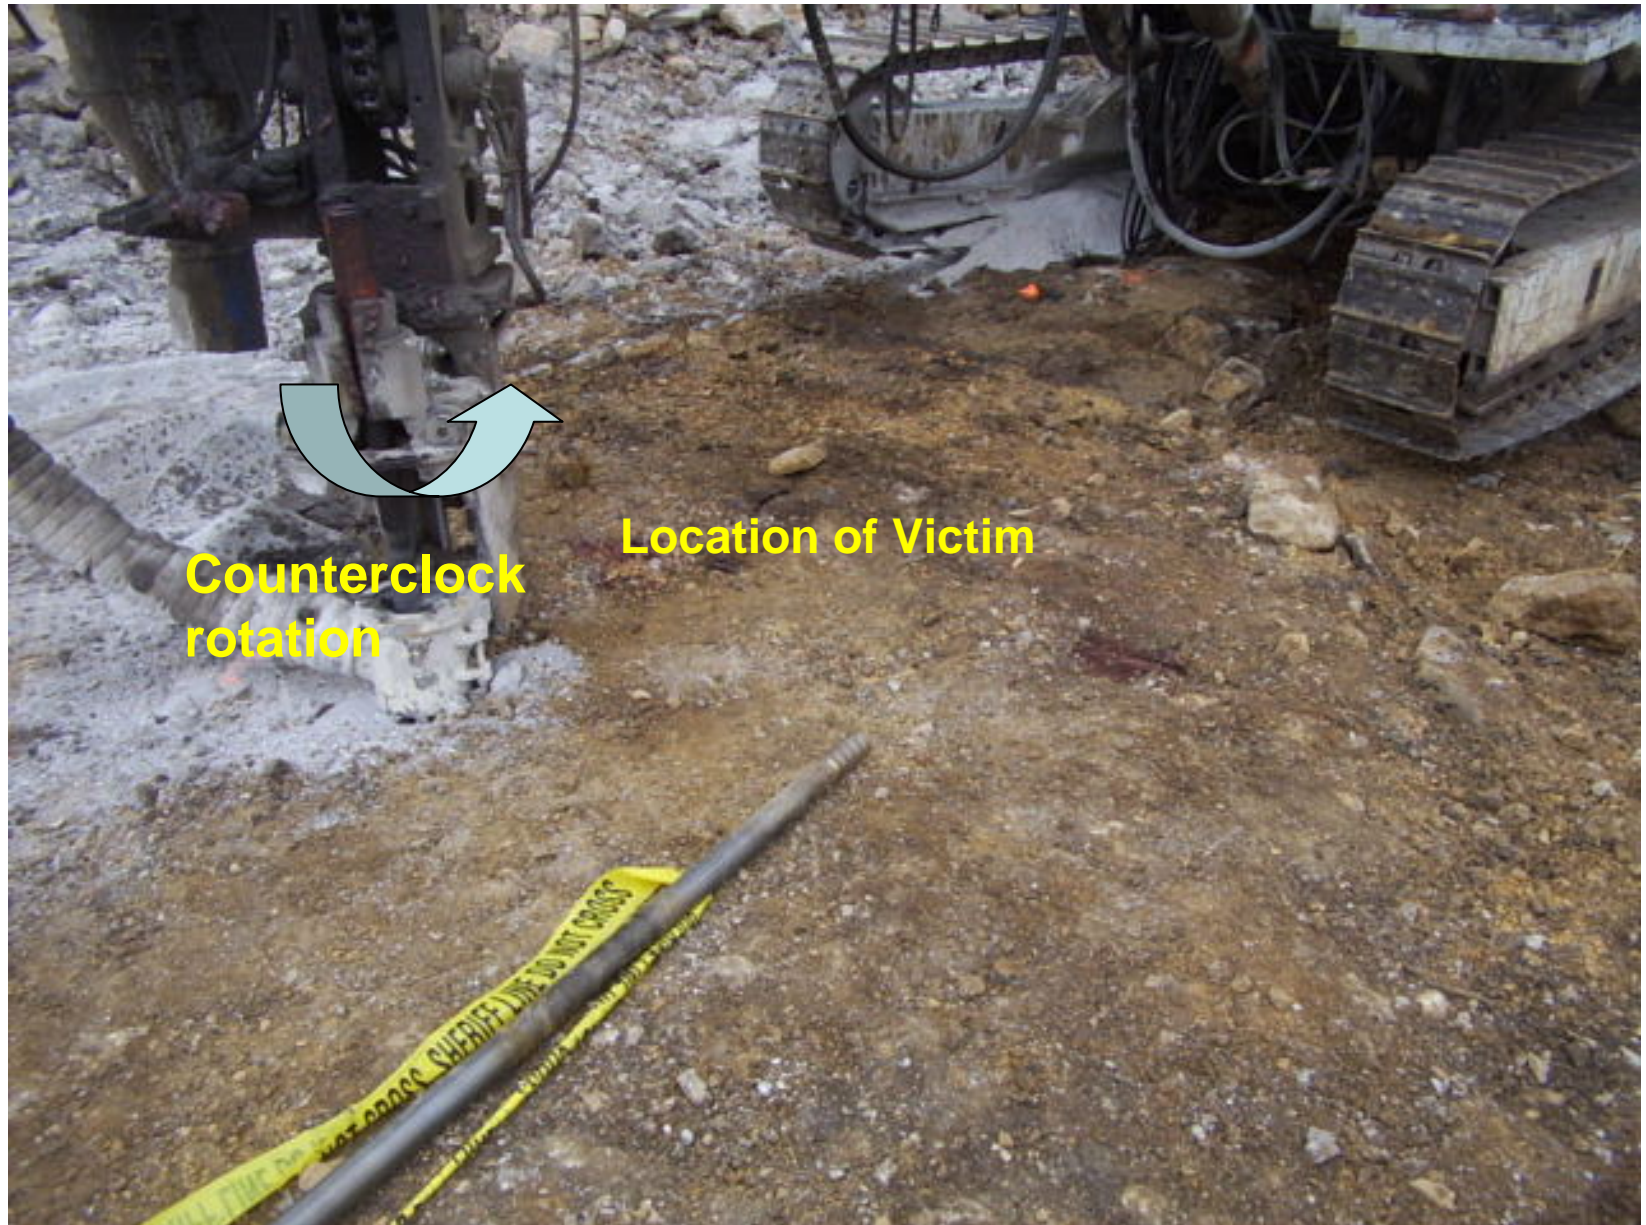
The drill operator was found lying next to the drill mast near the drill steel.

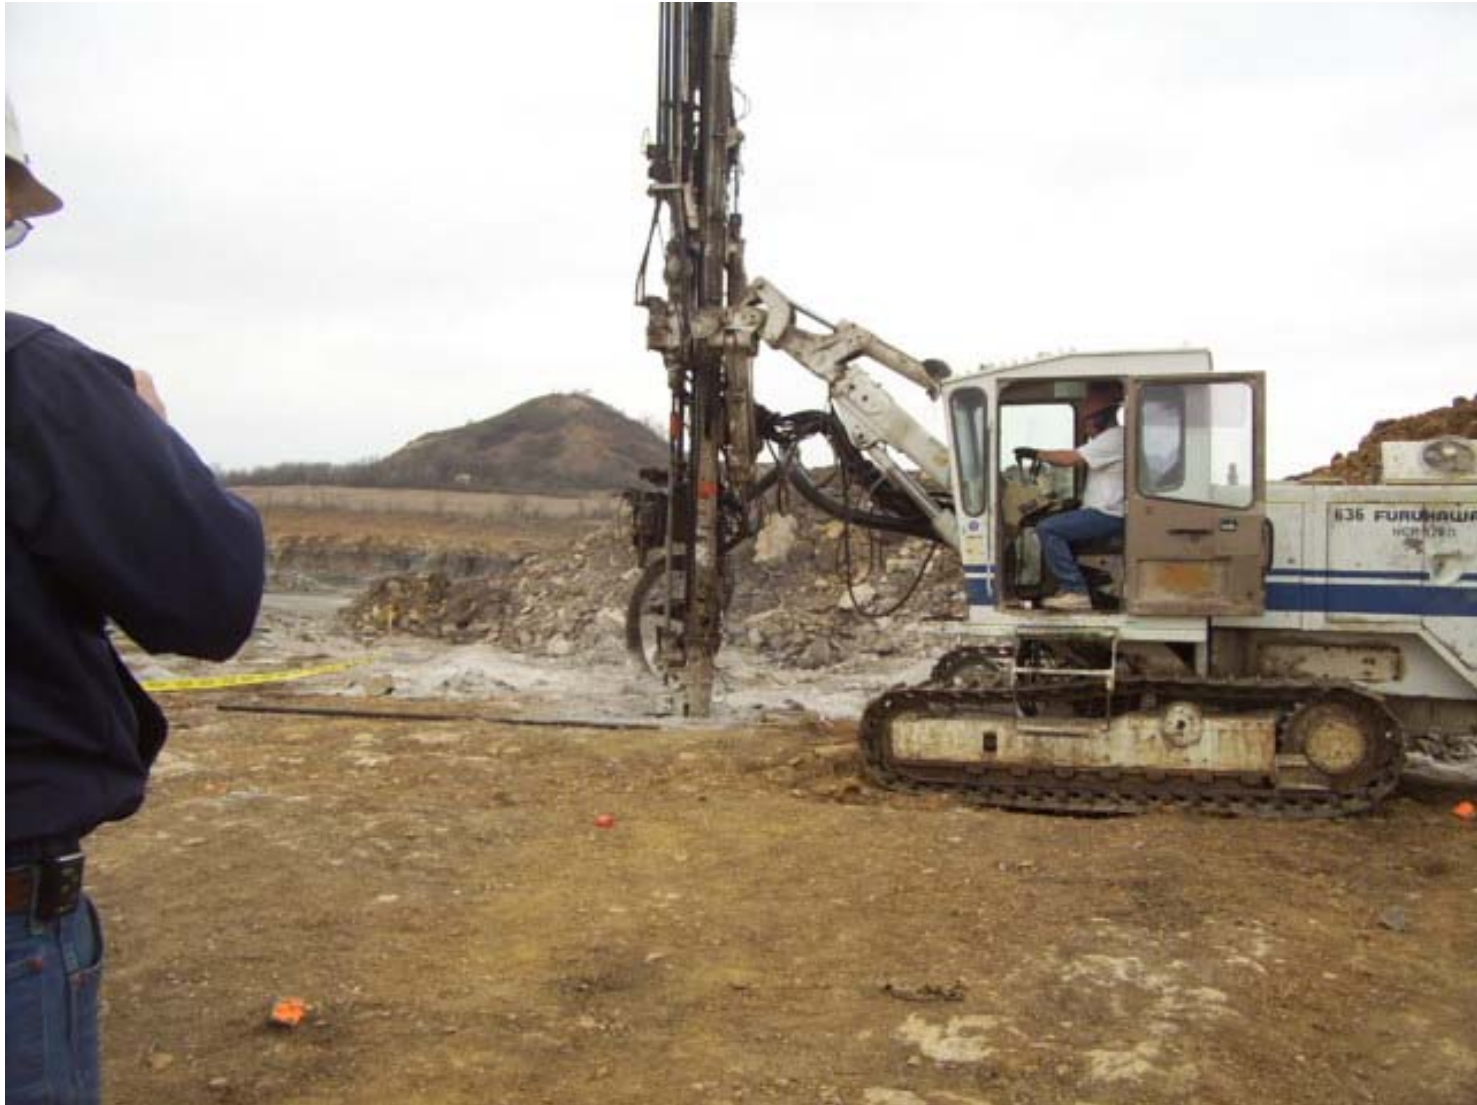
636 Furukawa HCR 12 ED Rock Drill

A 14-foot starter steel and a 12-foot steel were found in the prior hole drilled. One used steel was found in the magazine. The victim was manually feeding a steel into the collar with the mast vertical and the drill head rotating when it cross threaded and entangled him.

- Drill steel being added did not come from the storage magazine on the drill.
- Victim physically placed the drill steel on the rotating striker bar.
- Drill mats was in the vertical drilling position.
- Drill not turned off.
- Victim did not follow procedures. Two persons required to place steel in magazine with drill turned off and in lowered horizontal position.
- Victim's clothing became entangled in the drill steel.

- Drill operator did not follow the drill manufacturer's procedures for adding drill steels.

- Train all personnel to help them recognize and understand procedures to safely perform tasks before beginning any work.
- Ensure that personnel follow the manufacturer's procedures when adding drill steels.
- Never manually thread drill steels when the drill head is rotating.
- Do not wear loose fitting clothing when working around drilling machinery.
- Monitor personnel routinely to determine that procedures are followed.

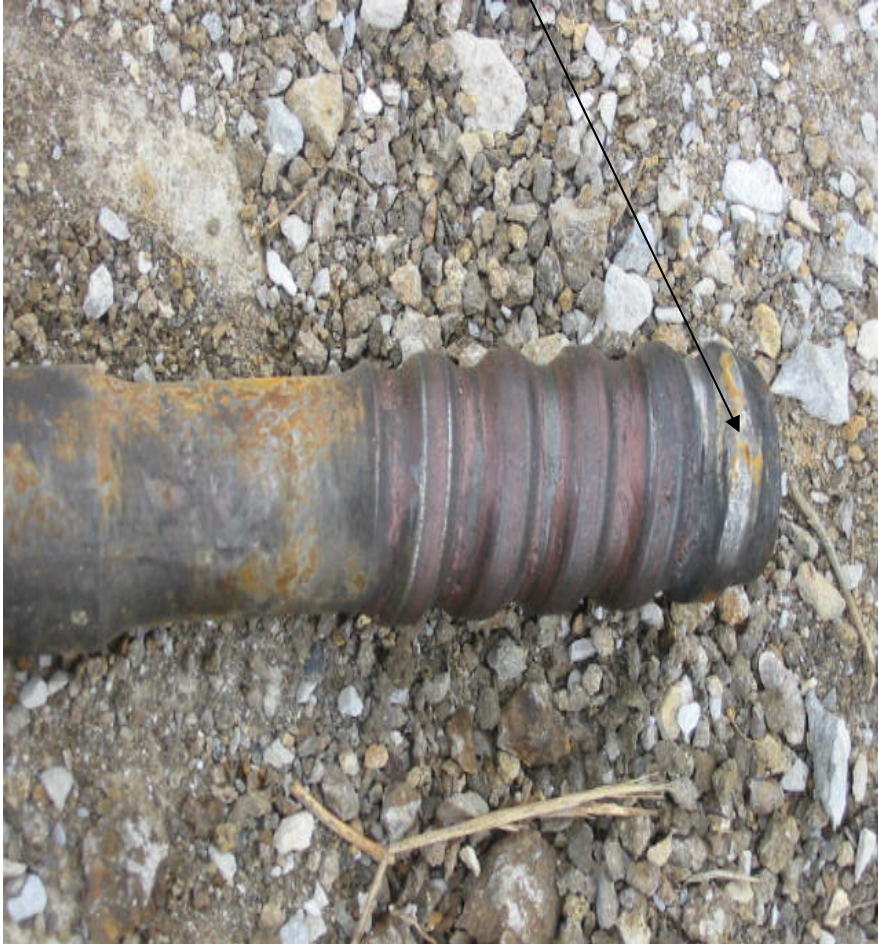
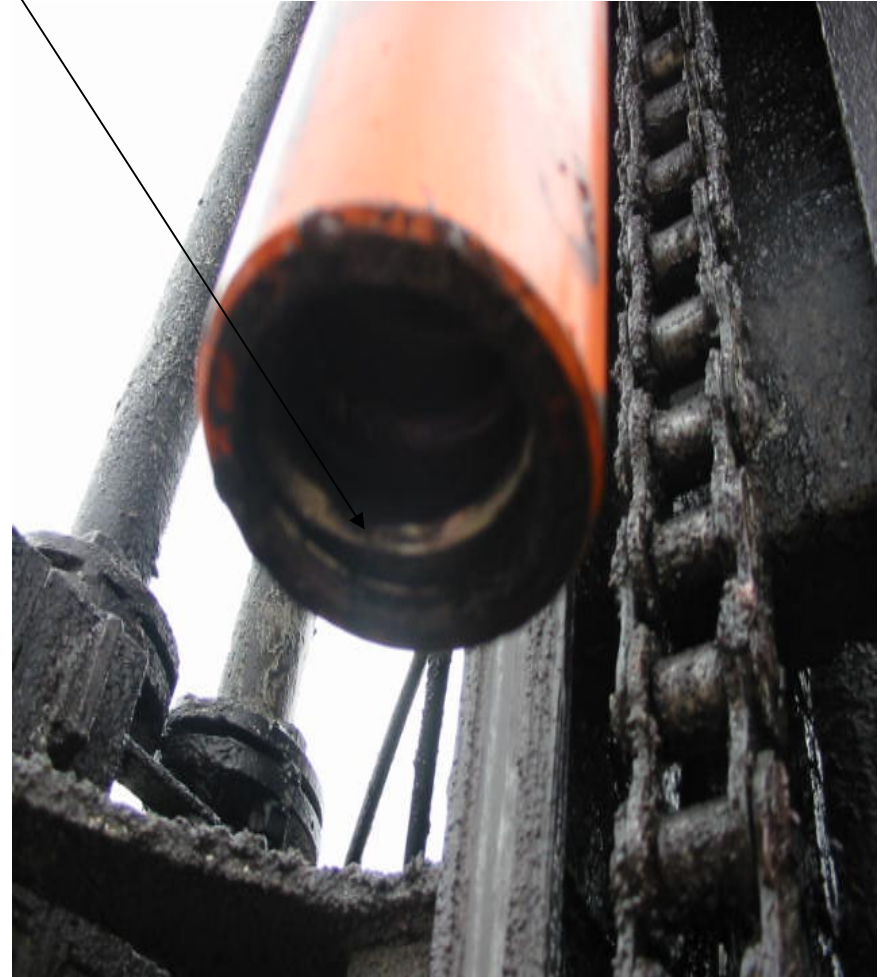
Note the abrasion marks (indicating possible cross threading) on the top of drill steel and in the collar.

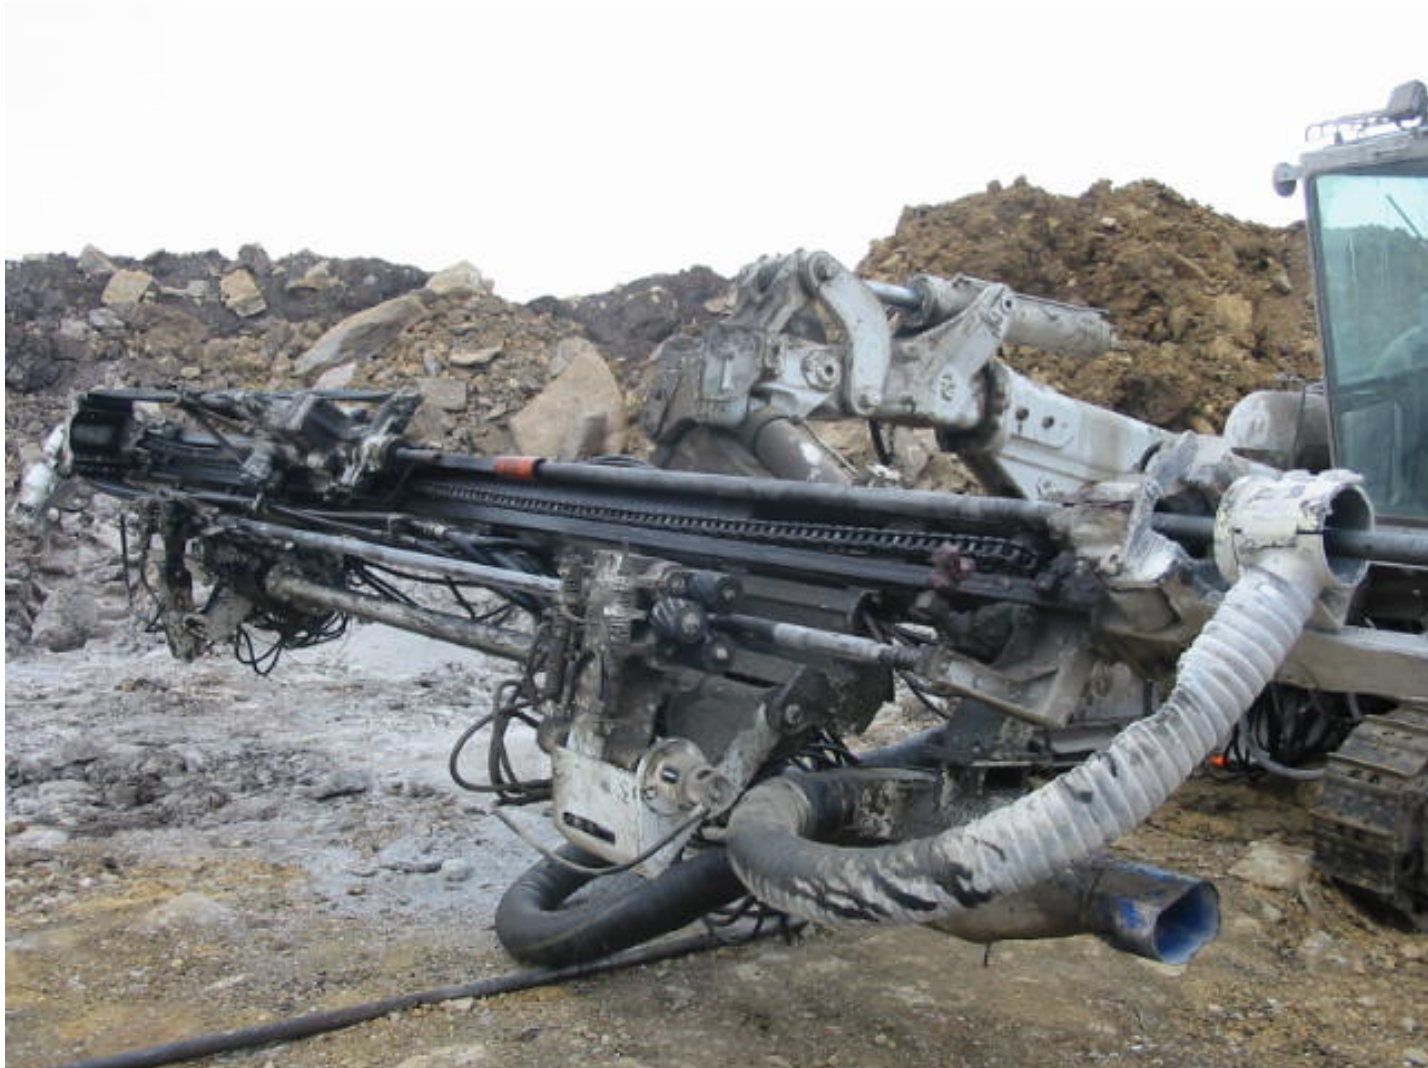
Drill mast in lowered horizontal position for correct way to manually place steel on collar and striker.
