MNMM Fatal 2004-20

- Powered Haulage
- October 12, 2004 (Iowa)
- Crushed Stone Operation
- Truck Driver
- 58 years old
- 17 years experience

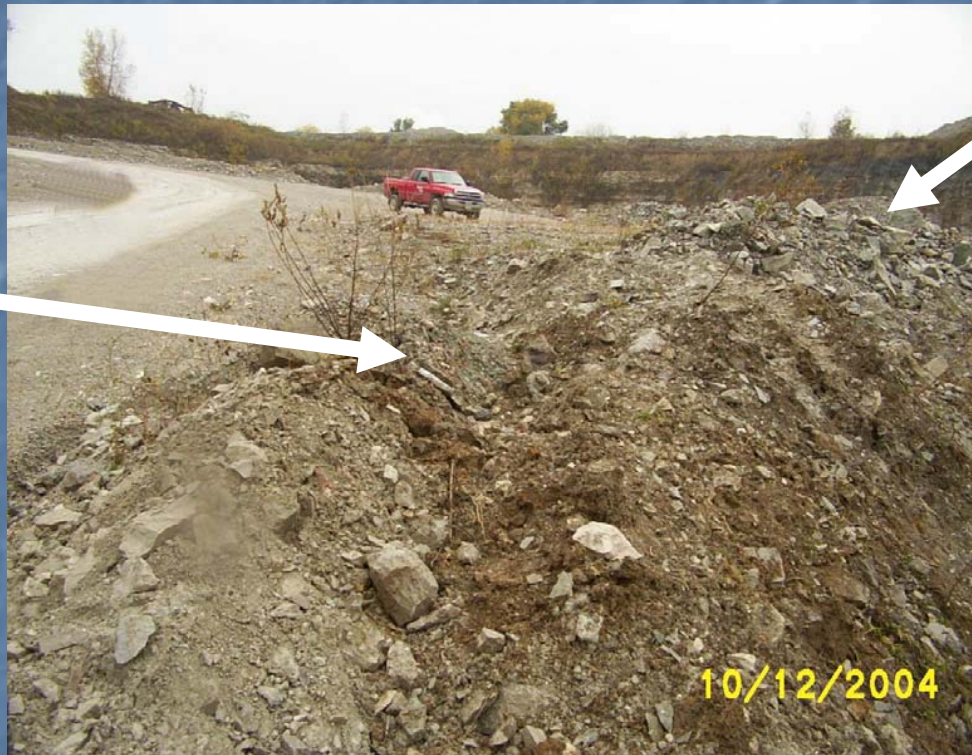
- The victim was driving a loaded haul truck down grade on a mine road when the truck traveled over the berm and came to rest about 20 feet below the edge of an embankment.

Area where truck ran over berm

Dual tire
marks

Dual tire marks

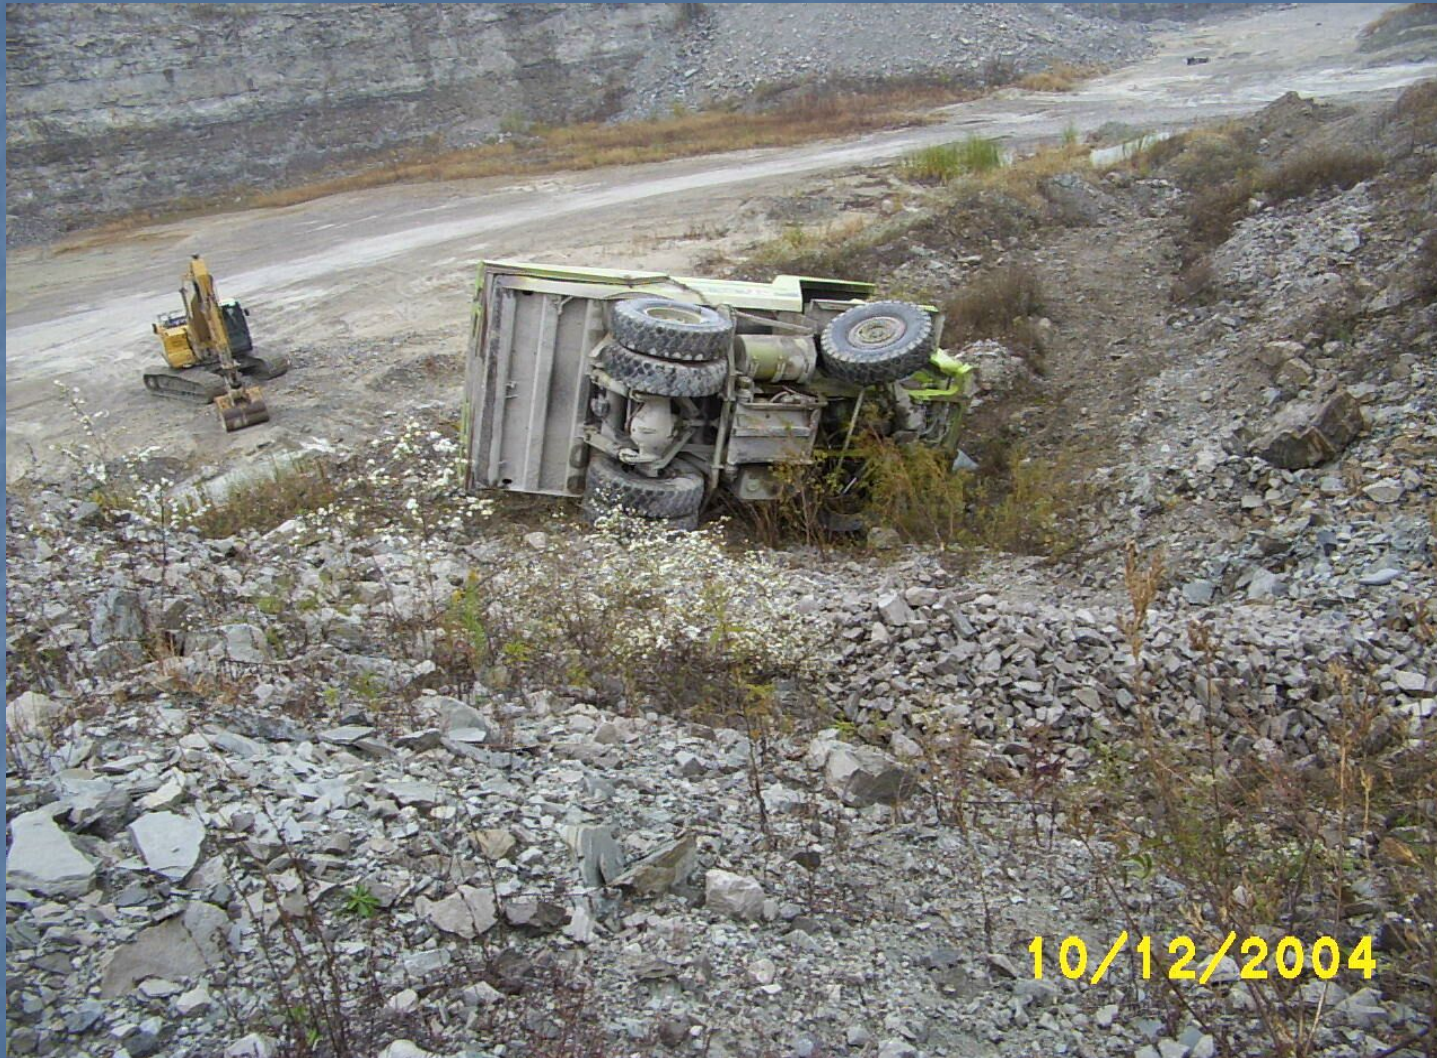
- The accident was caused by the failure to maintain the braking systems on the truck in a functional condition. Policies, standards, and controls were inadequate in that examinations of the haul truck had not identified the leaking wedge-type hydraulic brake actuators and oil coated drums as a safety defect. The victim was not wearing a seat belt at the time of the accident.

- Management policies, standards, and controls were inadequate. Examinations of the truck failed to identify the leaking wedge-type hydraulic brake actuators and oil coated drums as a safety defect. Maintenance procedures were deficient and didn't ensure the service brake system was maintained according to the specifications required by the manufacturer.

- Mobile equipment operators should ensure their seat belt is fastened before operating the equipment.
- Conduct thorough pre-operational checks on all self- propelled mobile equipment and ensure safety defects are corrected before operating the equipment.
- Ensure that service brakes will stop and hold mobile equipment prior to operating it.
- Operate trucks in an appropriate gear for the grade, load, and speed.
