MNMF Fatal 2004-21

- Electrical
- October 16, 2004 (Missouri)
- Crushed Stone Operation
- Laborer
- 37 years old
- 6 months experience

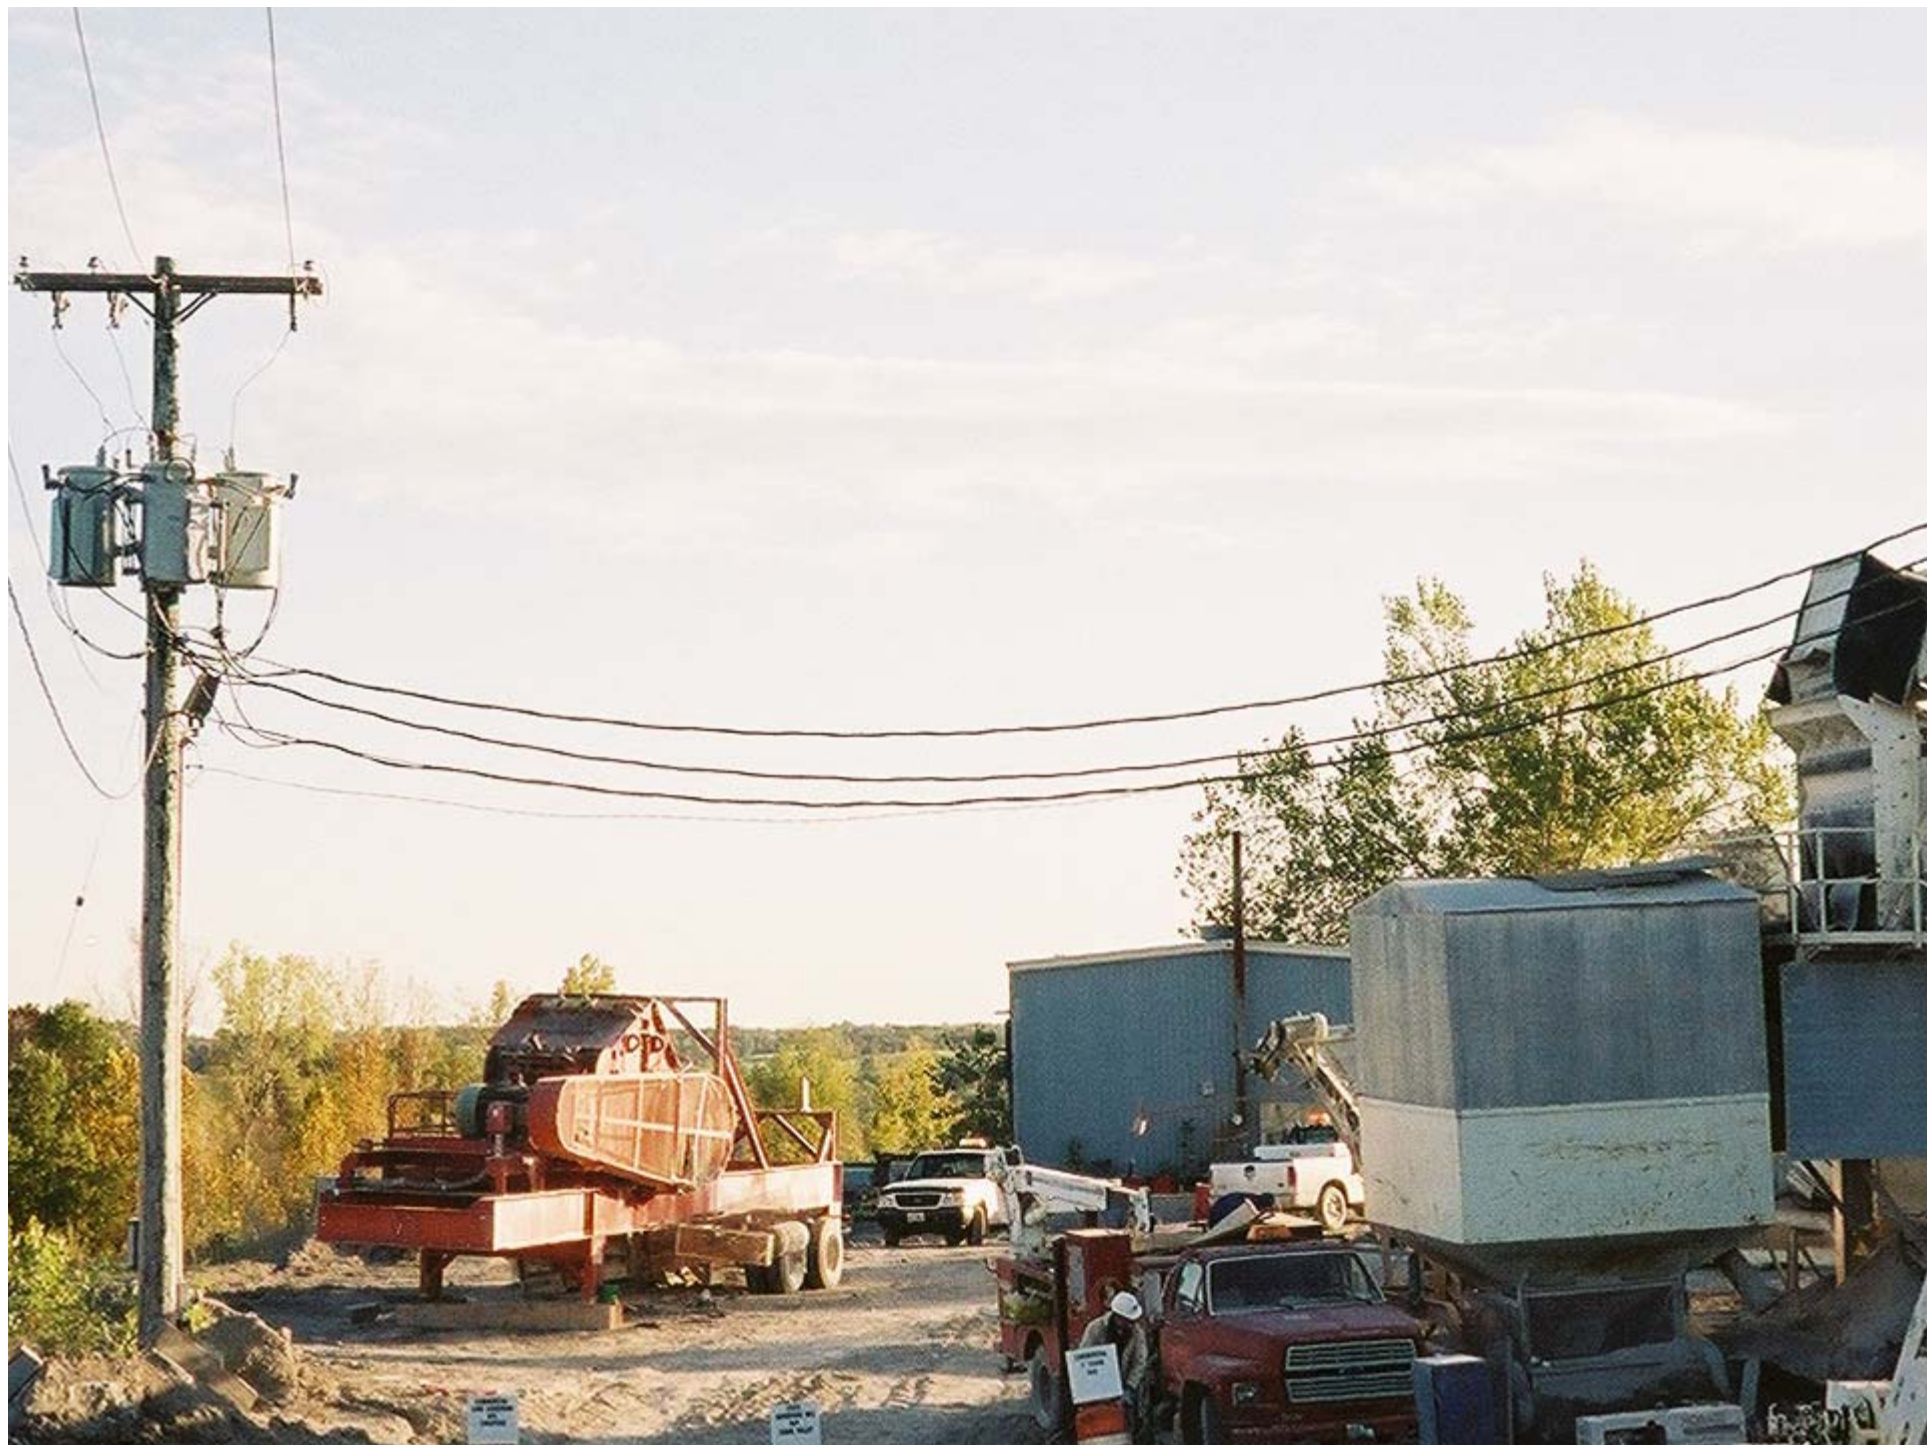
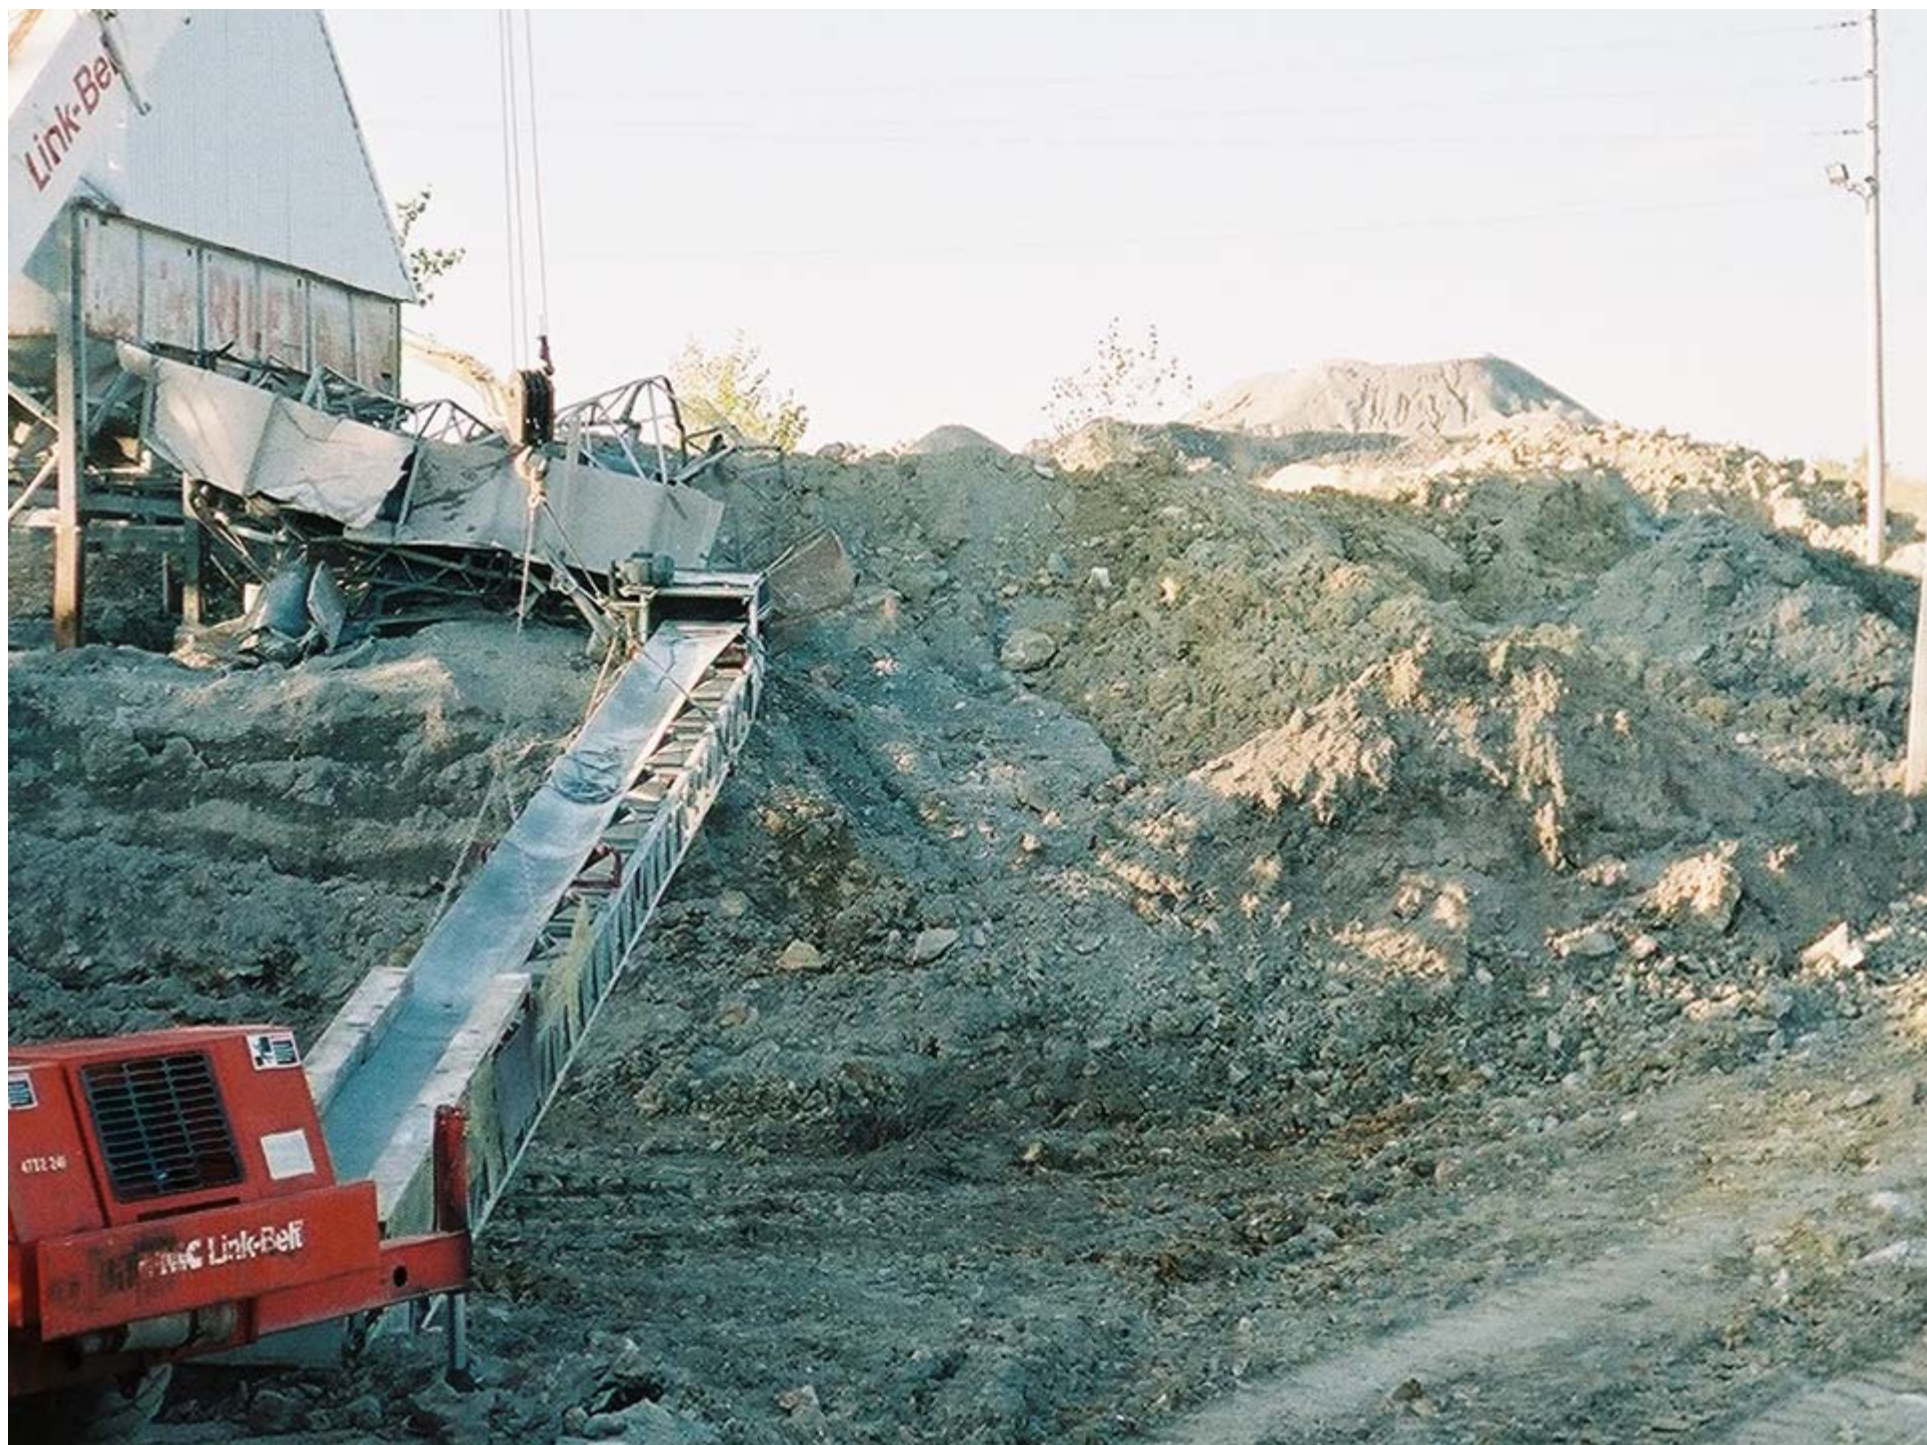
- A 4-man crew was positioning a conveyor utilizing a rubber-tired crane. The victim had both hands on the end of the conveyor. He was electrocuted when the crane hoist cable contacted a high-voltage power line.

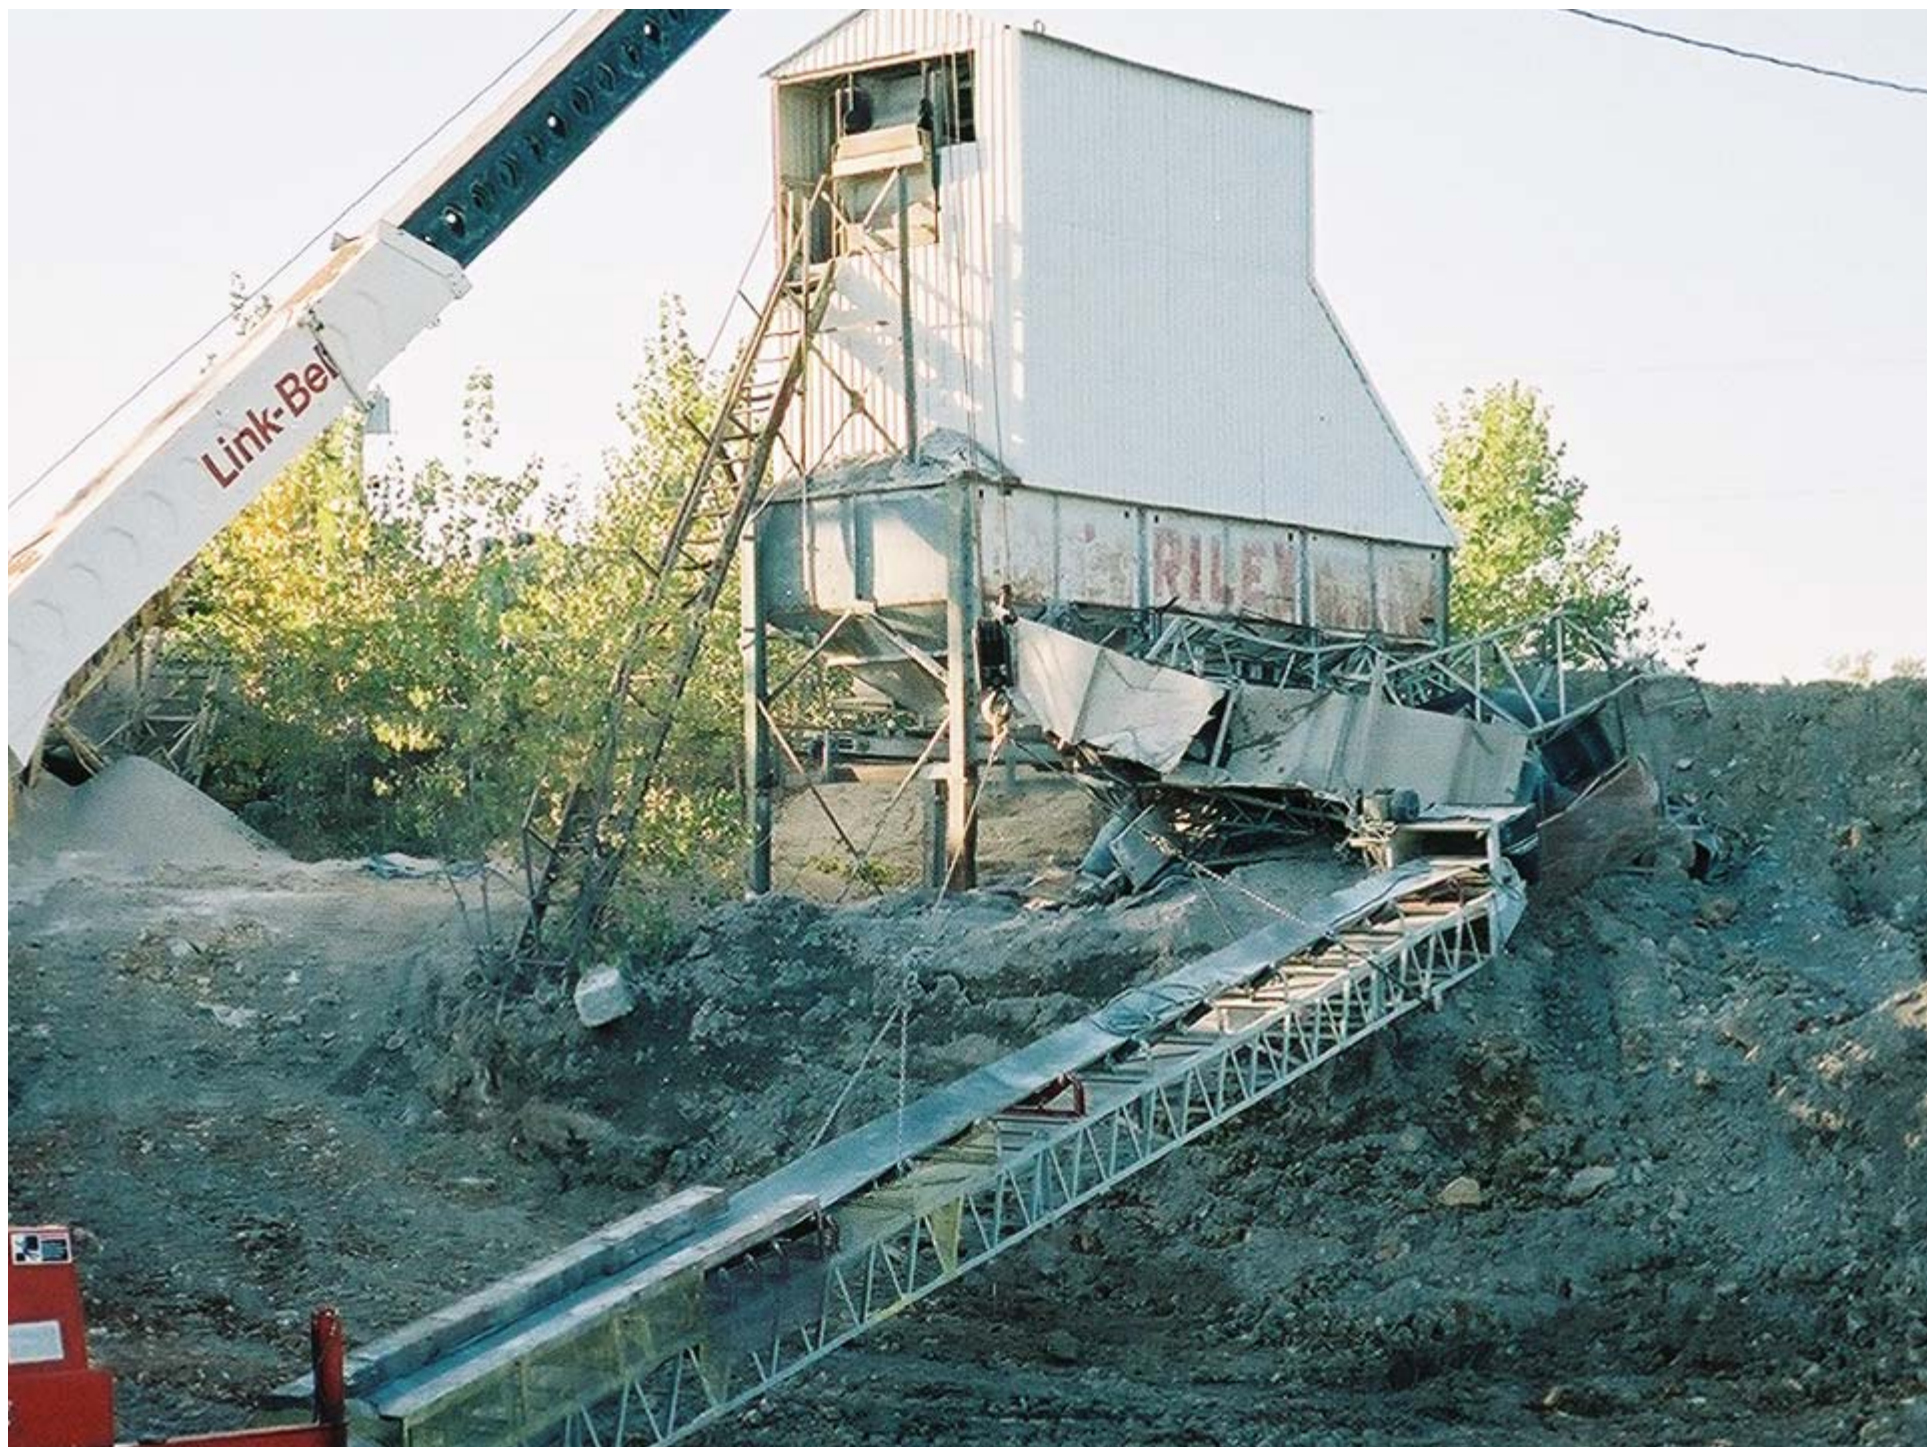
- The accident occurred because safe operating procedures were not implemented before operating the crane near an energized high-voltage power line. The power line was not de-energized and no other precautionary measures were taken. A risk assessment to identify all possible hazards and establish safe procedures was not conducted by the crew prior to starting this task.

- Management policies and controls were inadequate. Safe work procedures were not initiated to ensure that miners were protected while working near energized high-voltage power lines.

- Policies and administrative controls were inadequate and failed to assign a ground person to signal the crane operator during all phases of the lift. The crane operator was unable to observe the distance between the hoist cable and the power line.

- Before the work begins, miners should jointly discuss the job tasks, identify all possible hazards, and ensure that steps are taken to safely perform the task (risk analysis).
- Ensure that high-voltage power lines are de-energized before operating equipment within 10 feet of them.
- Ensure that someone on the ground is designated to give signals to the crane operator making the lift.

- Train all miners to recognize hazards associated with crane lifting and ensure that tag lines are attached to guide the load.
- Ensure that miners are in a safe location prior to lifting the load.
