## Coal Mine Fatal Accident 2004-17

Operator:	Hobet Mining, Inc.
Mine:	Hobet 21 Surface Mine
Accident Date:	August 29, 2004
Classification:	Electrical
Location:	District 4, Boone County, WV
Mine Type:	Surface
Employment:	306
Production	14,000 Tons/Day

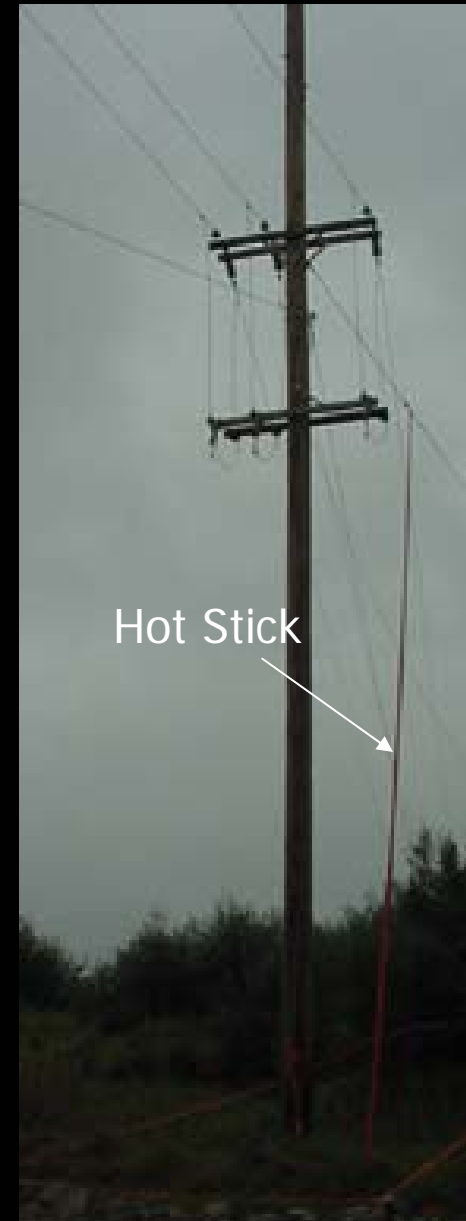
The mine operator discovered that a burned fuse link on a high voltage, pole-mounted, disconnect had resulted in a gap of 8-9" between the base of the middle phase knife switch and the load-side conductor.

The lineman climbed the pole to make the connections. Grounding jumpers were not hooked to the high voltage lines on the de-energized side of the disconnects prior to conducting the repair work.

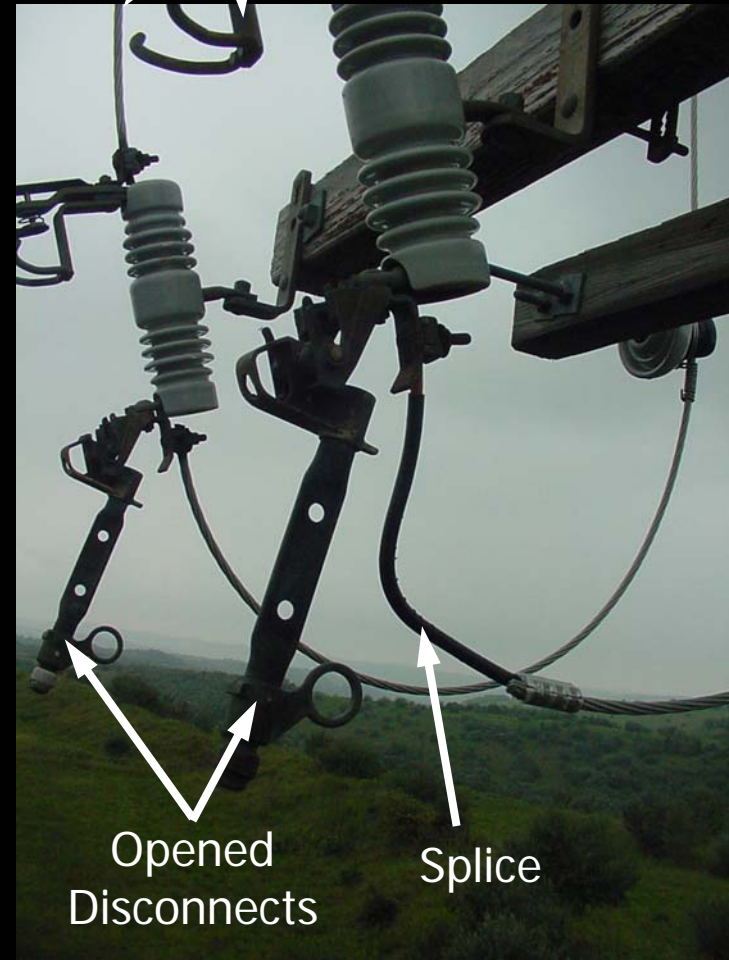
The foreman watched from the ground as the lineman, who was not a certified electrician, installed the splice within close proximity to the line side of the disconnects, which were energized with 12,470 volts.

Energized Load-Side Conductors

*Causal Factor:* The victim, an uncertified person, performed electrical work within close proximity to energized high voltage. Electrical power was deenergized at the pole mounted disconnects where the repair was being made rather than the substation or a set of disconnects located ¼ mile away.

*Corrective Actions:* The independent contractor's Employee Handbook & Safety Manual addresses electrical work performed (Awareness-Work Rules): A certified electrician will perform all electrical work according to MSHA standards. The mine operator's new policy and safety procedures for independent contractors performing electrical work on mine property is addressed in the training plan. The supervisor in charge of the electrical repair will request to see the contractor employees' electrical certification cards and a photo ID of all contractor employees who will be performing work for which certification is necessary. All affected persons were retrained in these requirements.
